The WRIA 9 Marine Shoreline Monitoring and Compliance Pilot Project

April 2014

King County

Department of Natural Resources and Parks
Water and Land Resources Division

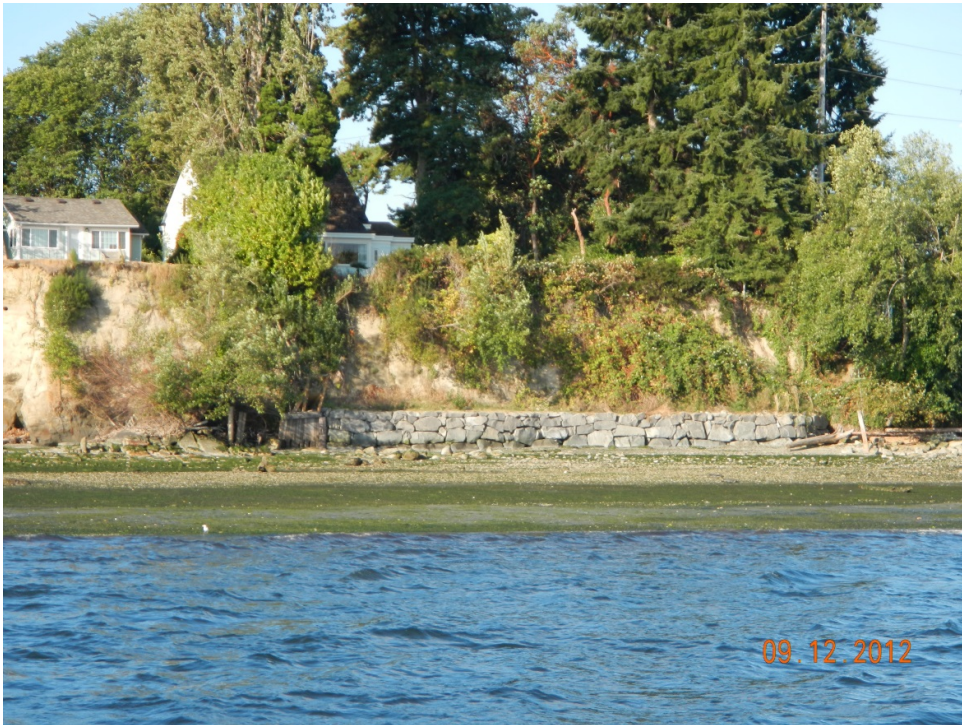
Figure B-1. An example of a rebuilt or major repair bulkhead.

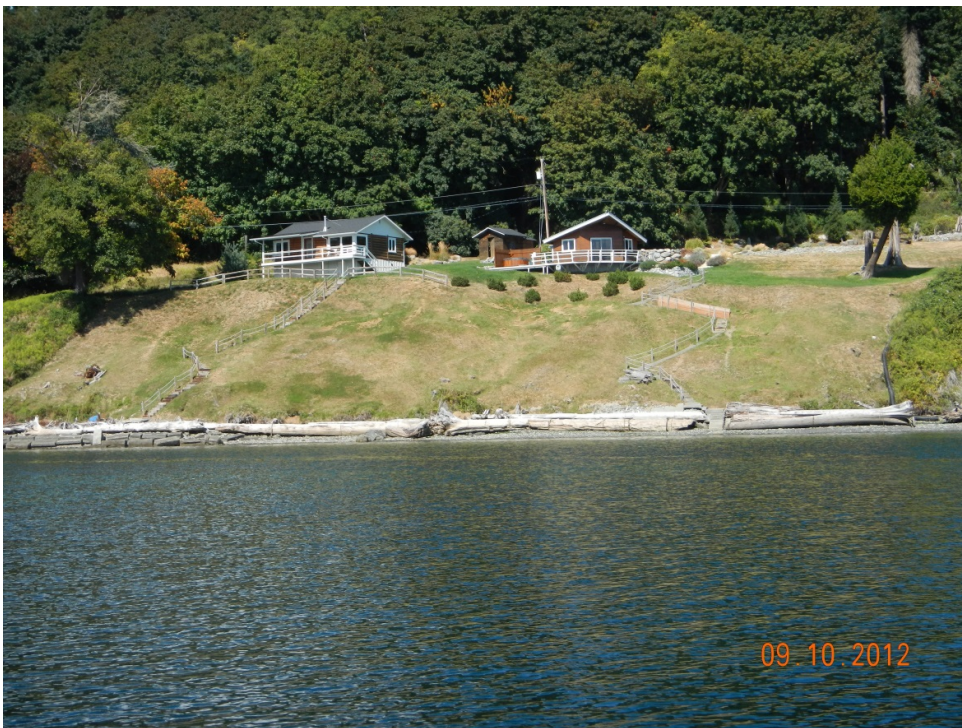
Figure B-2. An example of a new bulkhead.

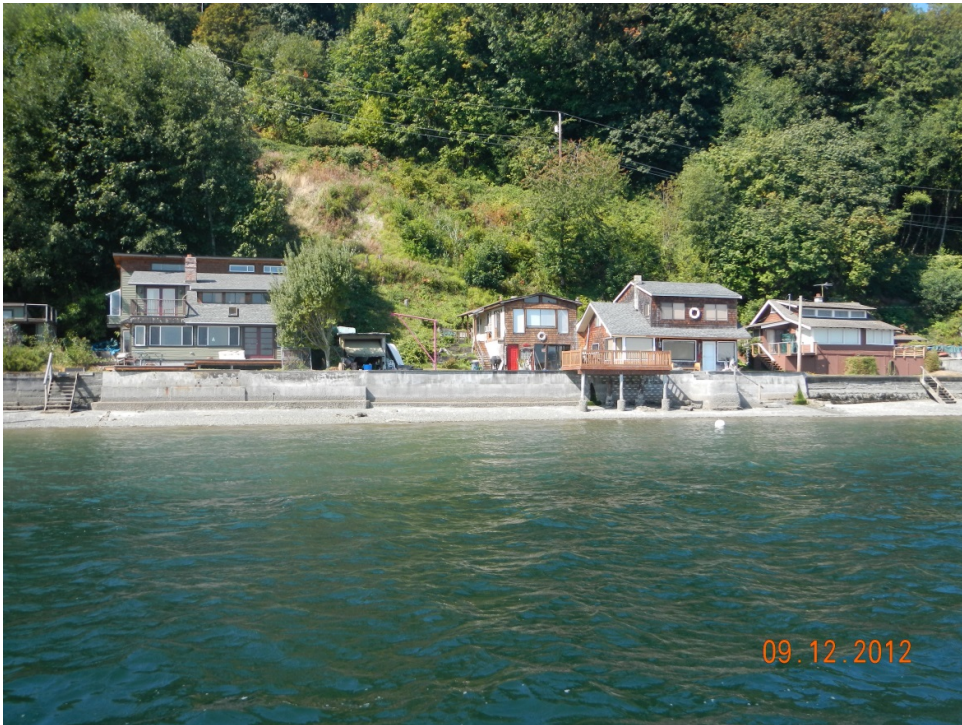
Figure B-3. An example of a major repair to a bulkhead and a new overwater structure.

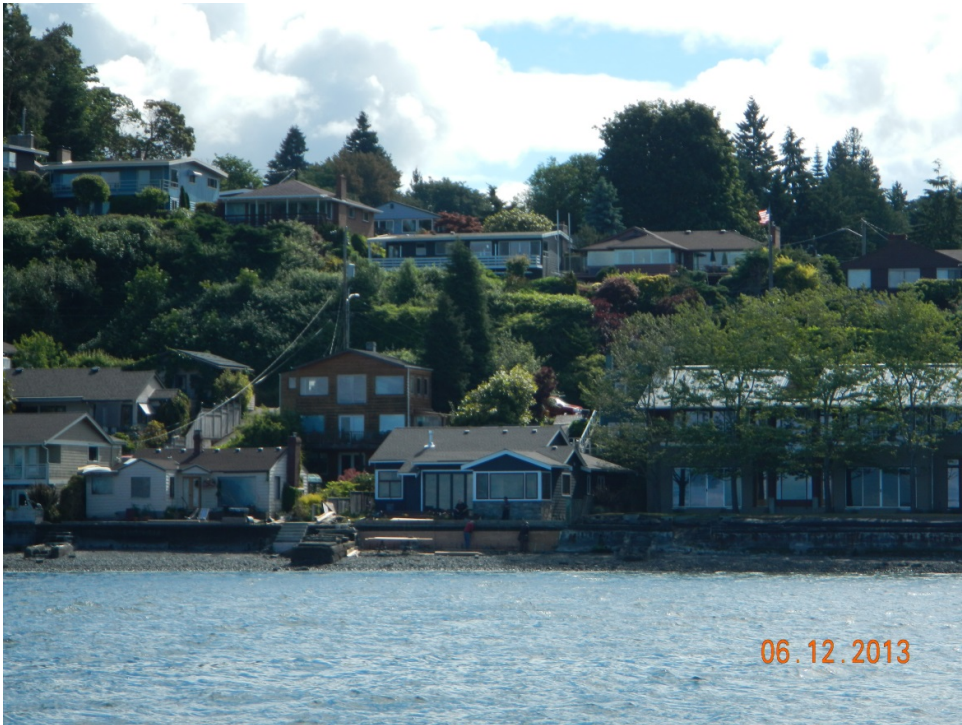
Figure B-4. An example of a permitted minor repair to a concrete bulkhead occurring at the time of the survey.

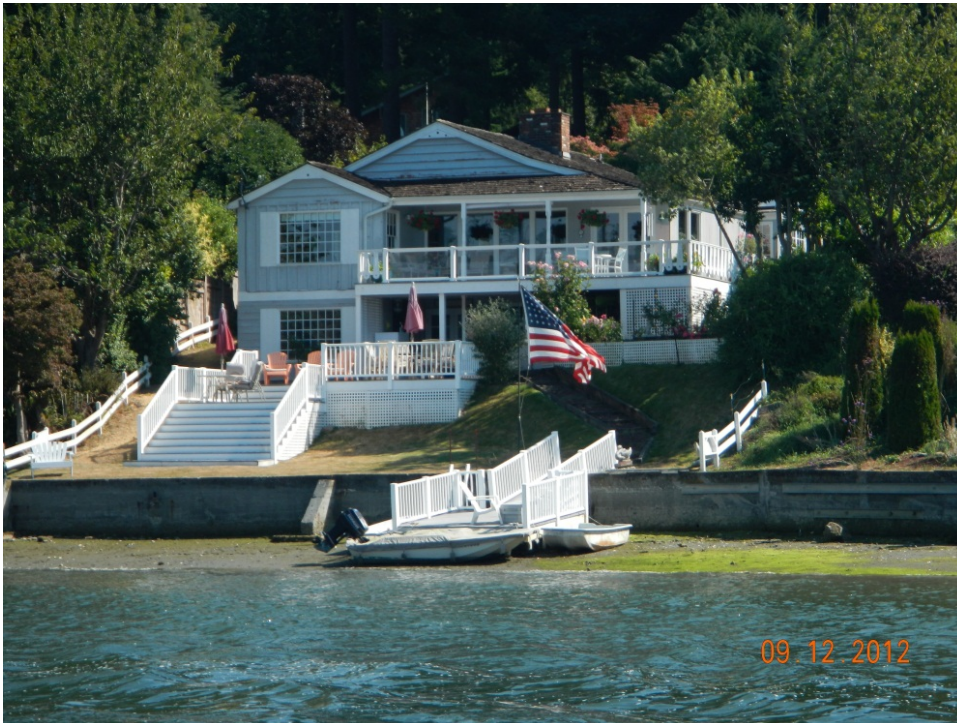
Figure B-5. An example of a new dock.

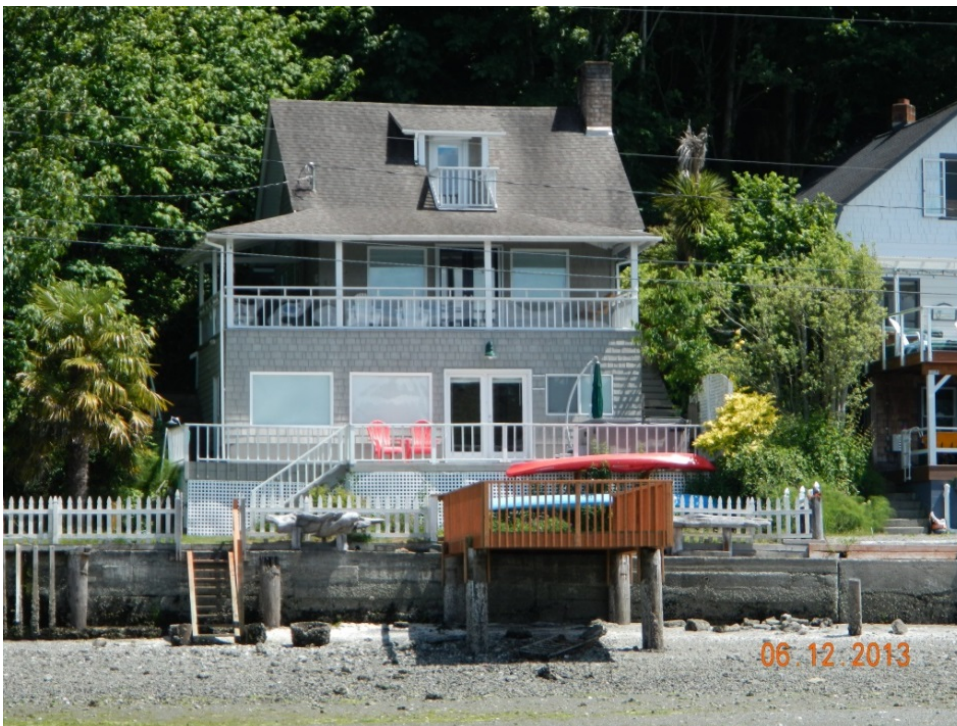
Figure B-6. An example of a rebuilt dock.

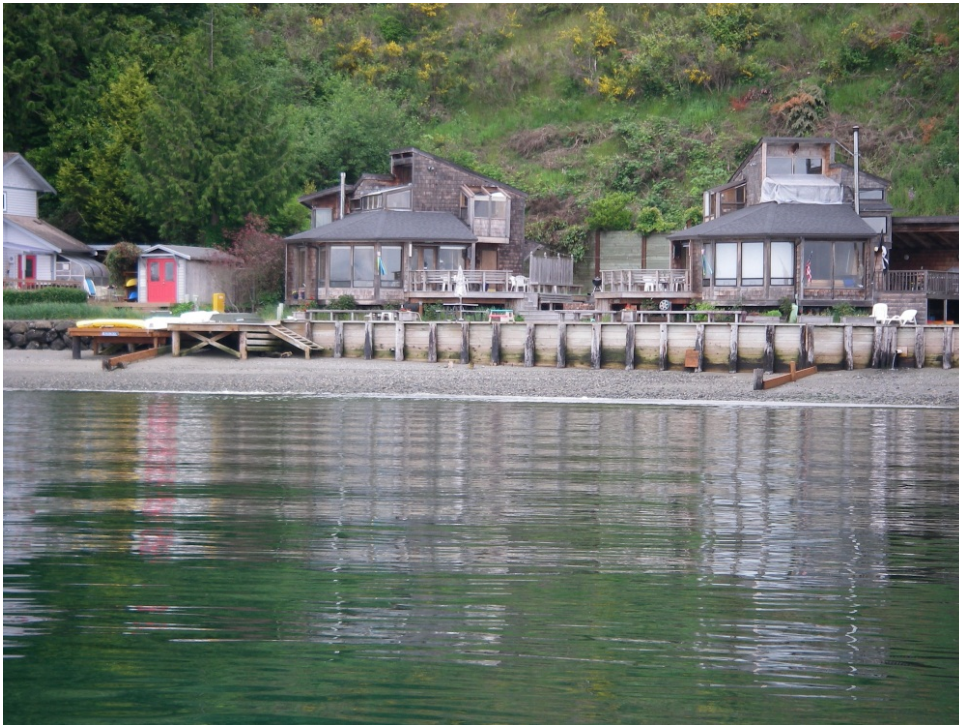
Figure B-7. An example of new wooden groins.

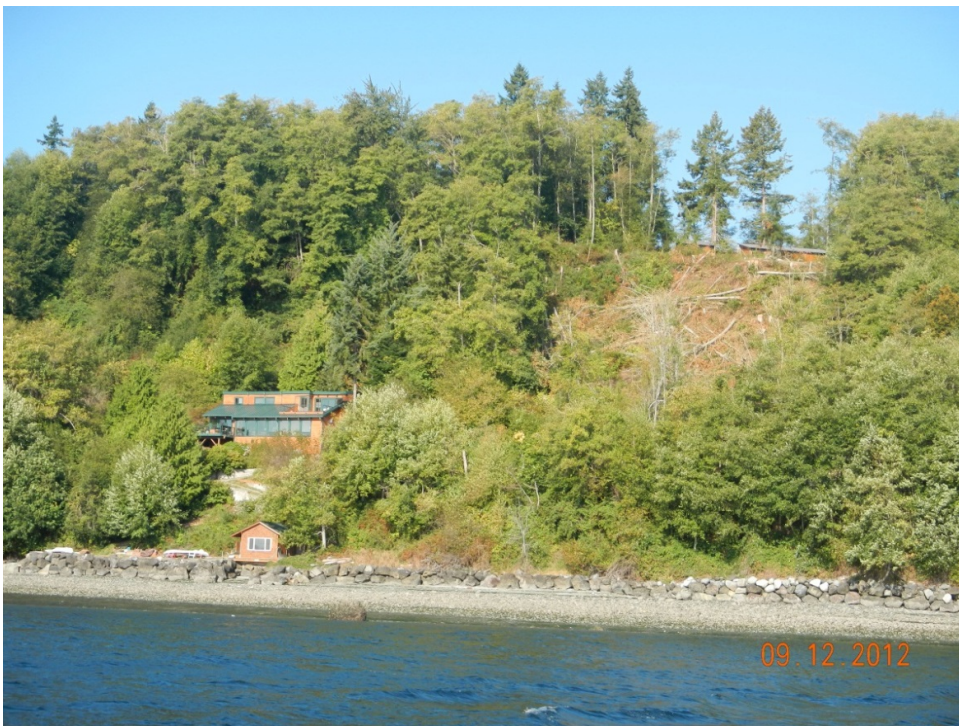
Figure B-8. An example of clearing of trees on a steep slope.

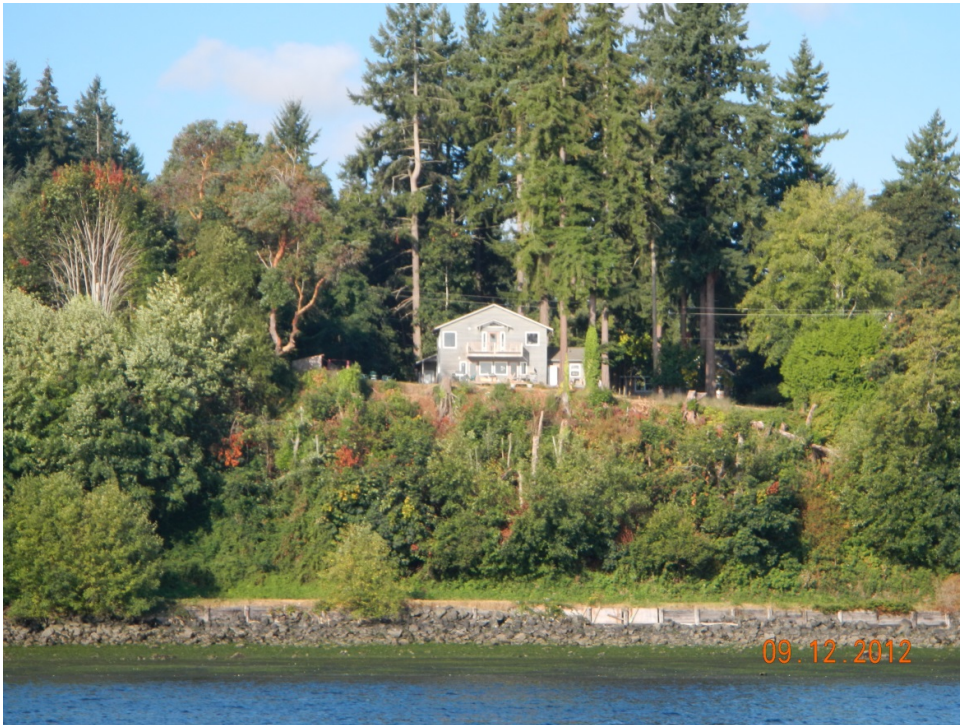
FigureB-9. An example of clearing and tree topping along a steep slope above a public road.

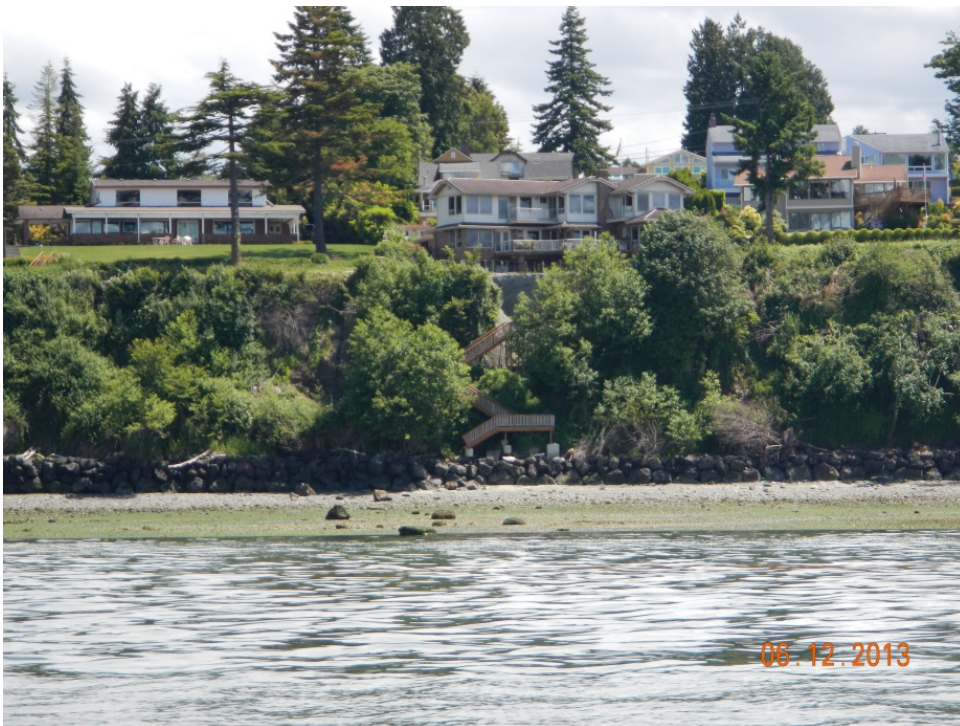
Figure B-10. An example of a site with a rebuilt set of stairs.

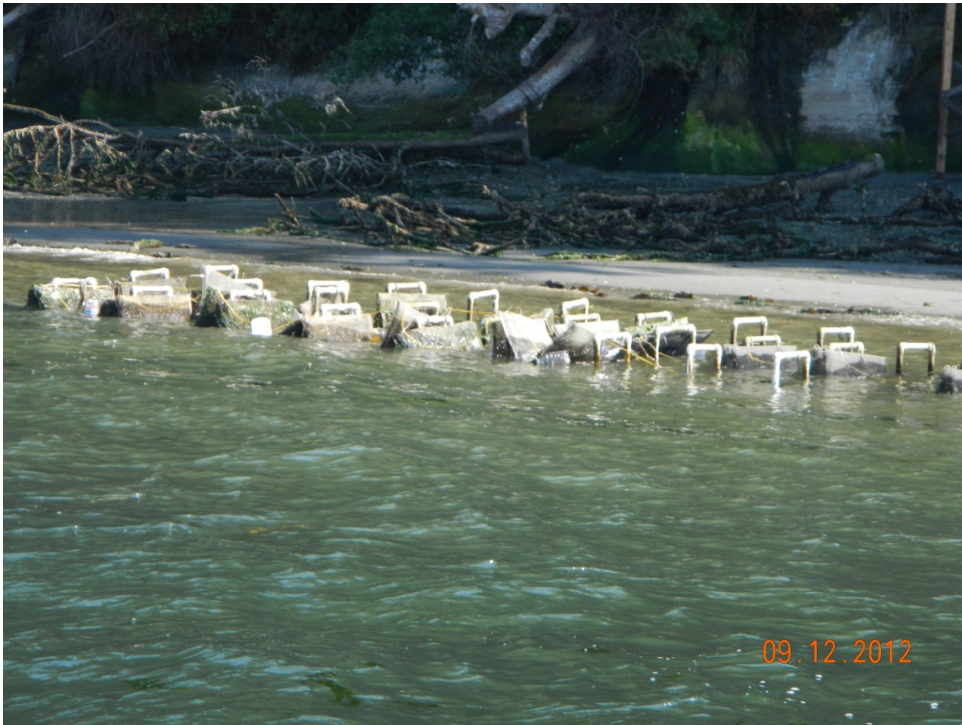
Figure B-11. The one example of an aquaculture operation.

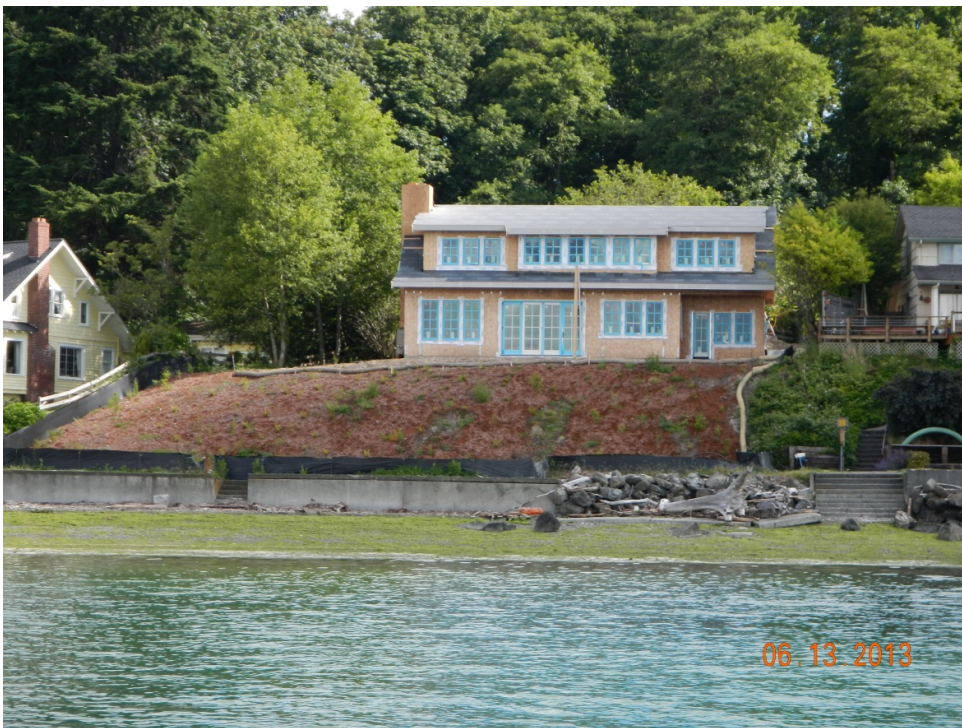
Figure B-12. An example of a new house and associated clearing.

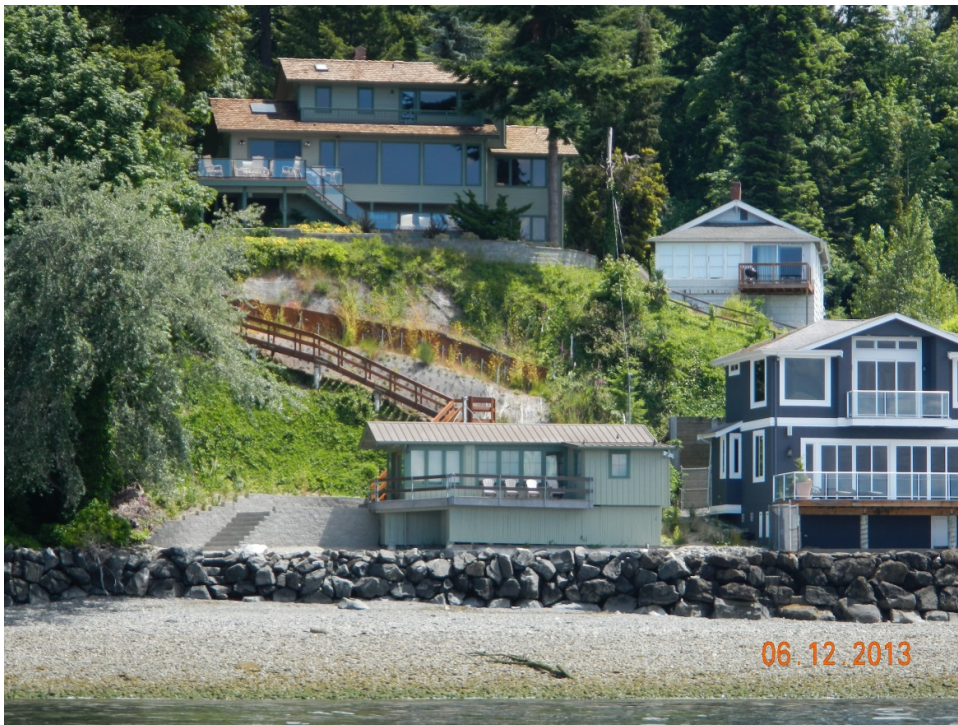
Figure B-13. An example of new retaining walls.

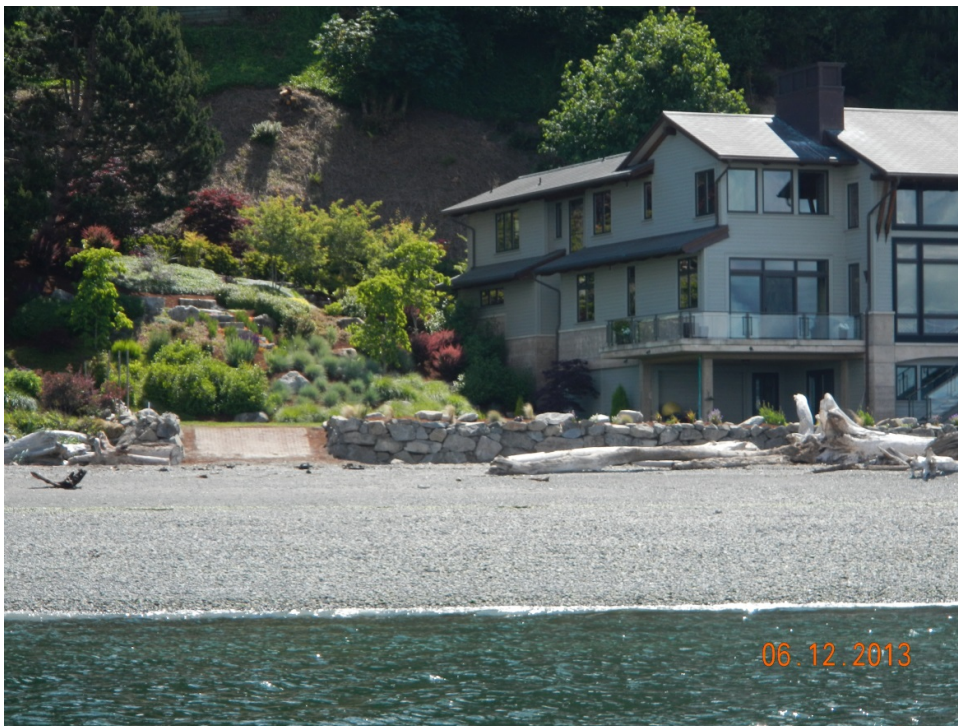
Figure B-14. An example of a new boat ramp.
