Hansen Creek Alluvial Fan and Wetland Restoration Project Report

Prepared by the Upper Skagit Indian Tribe
Environmental Planning Department
February 2012

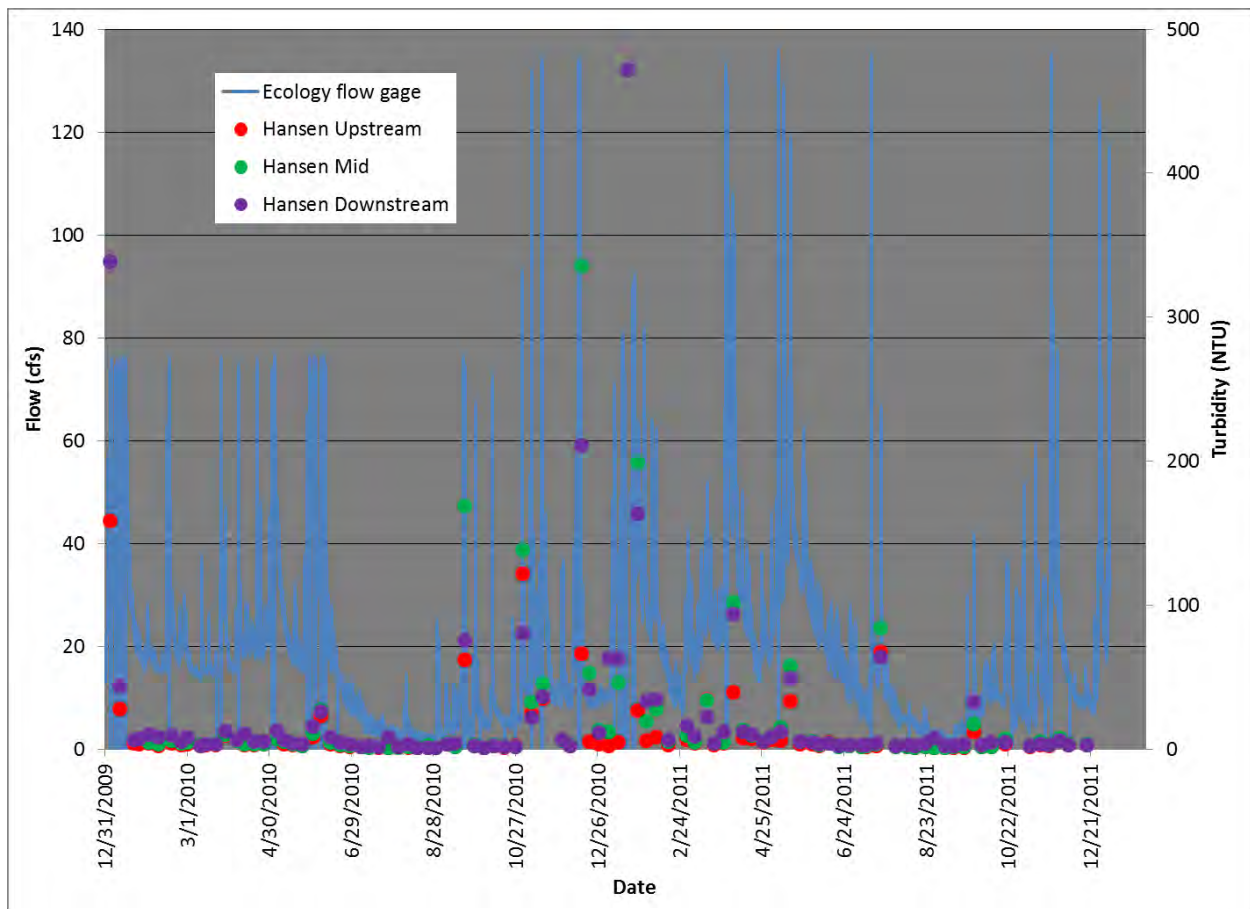
The turbidity on Hansen Creek reflected the flow conditions. During high flow events there was a spike in turbidity (Figure 8). When the flow receded, the turbidity dropped as well. However, this pattern was different between the spring and the fall of 2010. In the fall of 2010, the creek avulsed into the east fan and began scouring away sediment. Thus, under similar flow conditions, the turbidity was higher in fall 2010 –spring 2011 than it was in spring 2010. The new east fan channel has since begun to stabilize and the downstream turbidities remained low during high flow events in the fall of 2011. Additionally, due to several large

sediment transport events, the Ecology flow gage experienced dramatic changes in the channel bed morphology, affecting the accuracy of the flow gage. According to Ecology staff, the flows were underrepresented due to an inaccurate rating curve. Despite the inaccuracy of the flow gage, it was possible to estimate the flows; the discharge was 5-10 cfs in the dry season and 20-40 cfs in the wet season, with rain events bringing flows even higher. The higher turbidities are attributable to the natural process of channel avulsion and side channel development in the early restoration site as the channels and vegetation mature.

Figure 8. Graph comparing turbidity with flow data from the Ecology flow gage. Left vertical axis shows flow and right vertical axis shows turbidity. 2010 and 2011 data are included as a single data series.

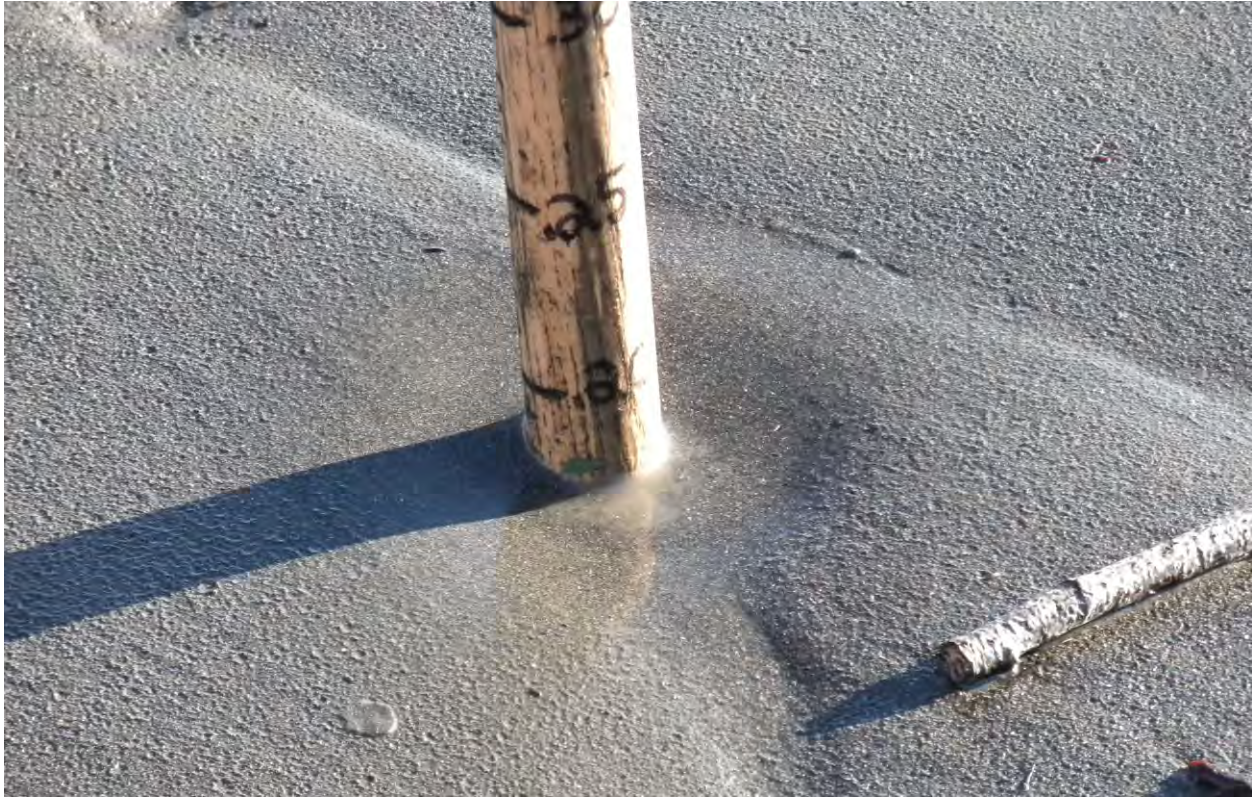
Figure 9. Almost 20 cm of sediment deposition in a wetland channel.

Sediment deposited in the wetland as well, leaving up to 8 inches (20 cm) of fine silt in many areas. In addition, both the constructed and naturally carved channels allowed for consolidation of channel bottoms via sorting. Larger pebbles now fill the channels and the substrate is approaching an ideal compaction and sediment size (Figure 11 and Figure 16).

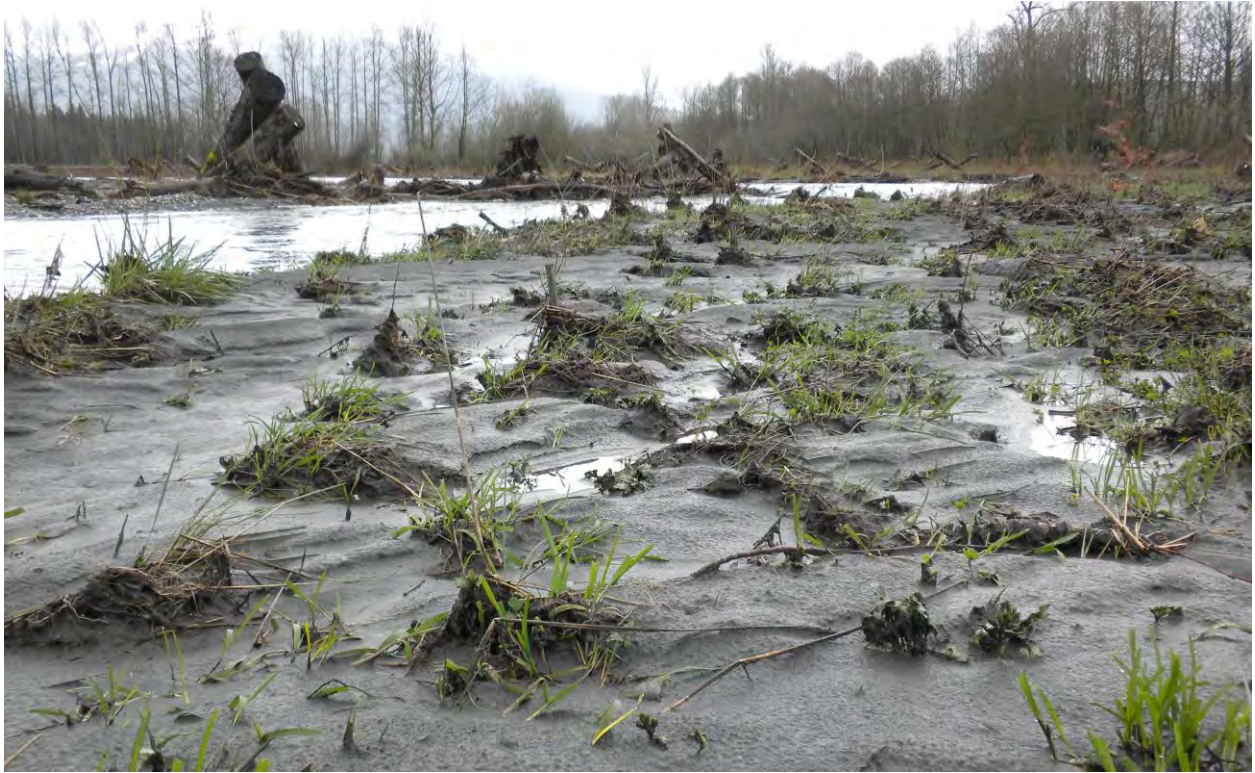
Sediment deposition measurements have been estimated by the design team, Herrera Environmental Consultants using the Syvitski Analysis. The project has been successful thus far in sediment holding after two wet seasons of receiving near the upper estimated event year sediment load. Sediment transport was estimated for the project between 300 and 33,000 cubic yards, with an annual input average of 3,000 cubic yards. In the alluvial fan where the stream avulsed, sediment sorting began and new layers of light silt can be seen in channels that were activated (Figure 9). The duning effects of water movement and fast deposition can be seen throughout the site and are most notable in areas where the stream topped the banks, spilling into the floodplain (Figure 10).

Figure 10. Sediment deposition in the wetland due to channel overflowing during flood events.

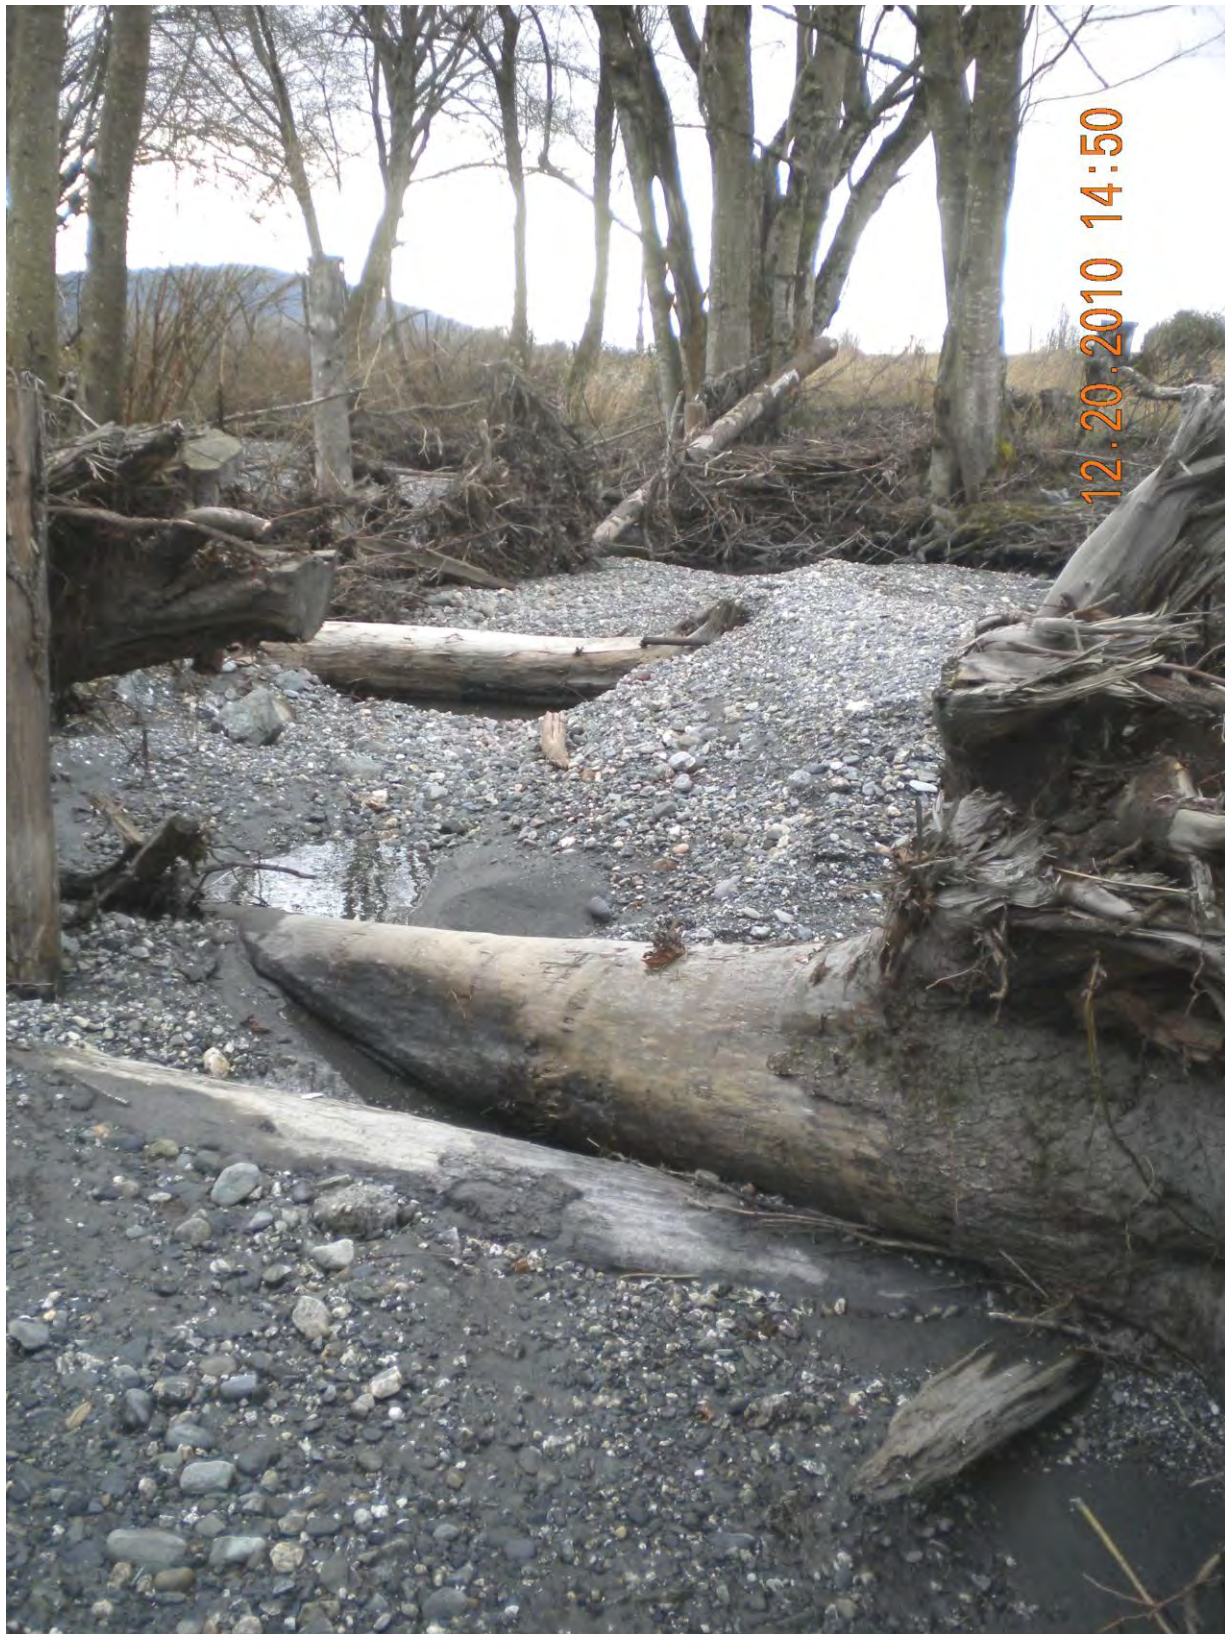
Figure 11. Several feet of sediment were deposited in the historic main stem when the channel avulsed into the east fan design channel.

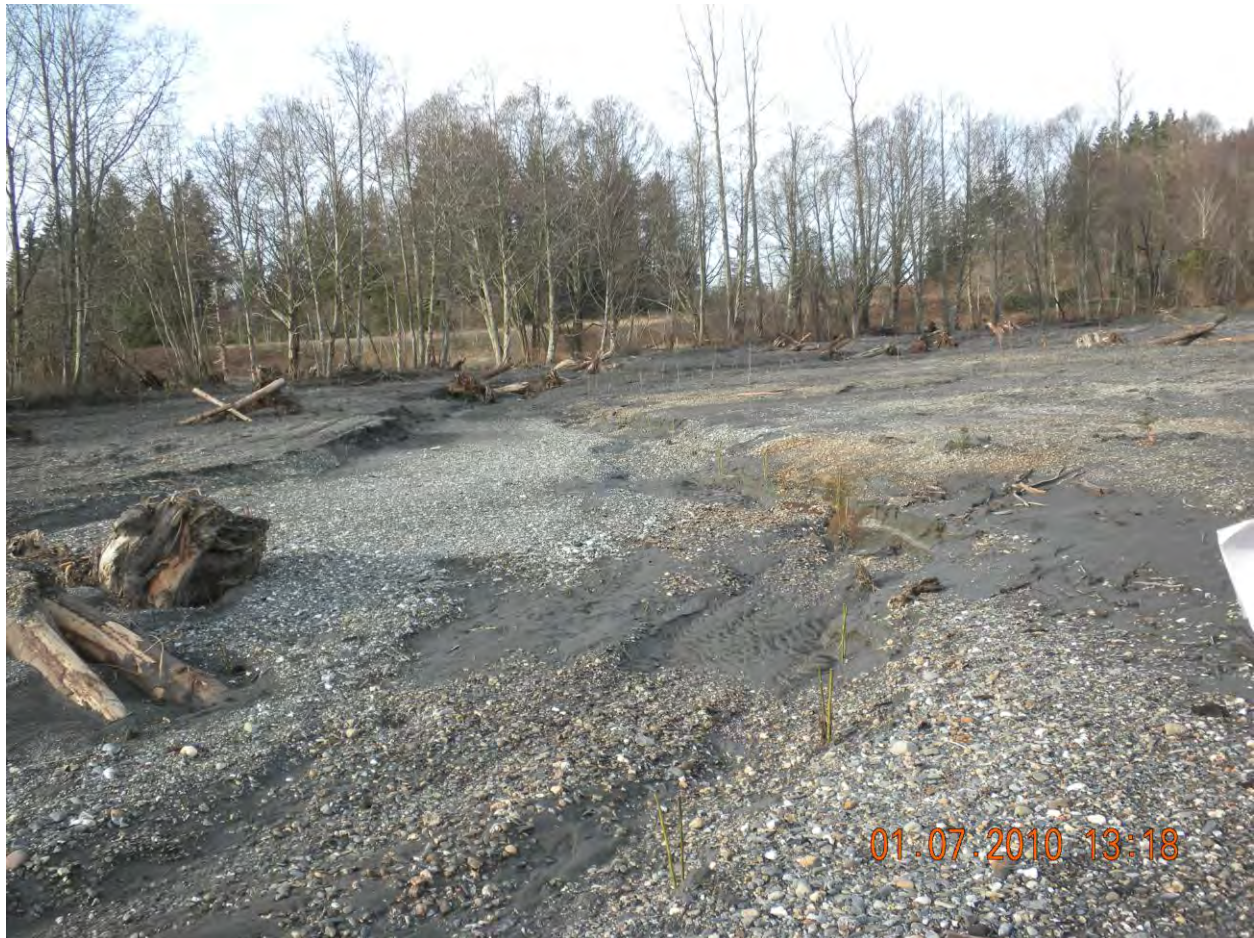
Figure 12. East fan design channel before the Hansen Creek main stem avulsed into this channel (facing upstream).

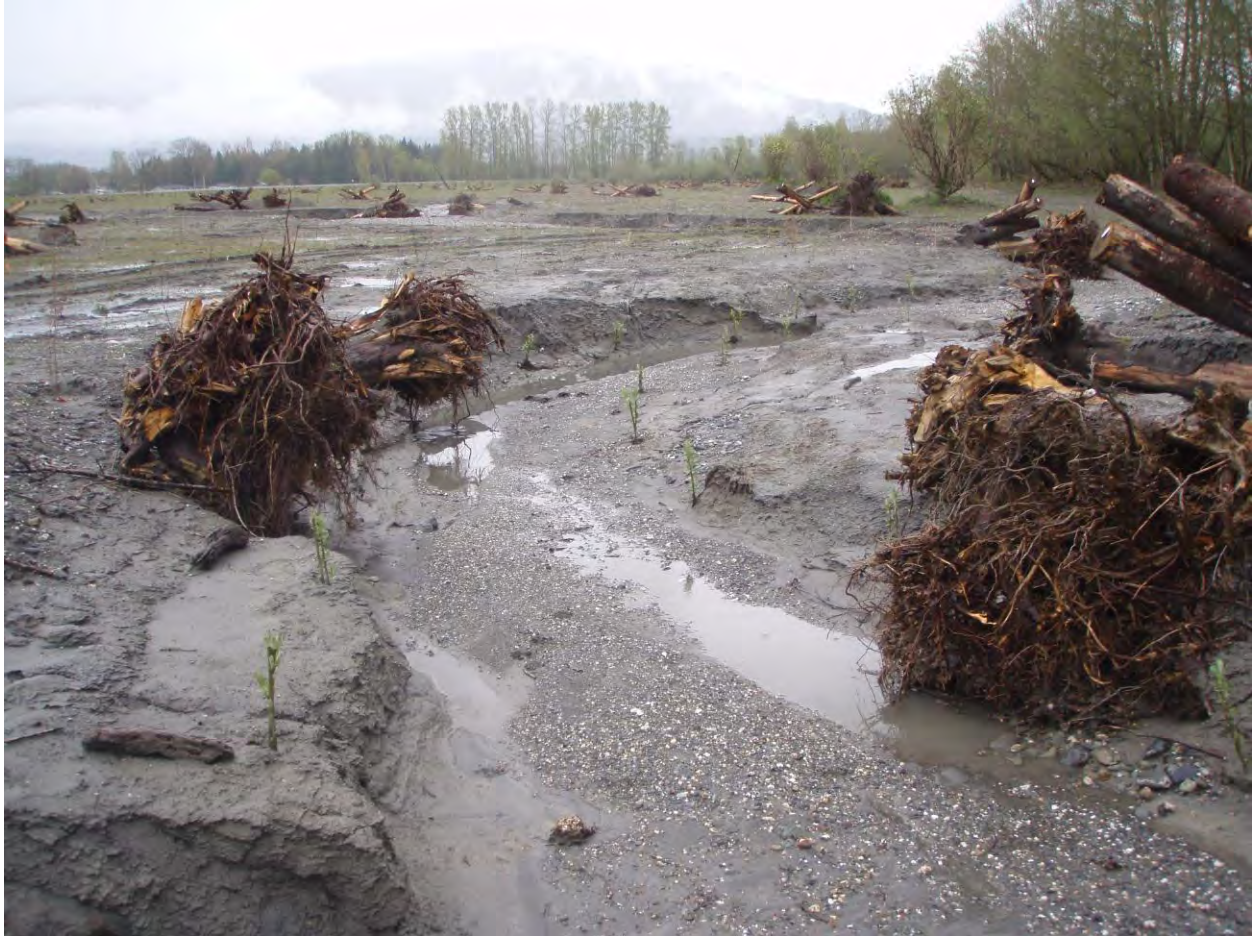
Figure 14. East fan design channel before Hansen Creek main stem avulsed into this channel (facing downstream)

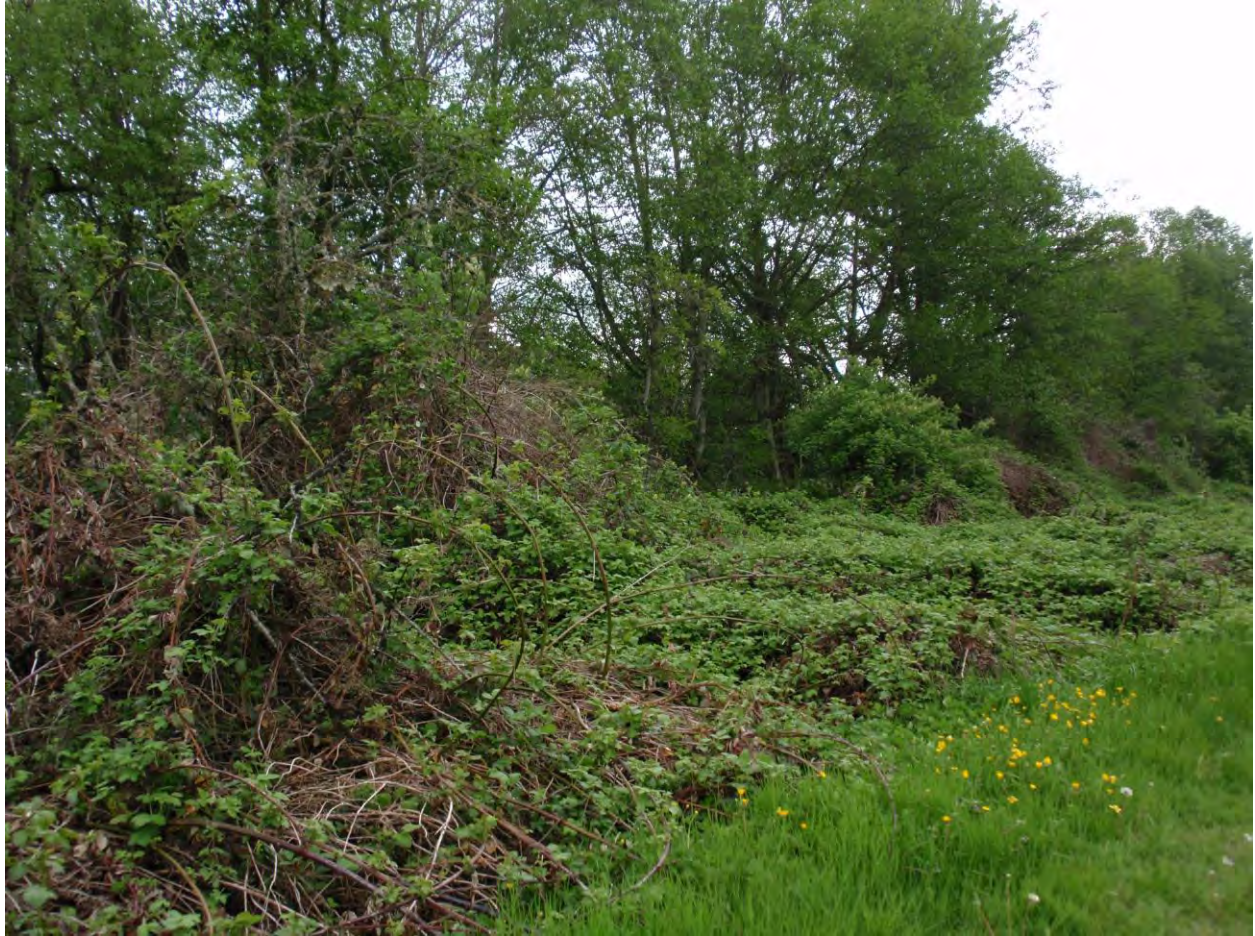
Figure 20. The dredge spoil levies were covered in Himalayan blackberry and reed canarygrass prior to the project.

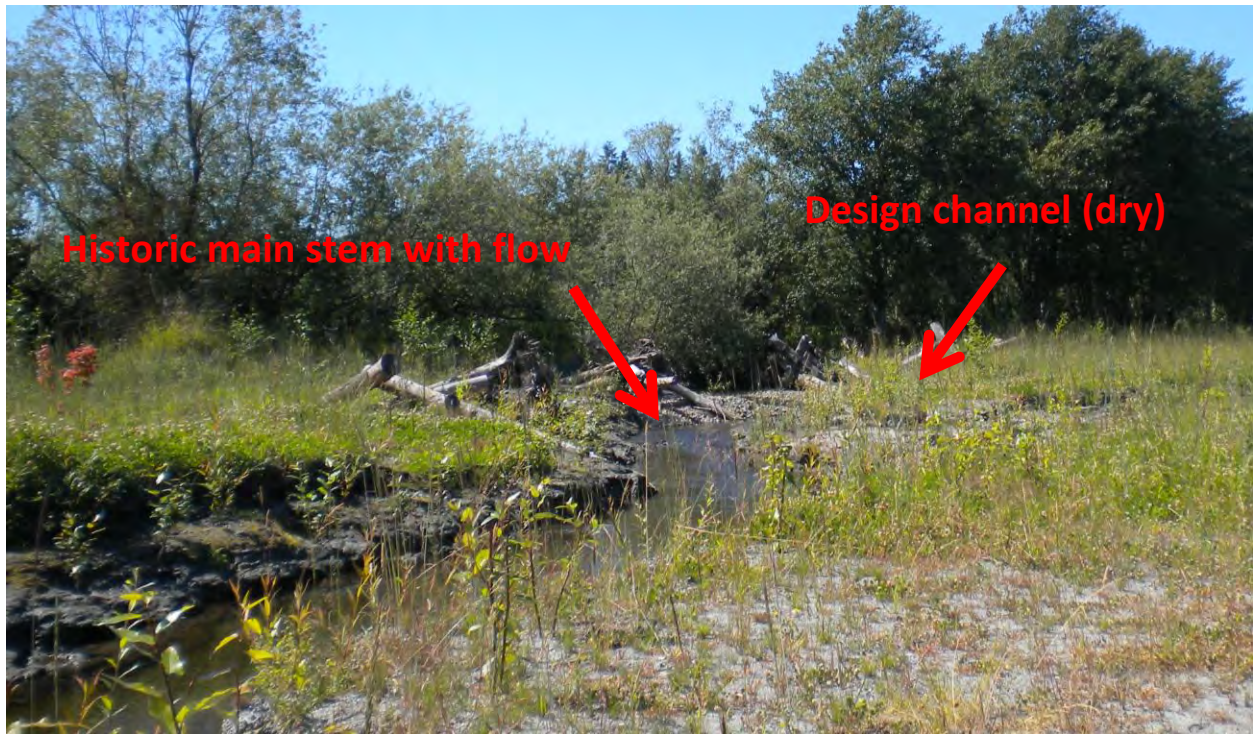
Figure 43. Photo Point F on 7/15/2010. The historic main stem can be seen on the left with the dry east fan design channel on the right.

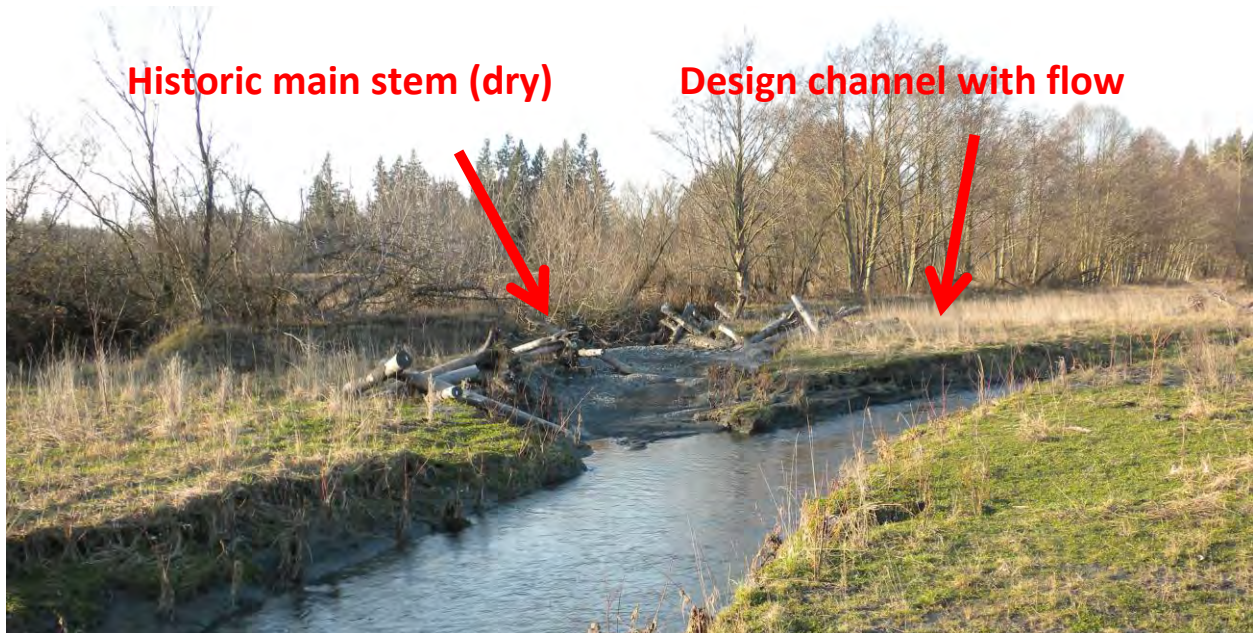
Figure 44. Photo Point F on 2/10/2011. The historic main stem has been abandoned and all the flow now passes through the east fan design channel.

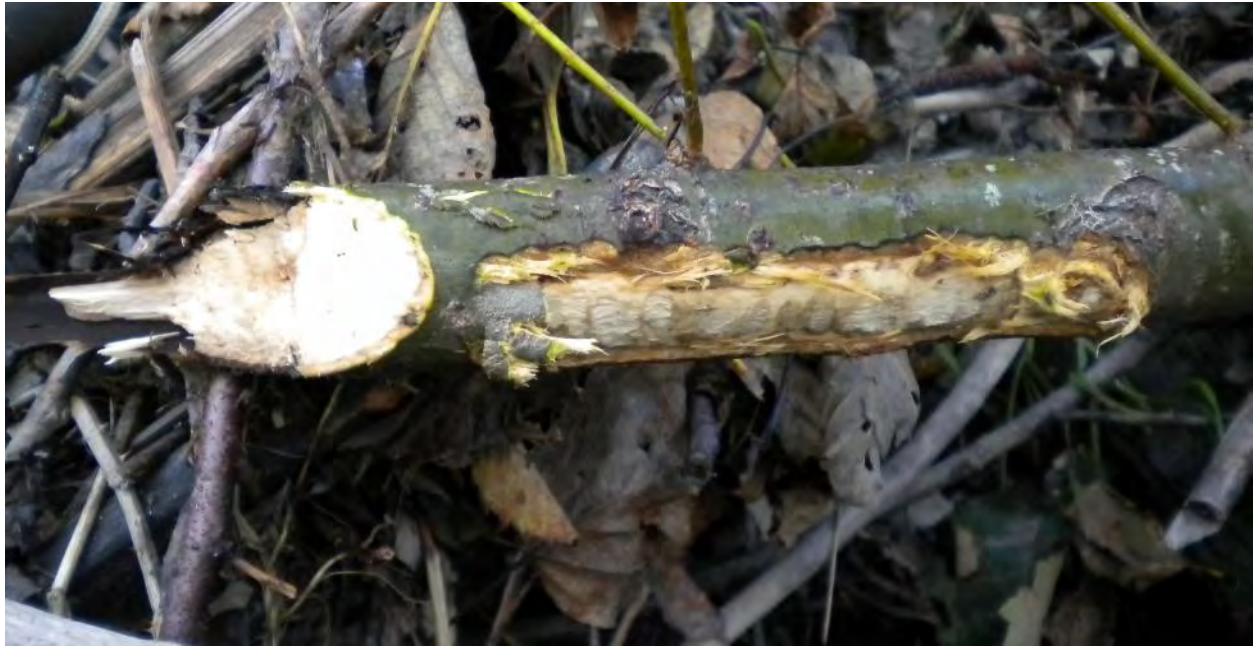
Figure 62. Beaver activity observed within Hansen Creek restoration site on 10/13/2010.

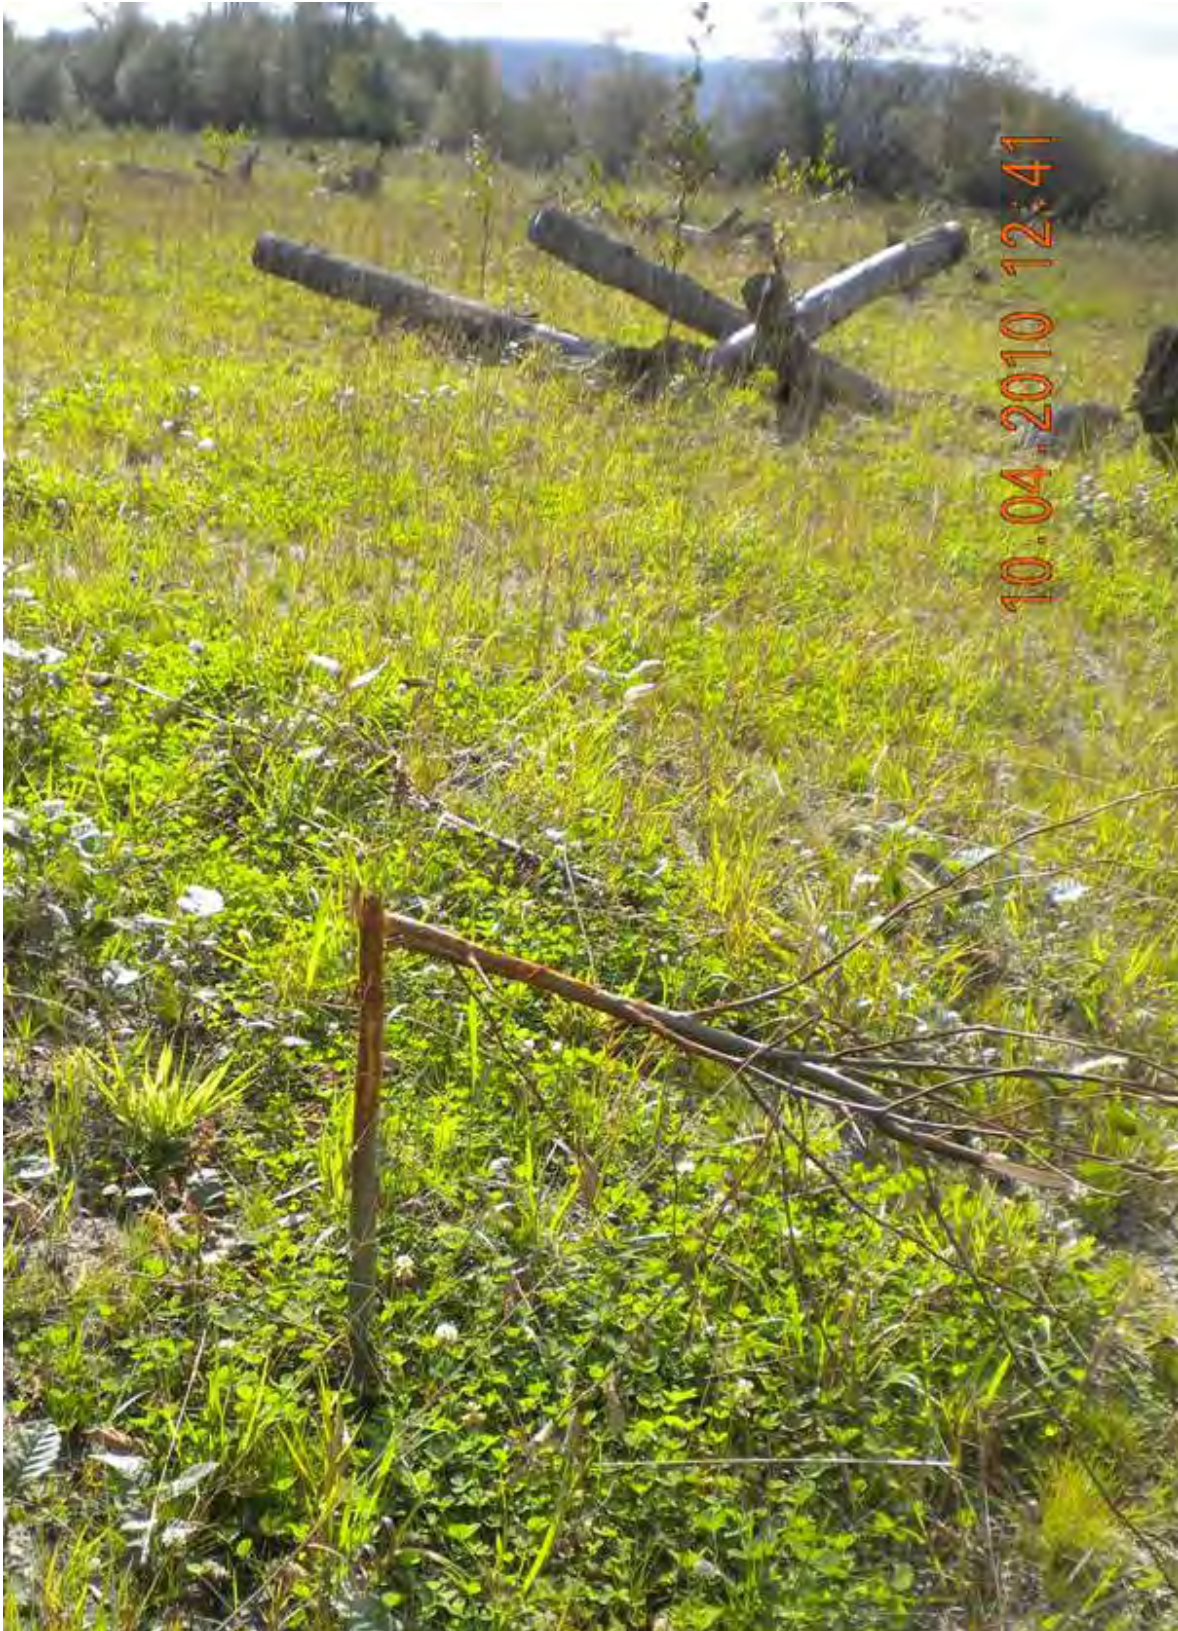
Figure 65. Elk-damaged tree within the project site.
