Eyes Over Puget Sound

Surface Conditions Report: Sept 8, 2021

Up-to-date observations of water quality conditions in Puget Sound and coastal bays

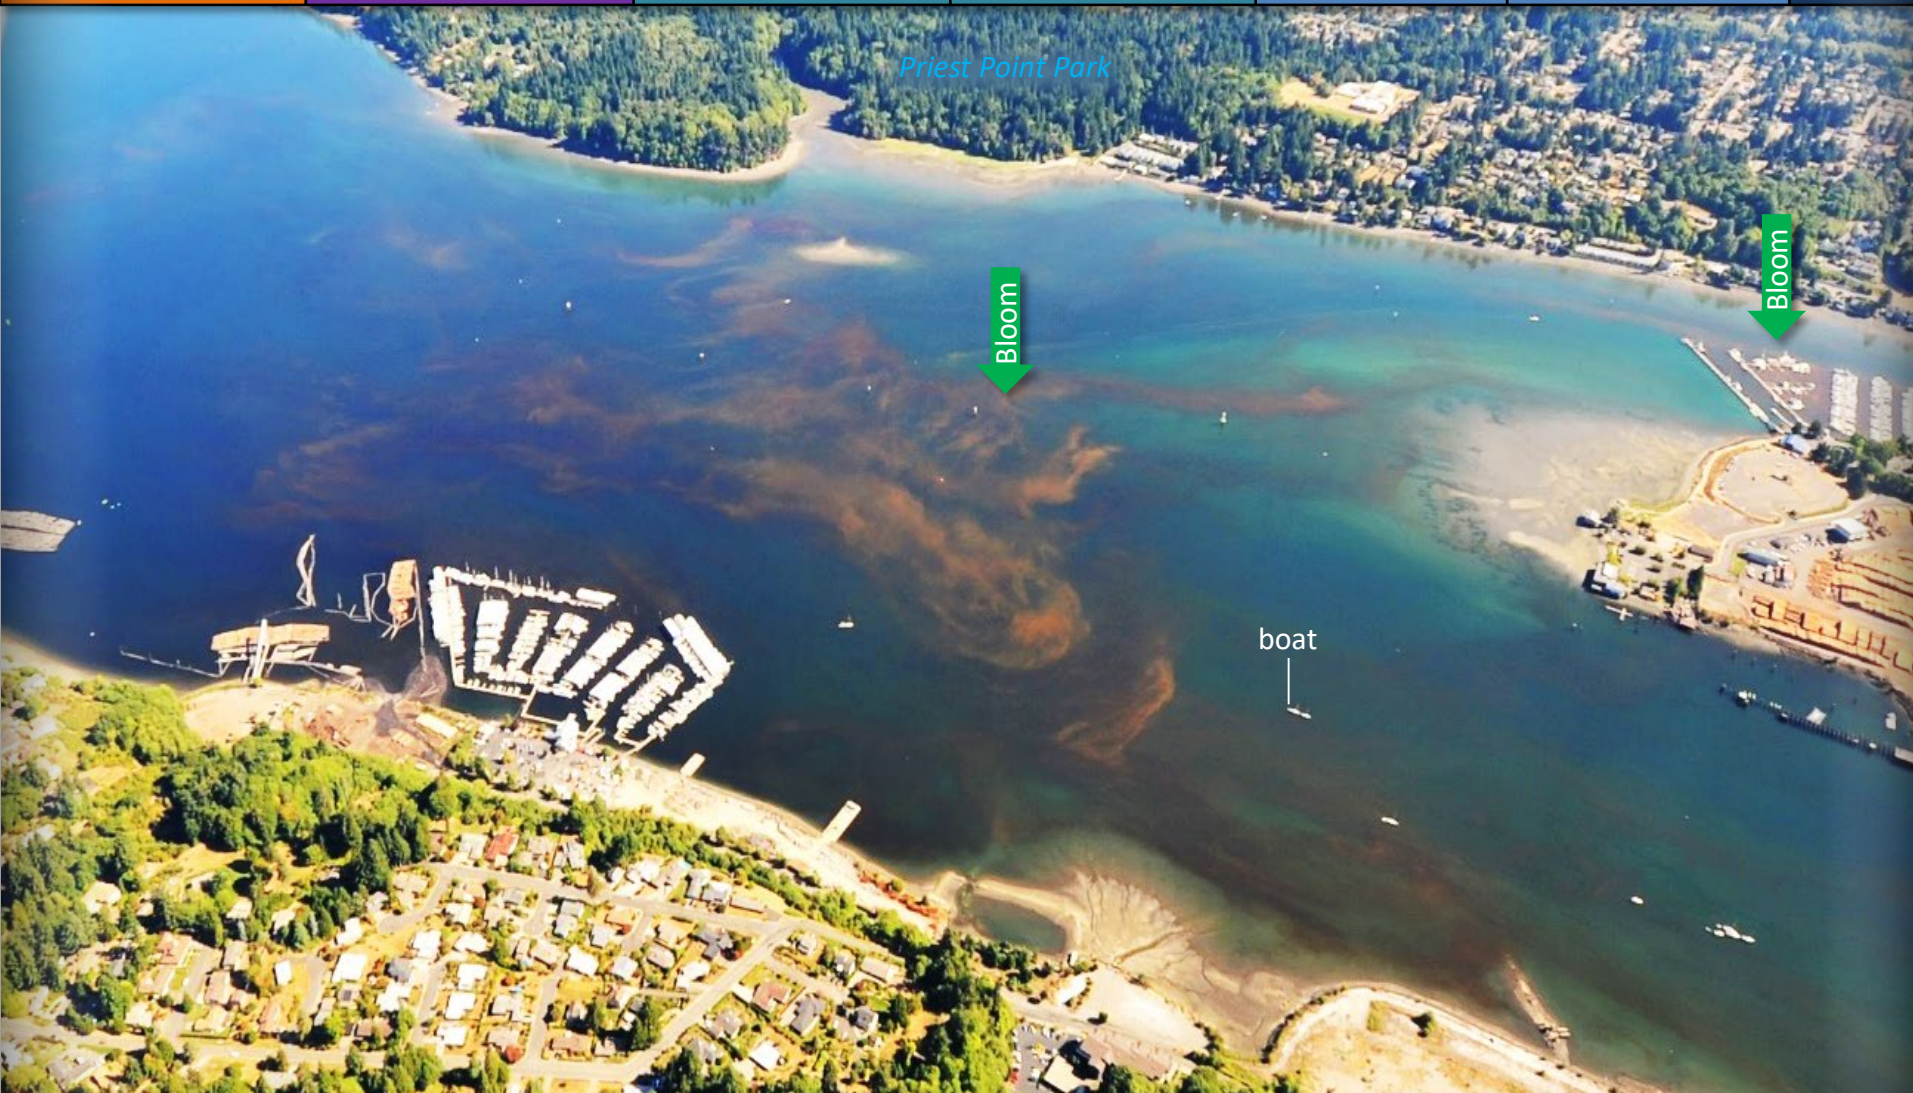
Strong red-brown bloom. Location: Budd Inlet (South Sound), 11:34 AM

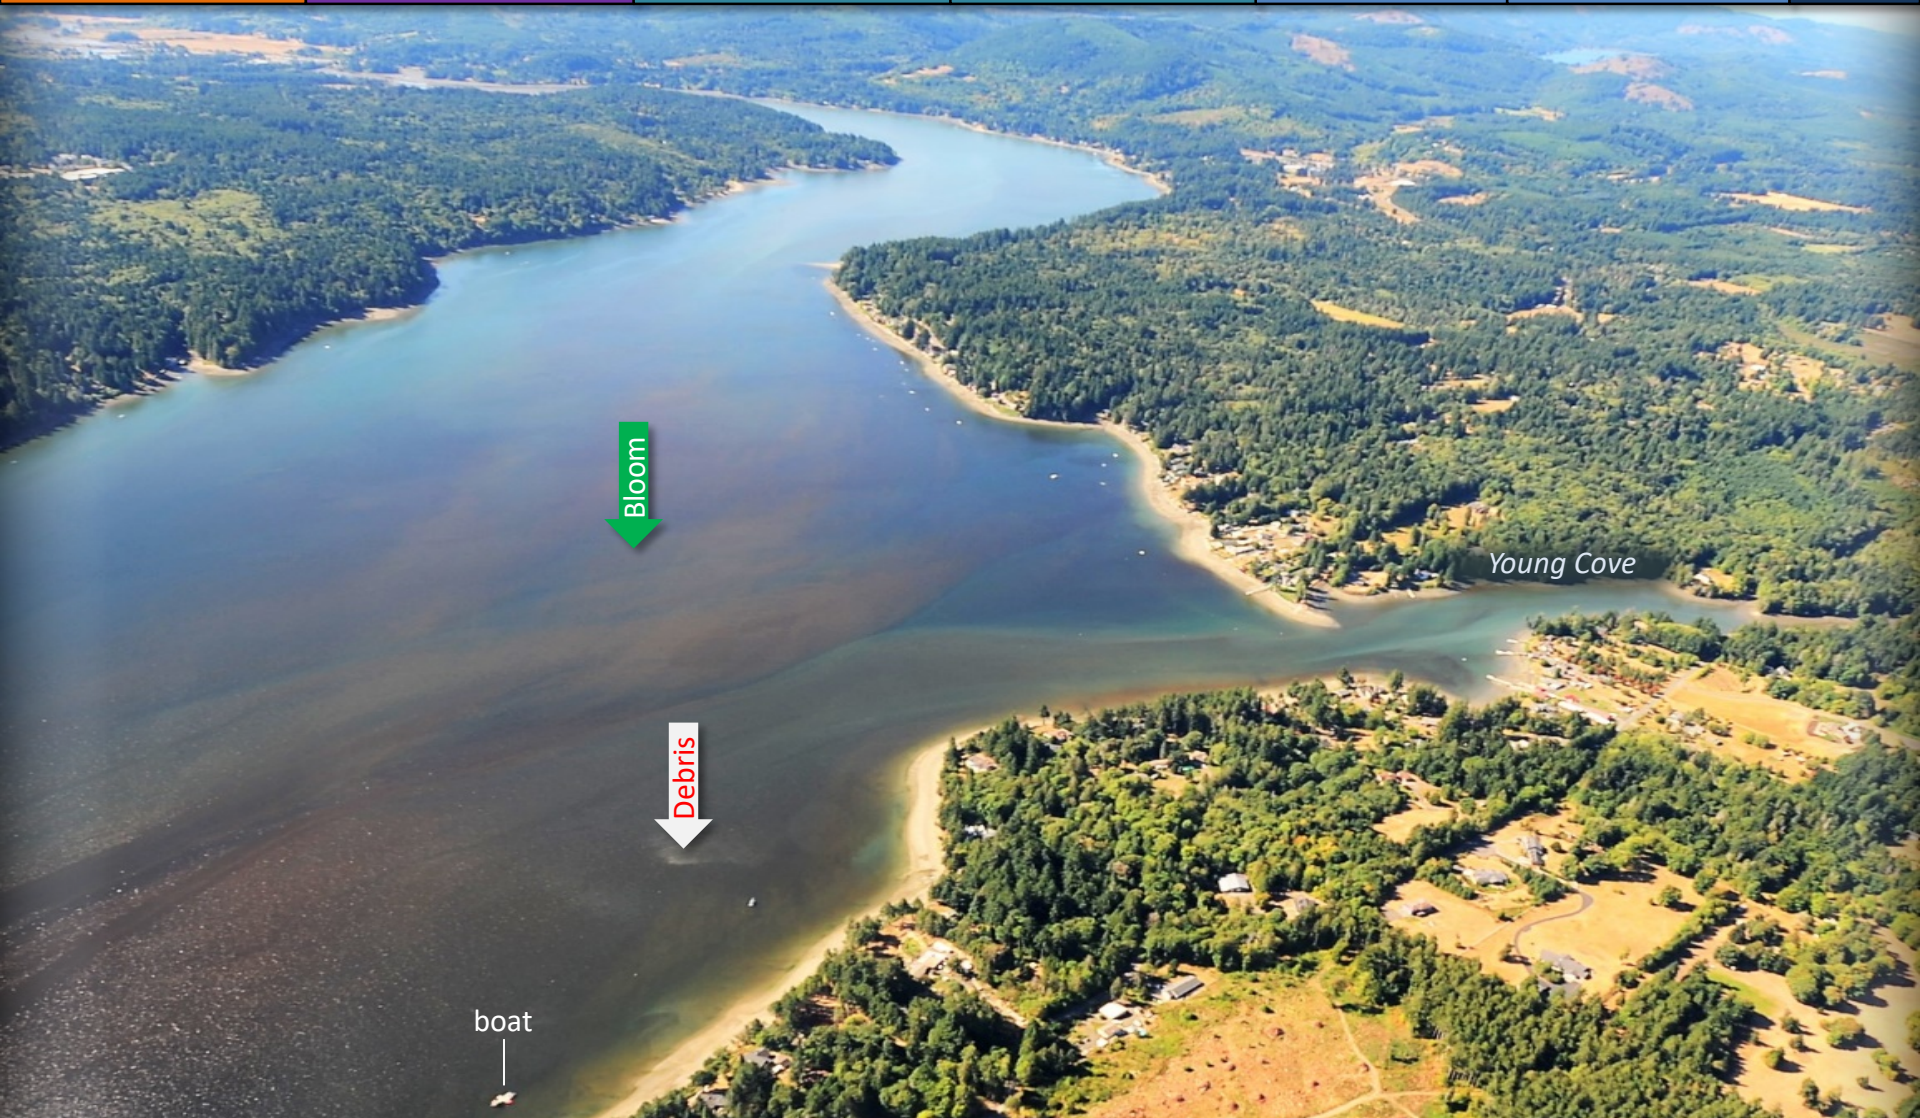
Red-brown bloom and milky-white water originating in Young Cove. Location: Eld Inlet (South Sound), 11:35 AM

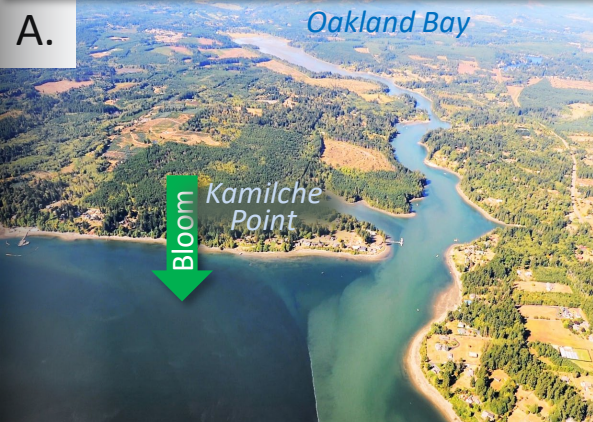
Different-colored water originating from A. Oakland Bay. B. Water remaining separated while flowing north.
Location: Totten Inlet (South Sound), 11:38 AM

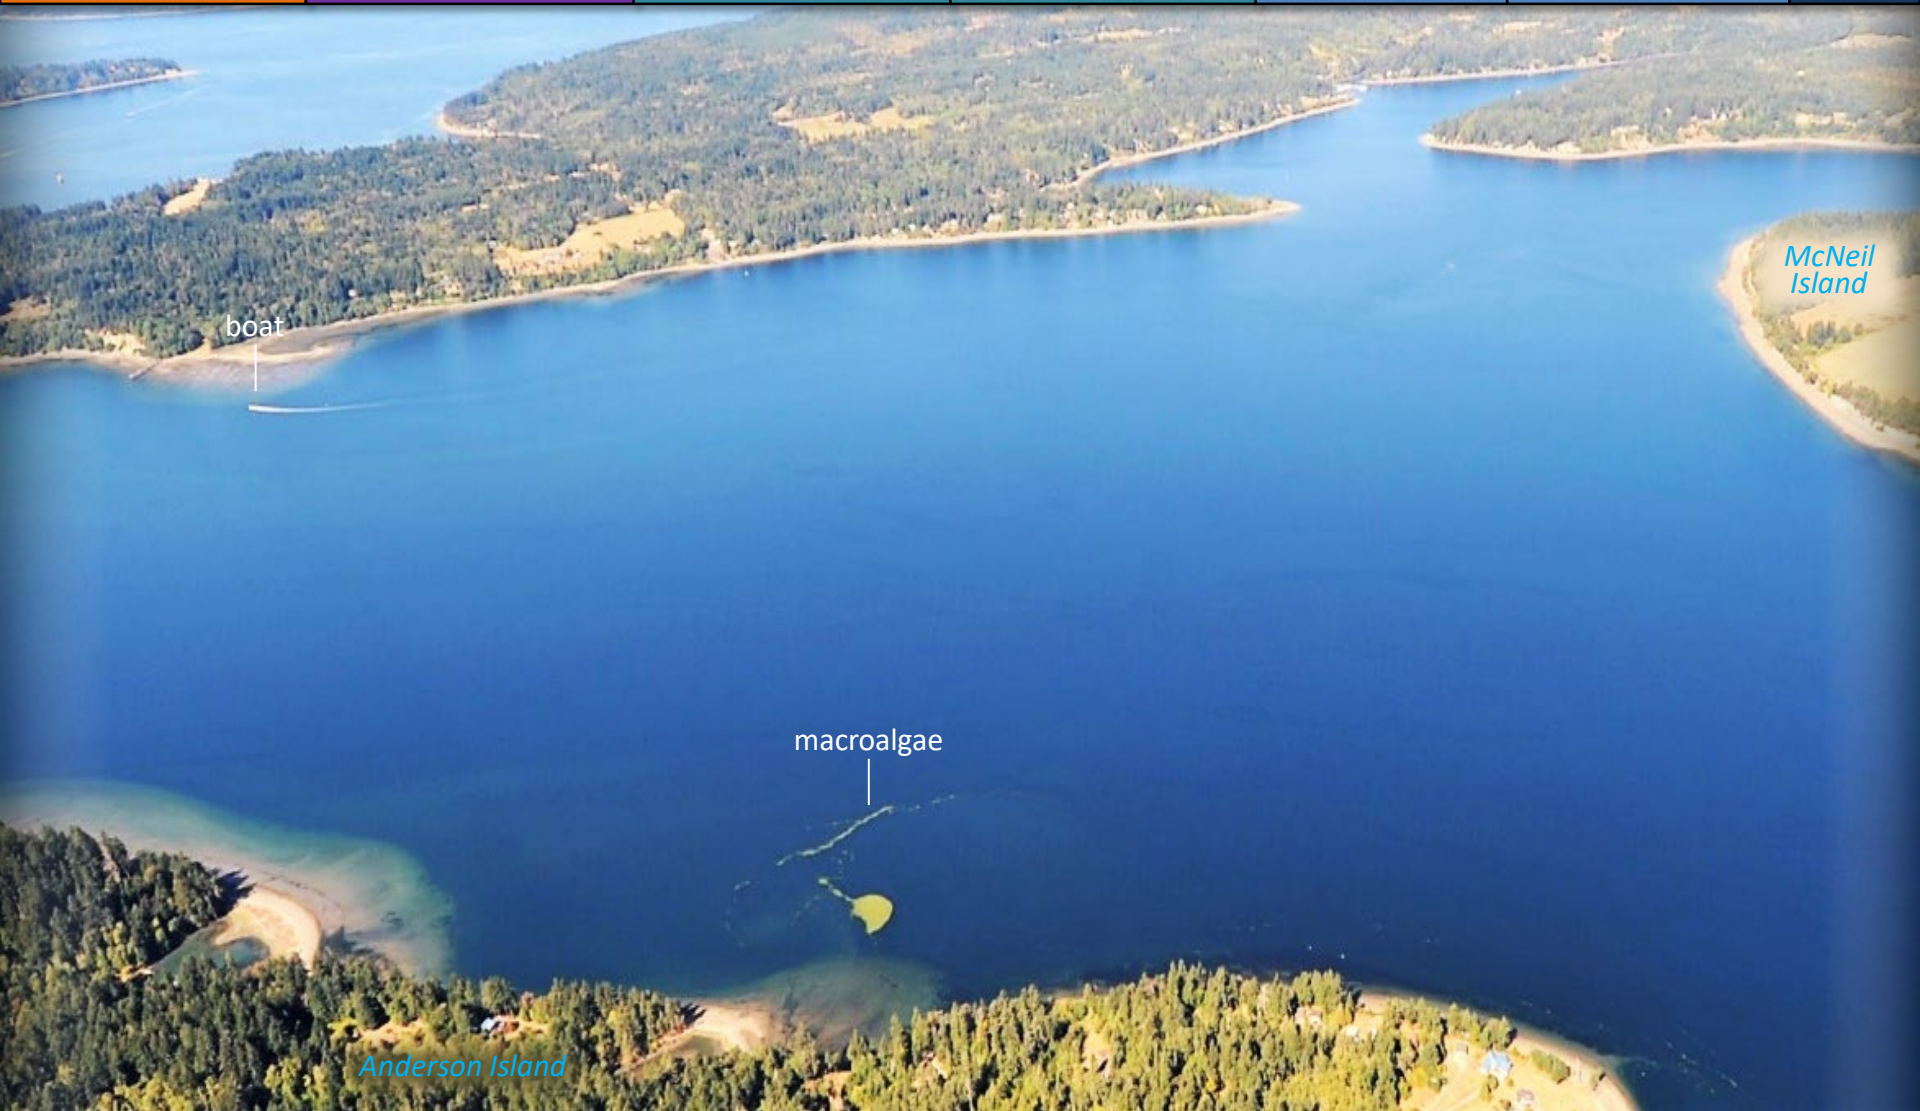
Large raft of organic material. Location: Anderson Island (South Sound), 11:46 AM

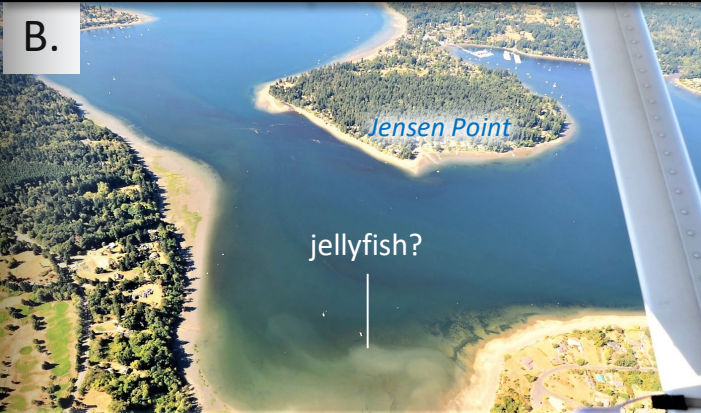
A. Weak brown-reddish bloom near Dockton. B. Whitish water, perhaps jellyfish, in Rabbs Lagoon.
Location: Quartermaster Harbor (Central Sound) 11:55 AM

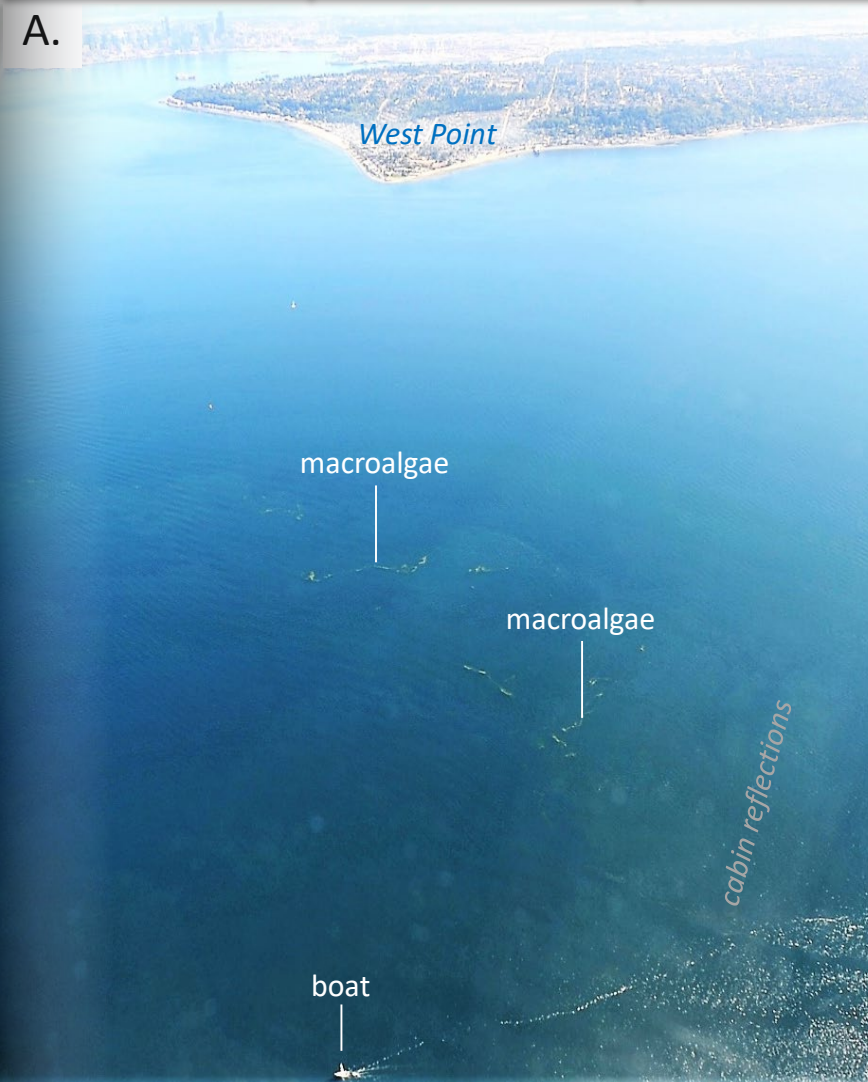
Large of organic debris drifting between A. West Point and B. Kingston.

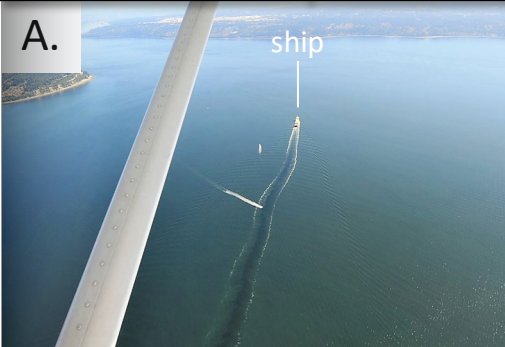
The wake of a boat reveals A. a thin surface layer of lower-density water and B-C. slightly warmer water from Whidbey Basin entering Central Sound. Location: Edmonds (Central Sound), 12:12 PM

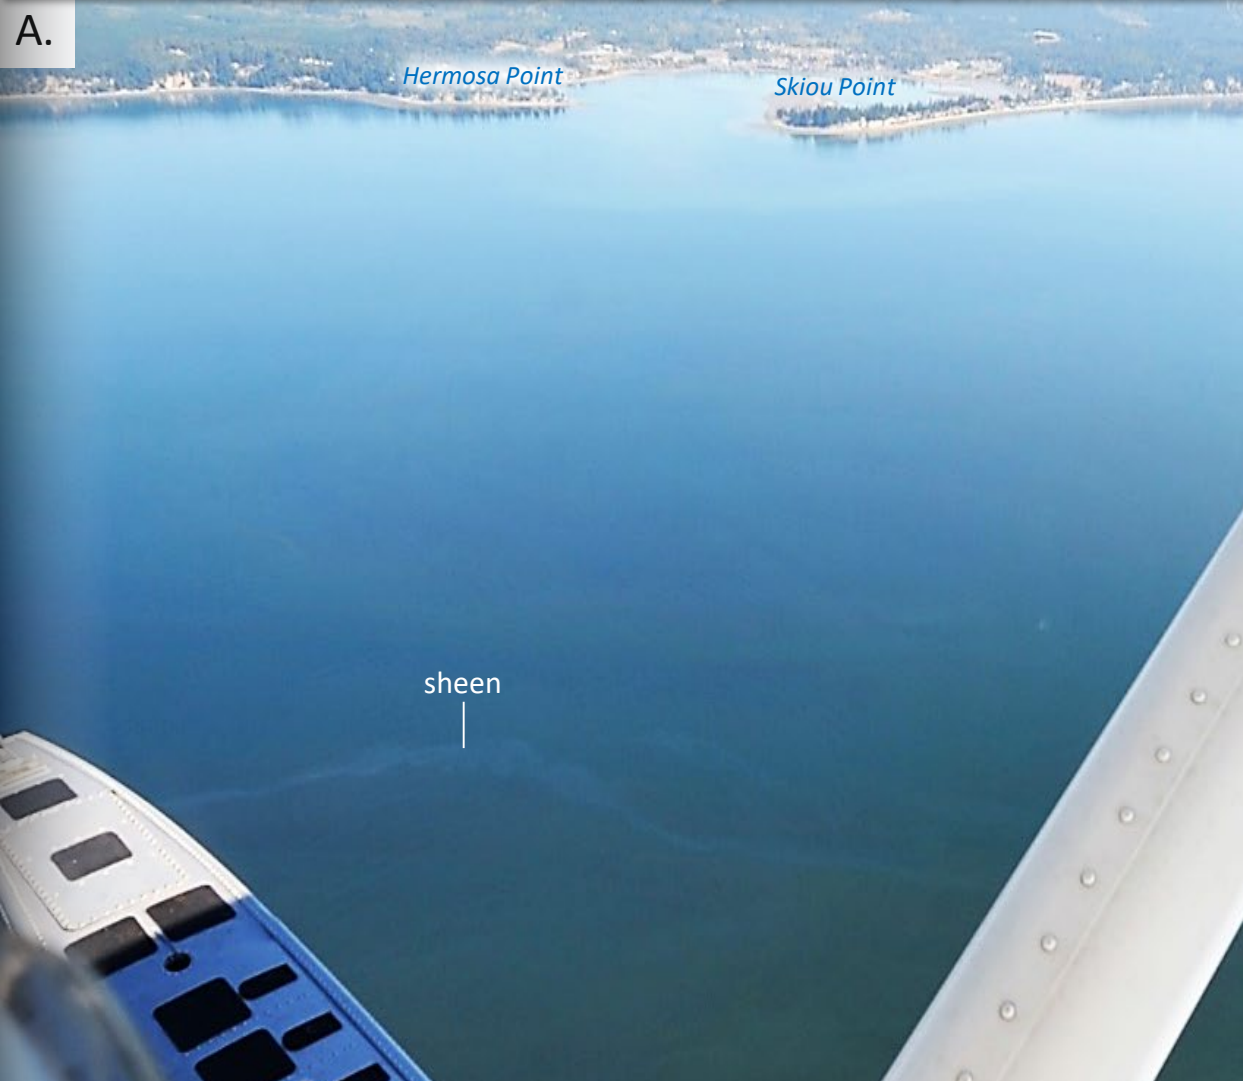
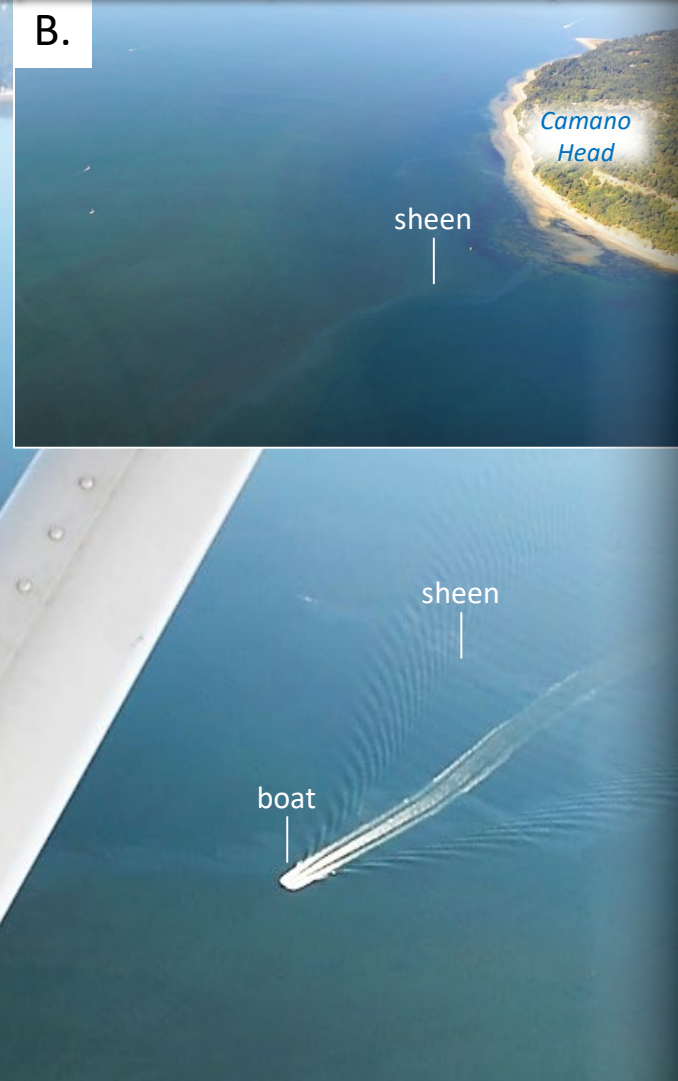
Long oil sheen stretching from Hat Island to Camano Head.
Location: Entrance to Port Susan (Whidbey Basin), 12:17 PM

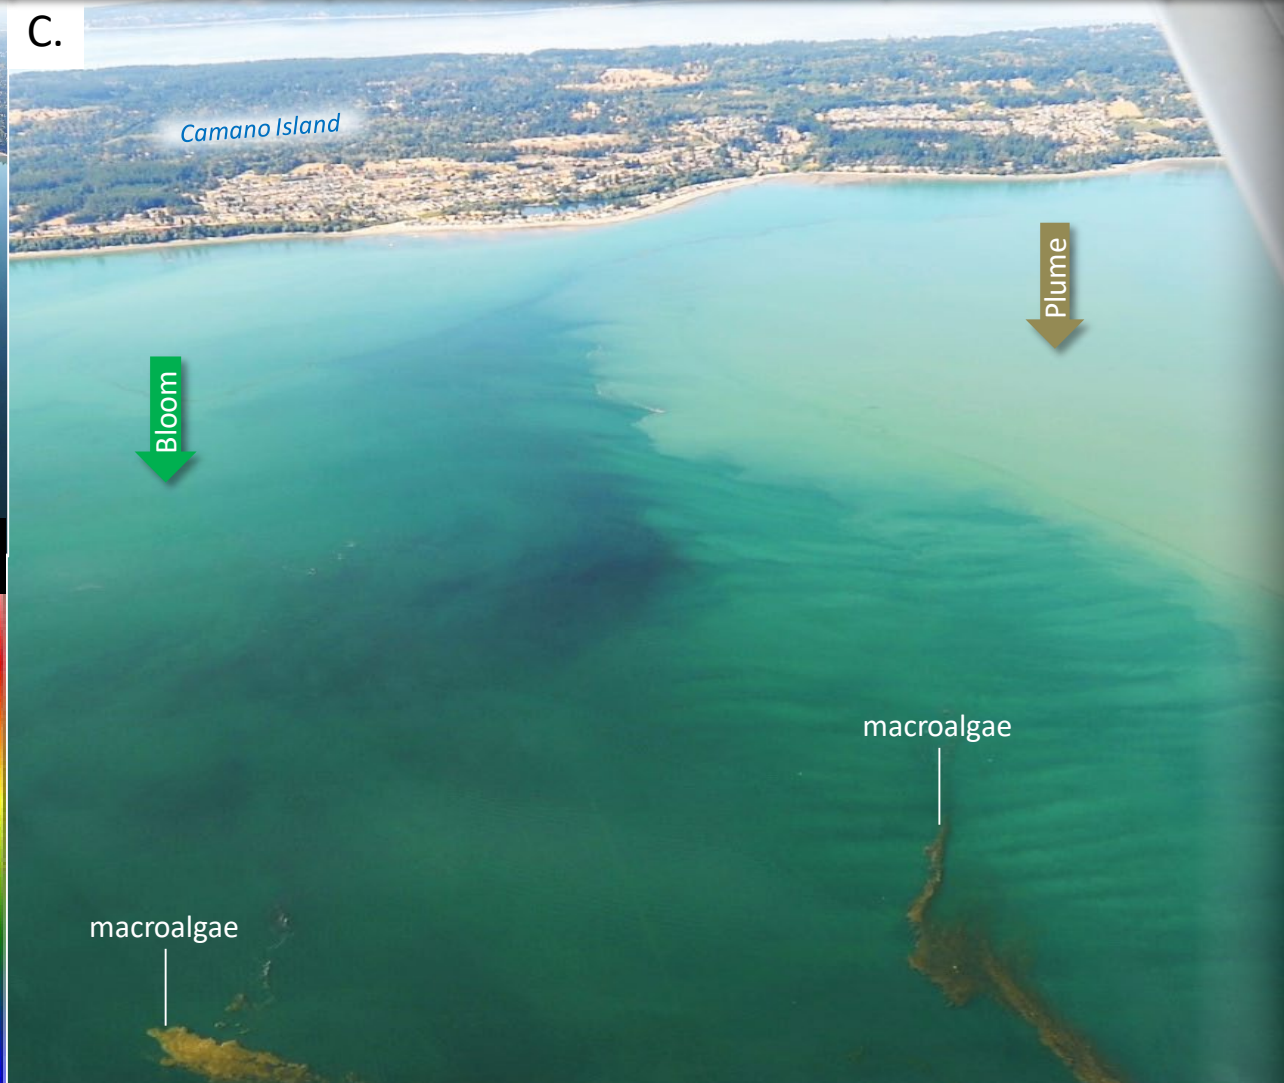
A. Stillaguamish estuary with B. relatively cool tideflat despite sunshine. C. Large rafts of organic material of different color and composition. Location: Port Susan (Whidbey Basin), 12:23 PM

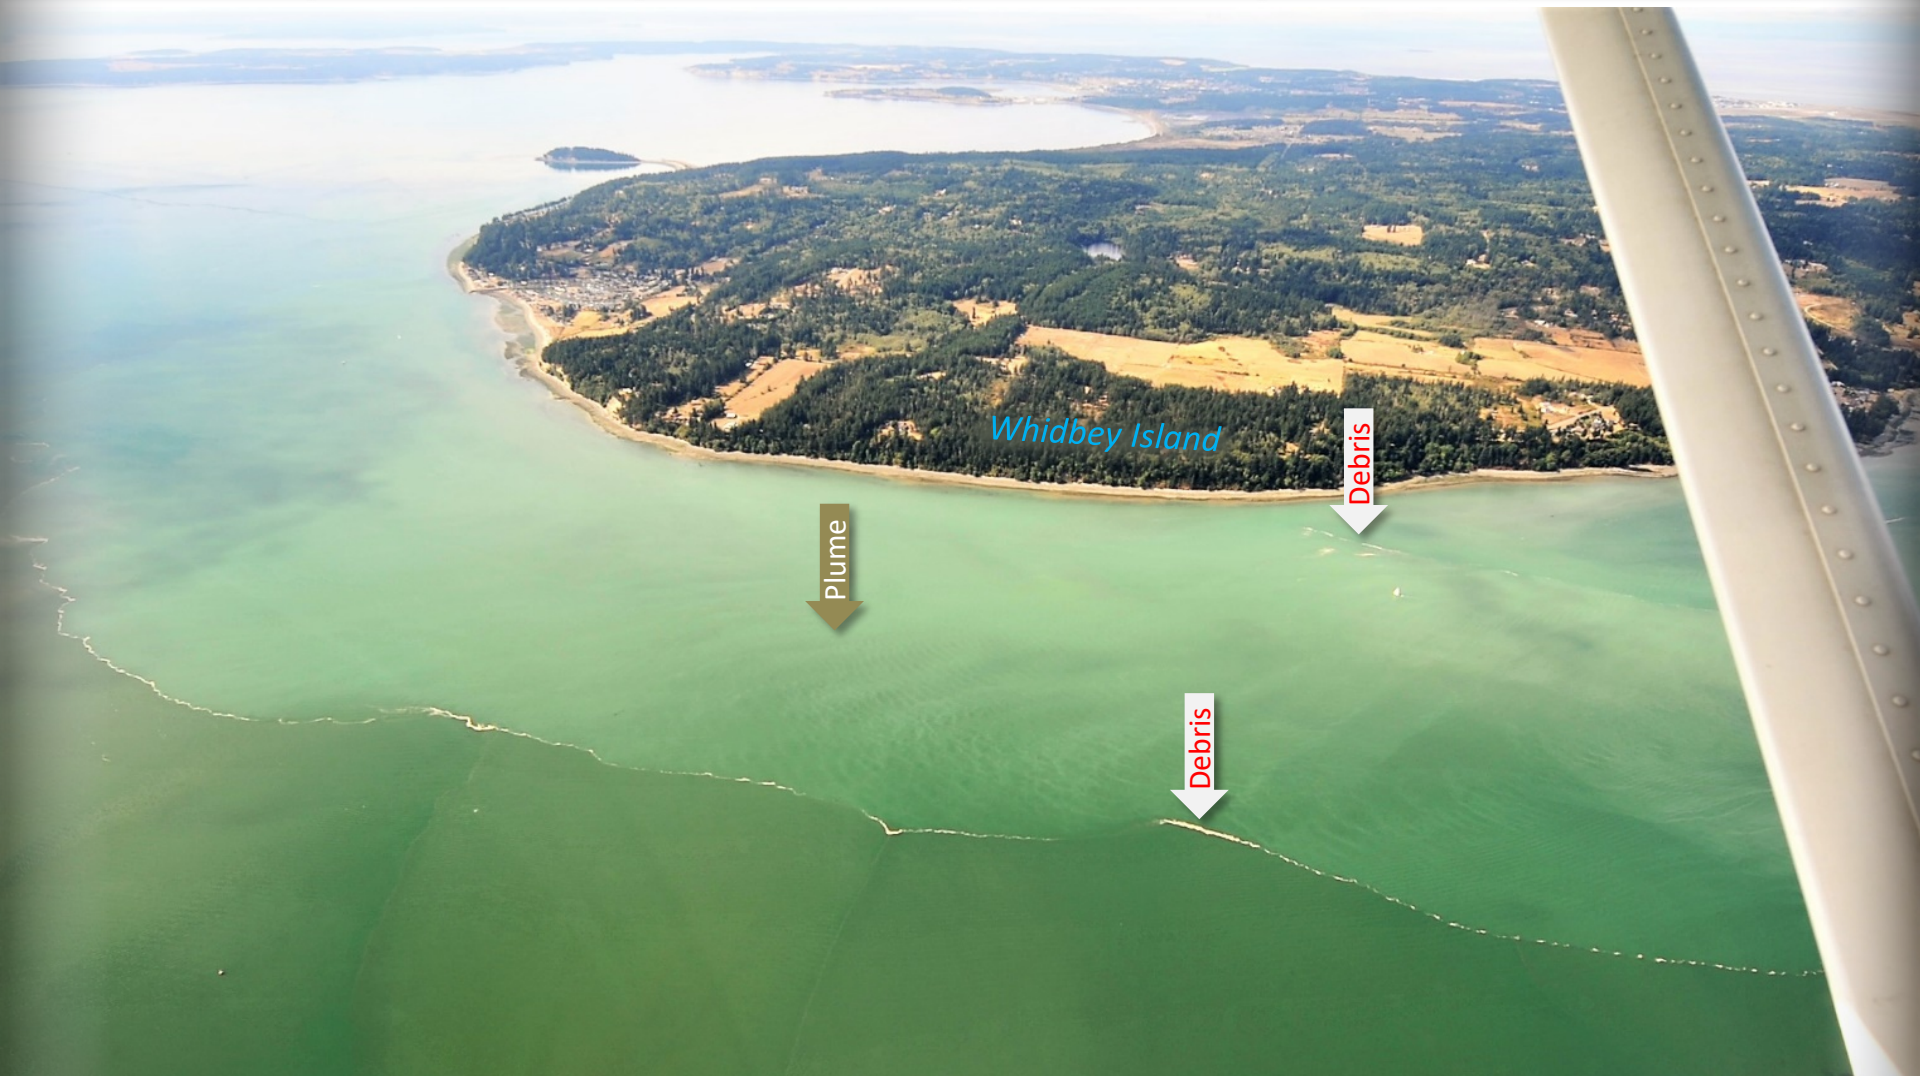
Organic material accumulating at edge of Skagit River plume.

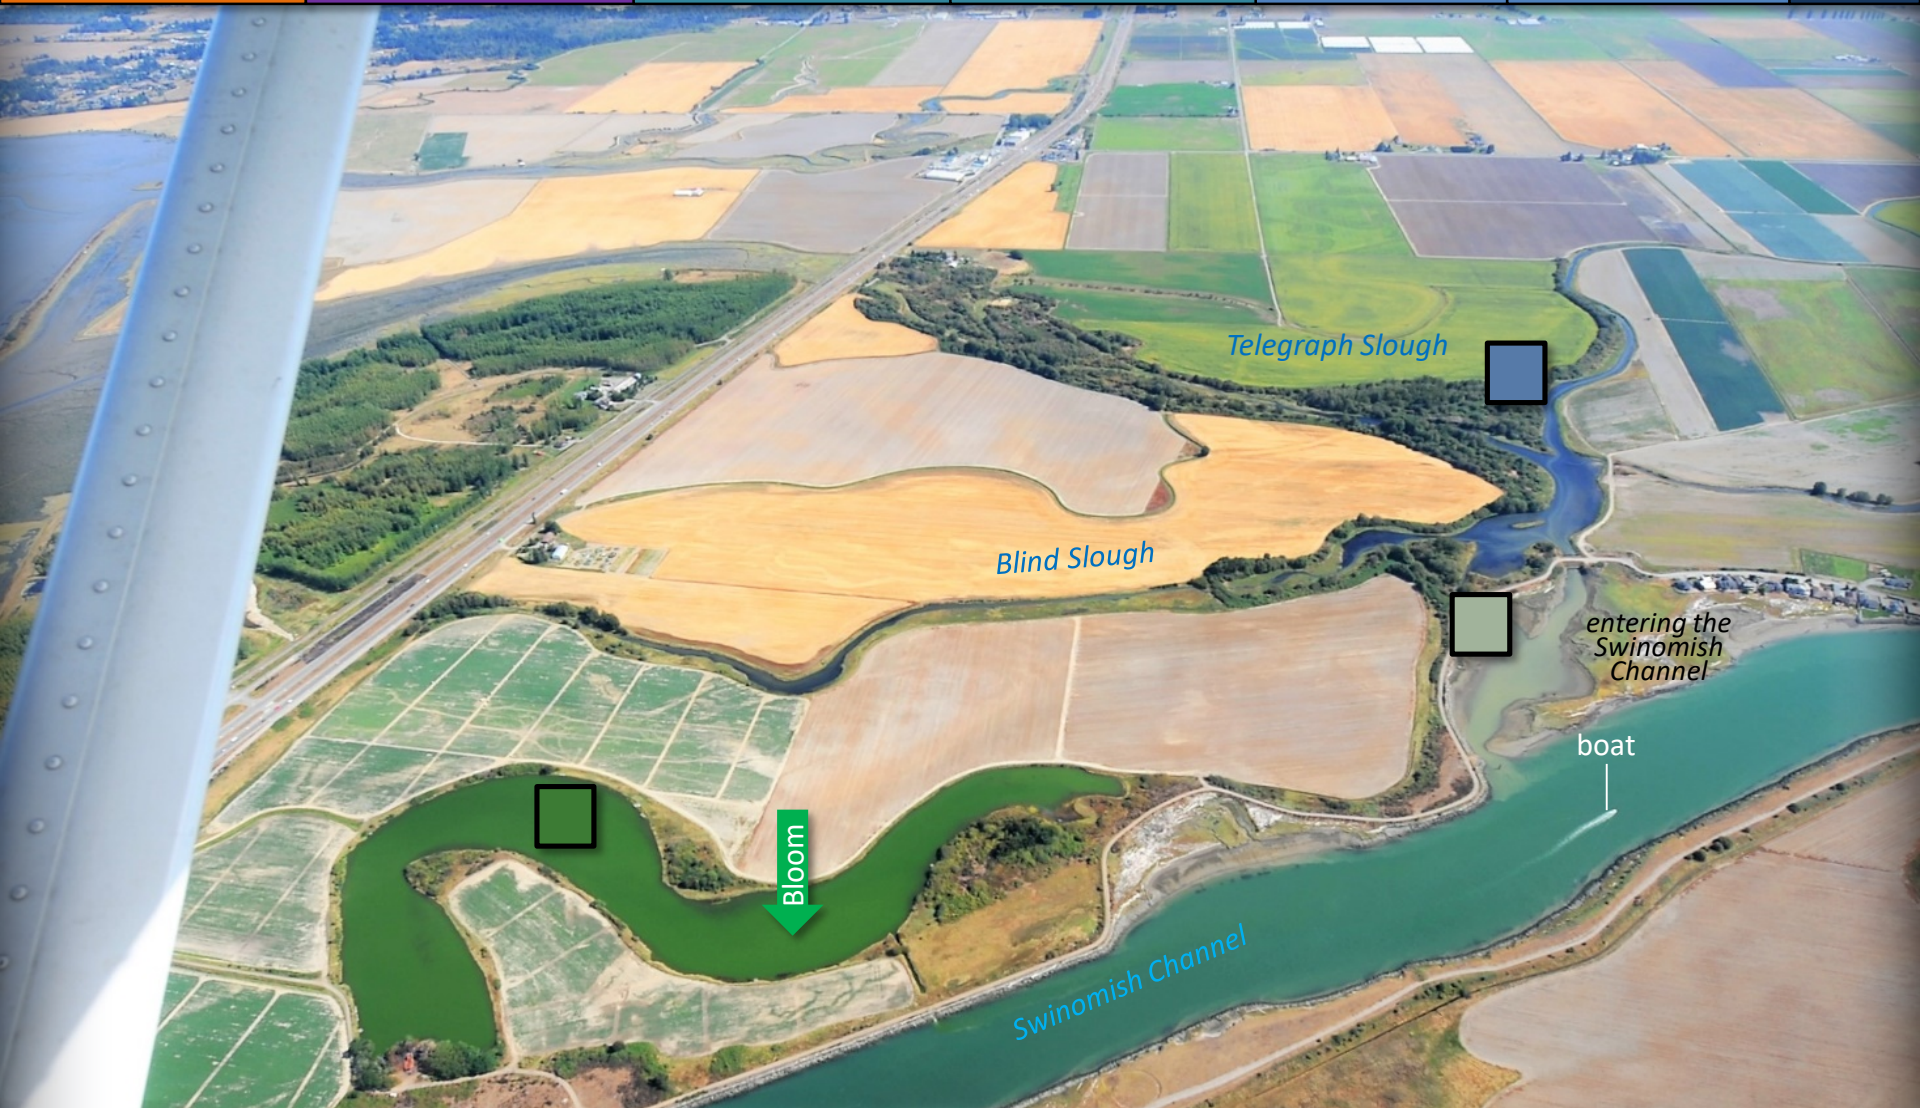
Very green bloom in an old disconnected slough. Very different water colors in Telegraph and Blind Sloughs and as the water enters the Swinomish Channel. Location: Swinomish Channel (North Sound), 12:33 PM

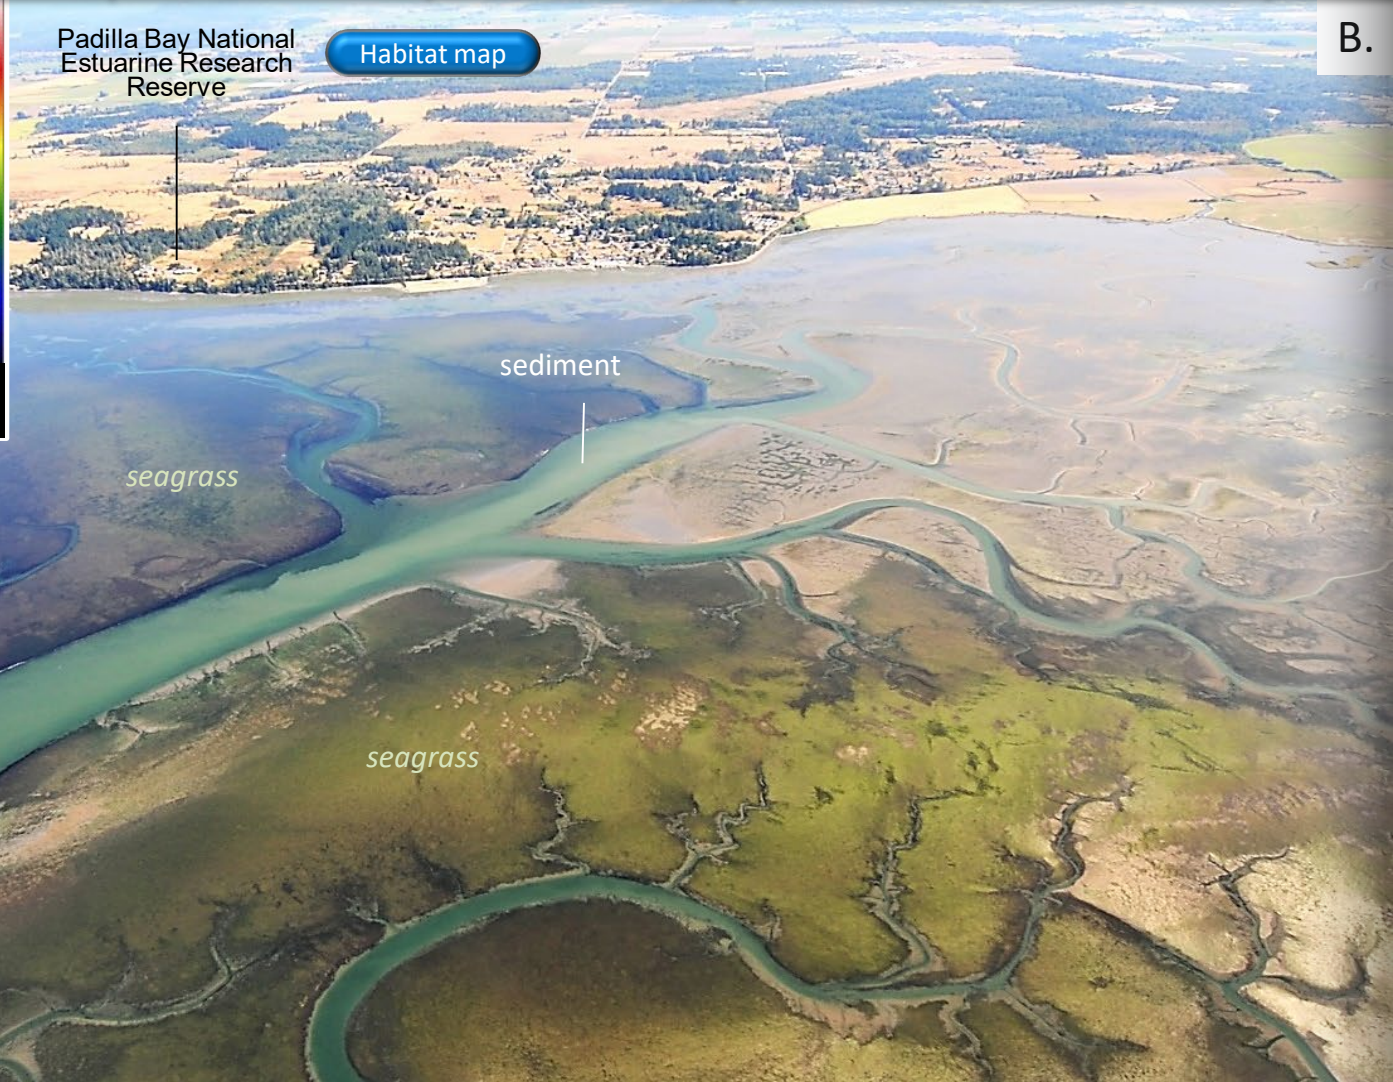
Padilla Bay seagrass experiences much cooler temperatures north of the tidal gully. Sediment from south of the gully discolors the water. Location: Padilla Bay (North Sound), 12:35 PM

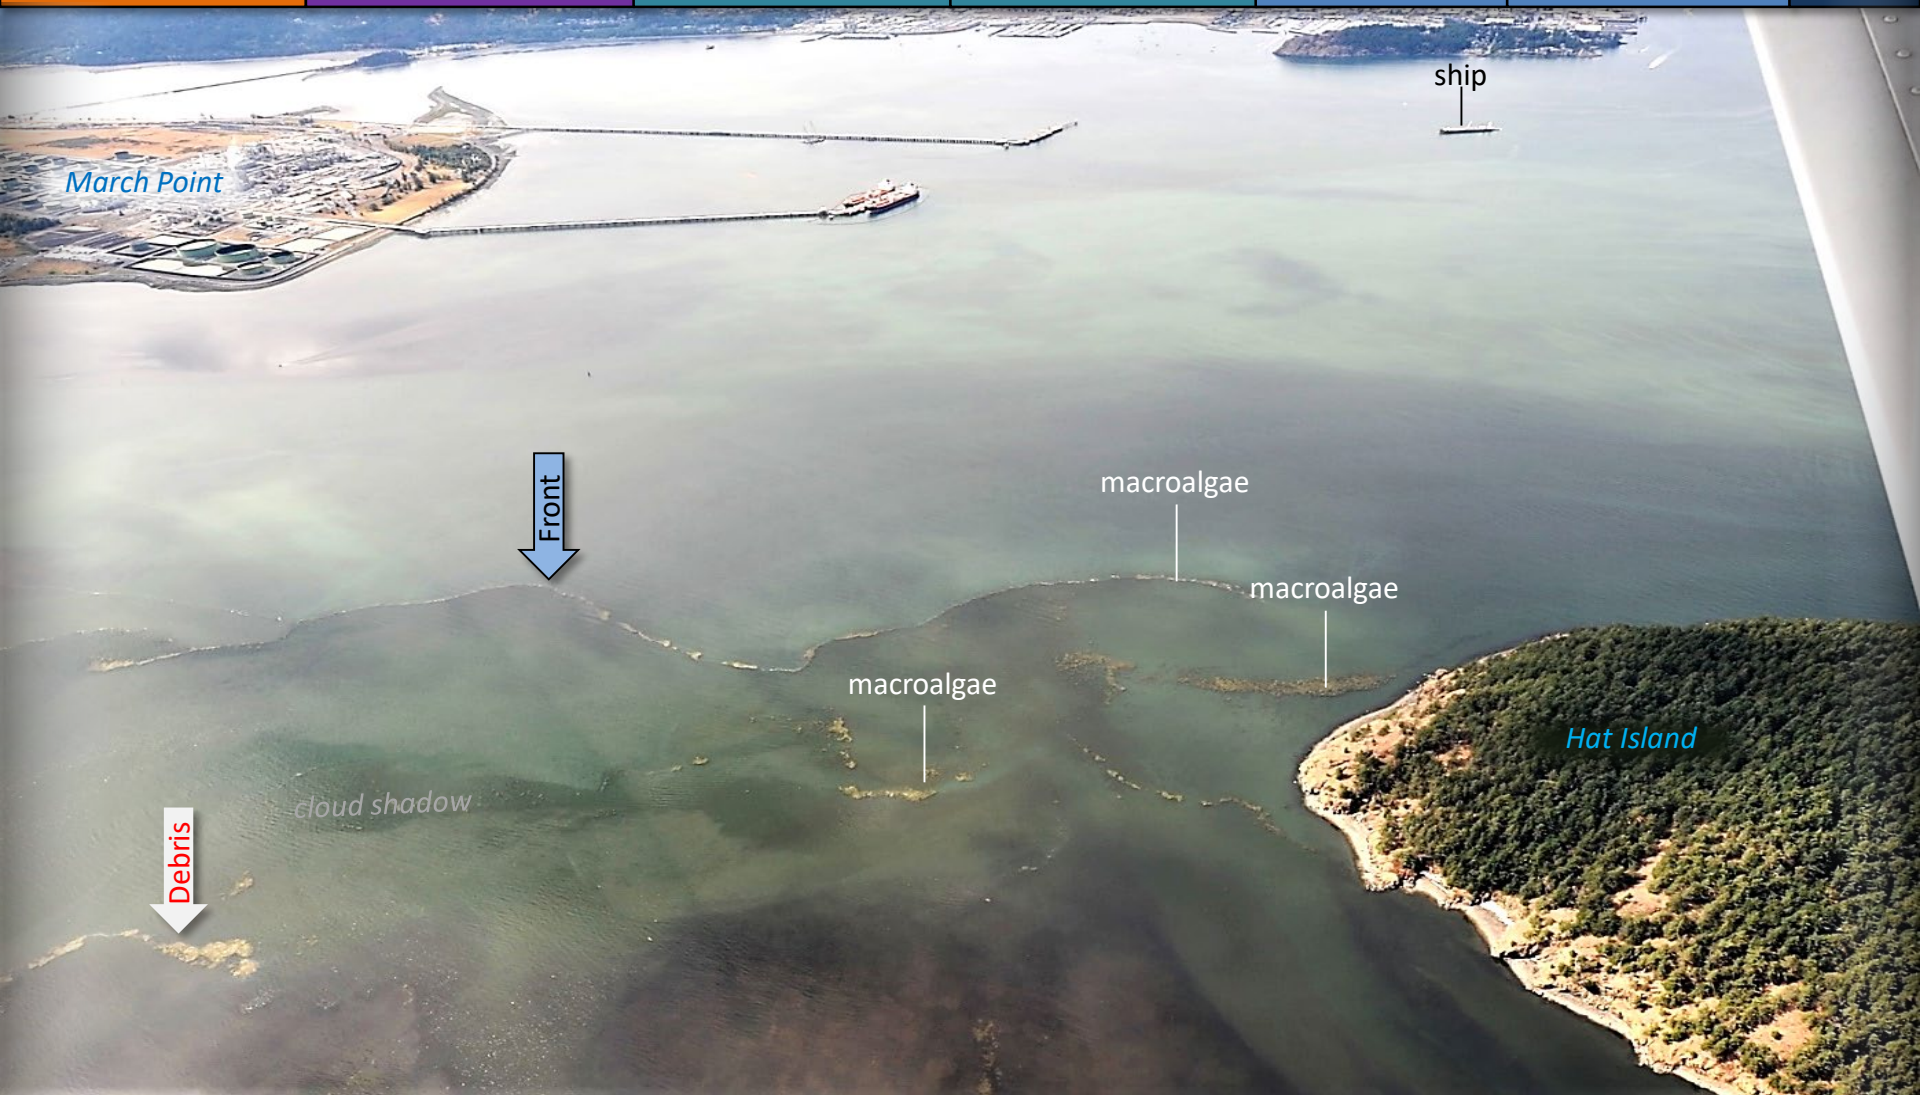
Large rafts of organic material drifting in water discolored by a bloom.
Location: Padilla Bay (North Sound), 12:36 PM

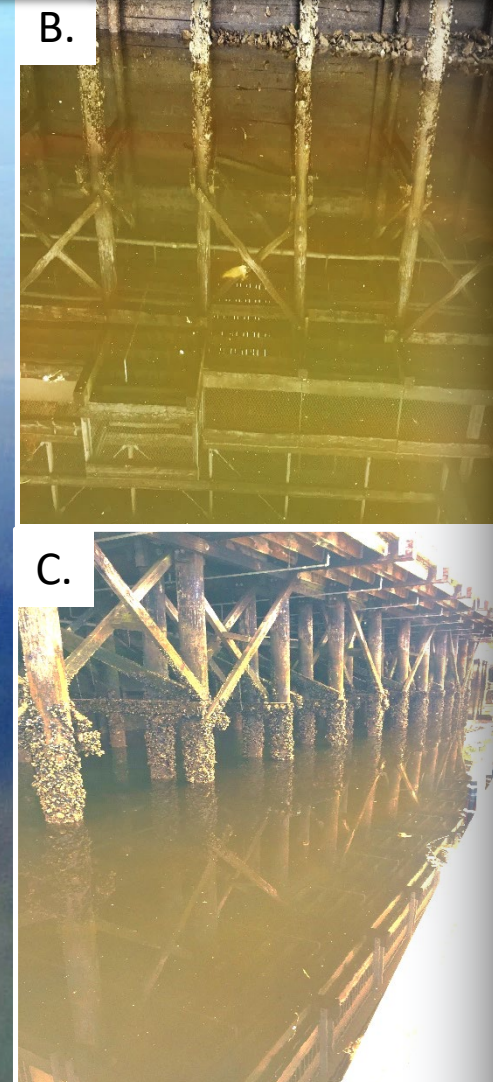
A. Strong red bloom and drifting organic material in Samish Bay. B-C. Red-brown bloom in Squalicum Harbor.
Location: A. Samish Bay, B-C. Bellingham Bay (North Sound), 12:40 PM

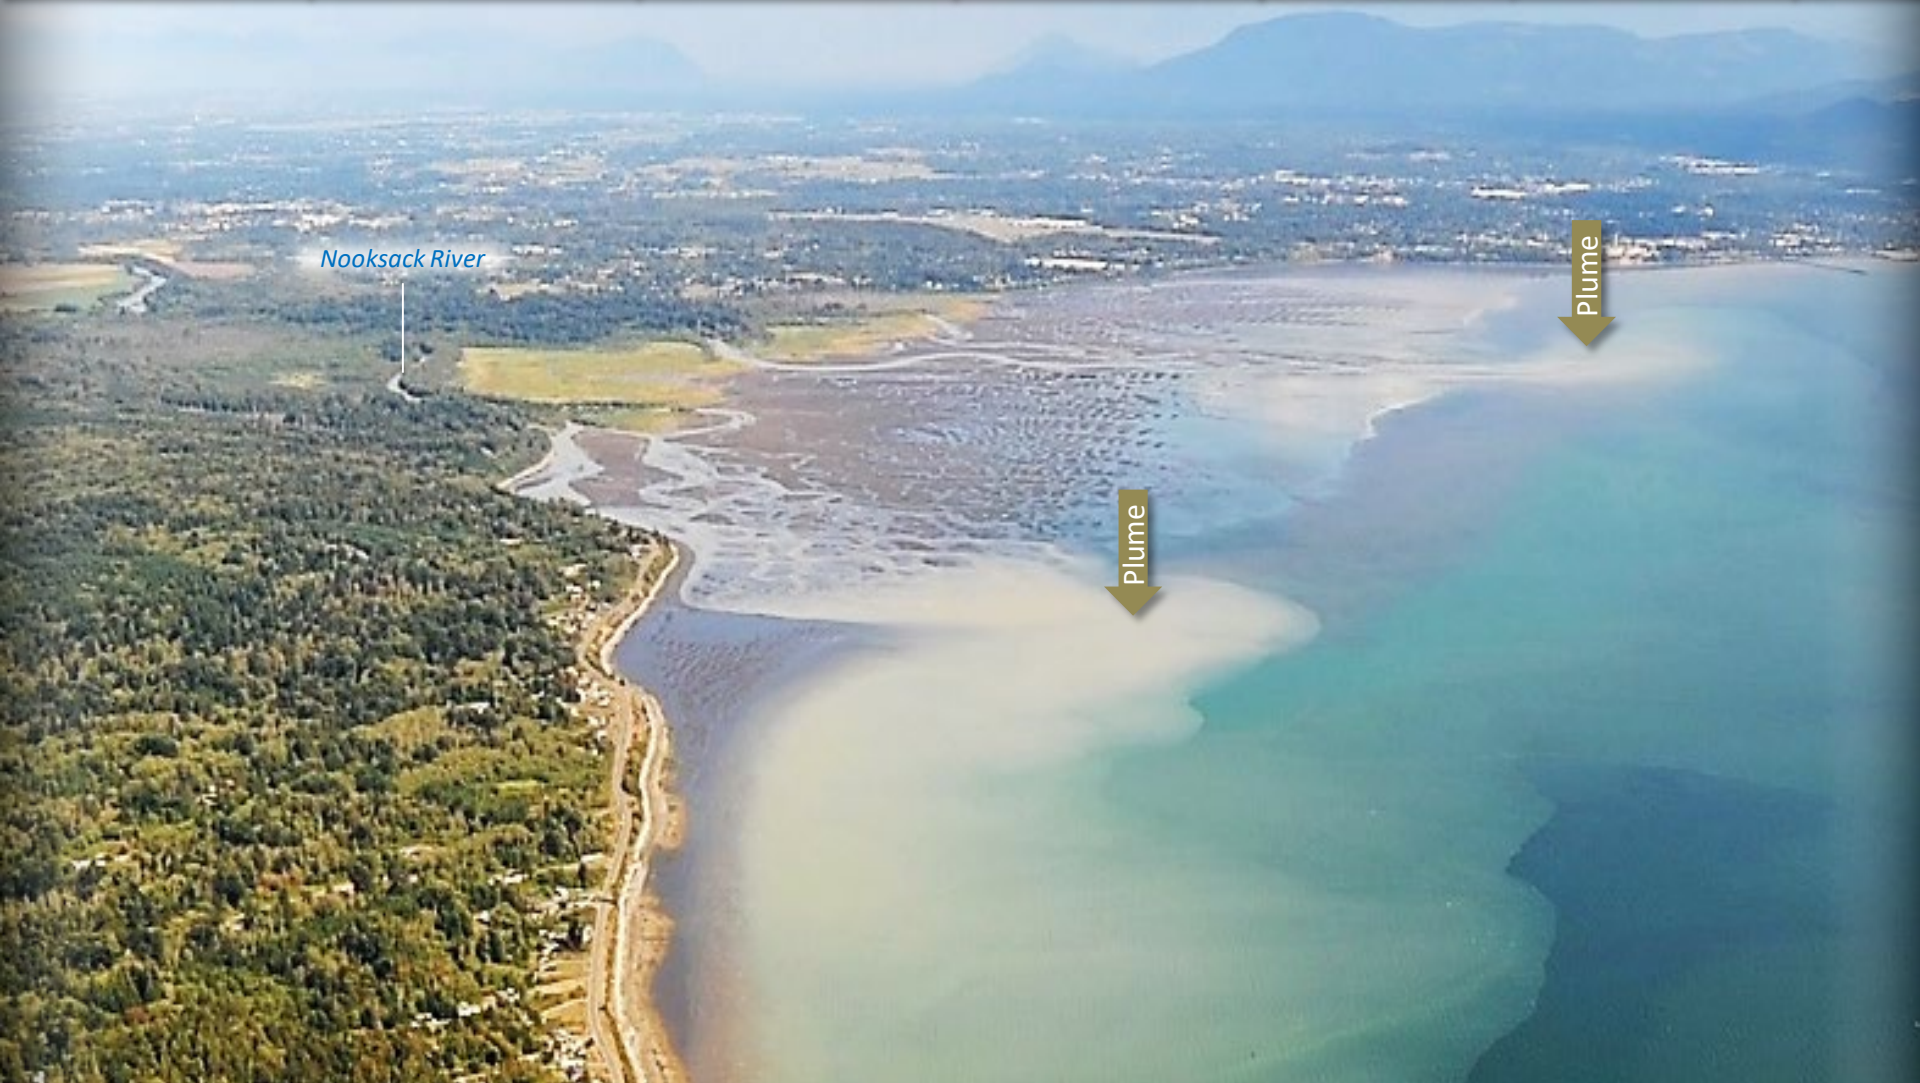
Plumes of the forks of the Nooksack River moving in opposite directions.
Location: Bellingham Bay (North Sound), 12:46 PM
