Eyes Over Puget Sound

Surface Conditions Report: Sept 8, 2021

Up-to-date observations of water quality conditions in Puget Sound and coastal bays

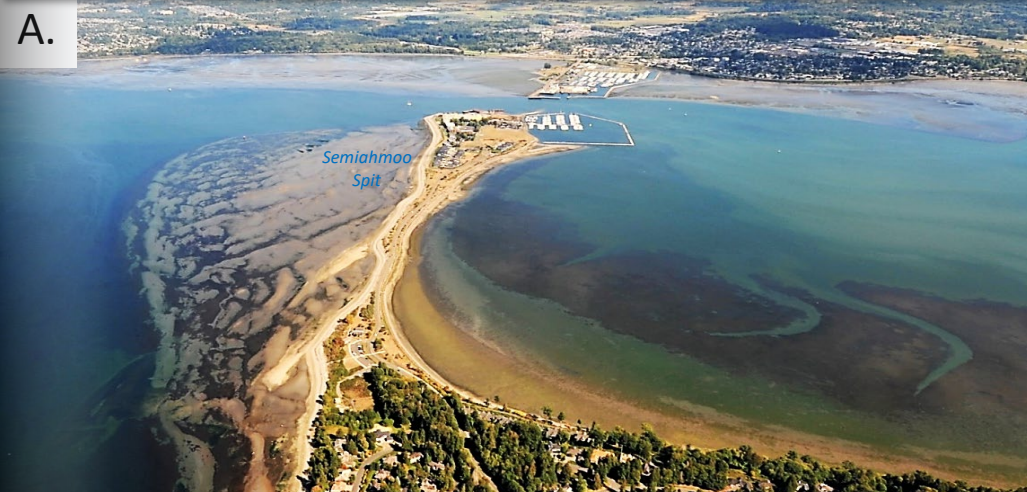
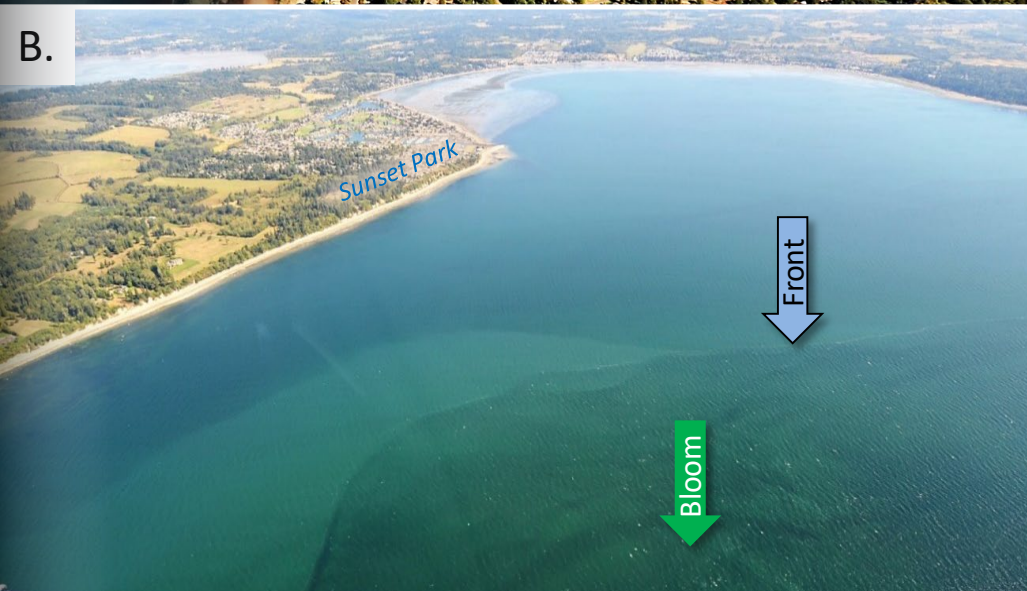
A. Drayton Harbor with seagrass. B. Front and different water masses at entrance to Birch Bay. C. Schools of fish near seagrass bed. Location: A. Drayton Harbor, B-C. Birch Bay (North Sound), 12:53 PM

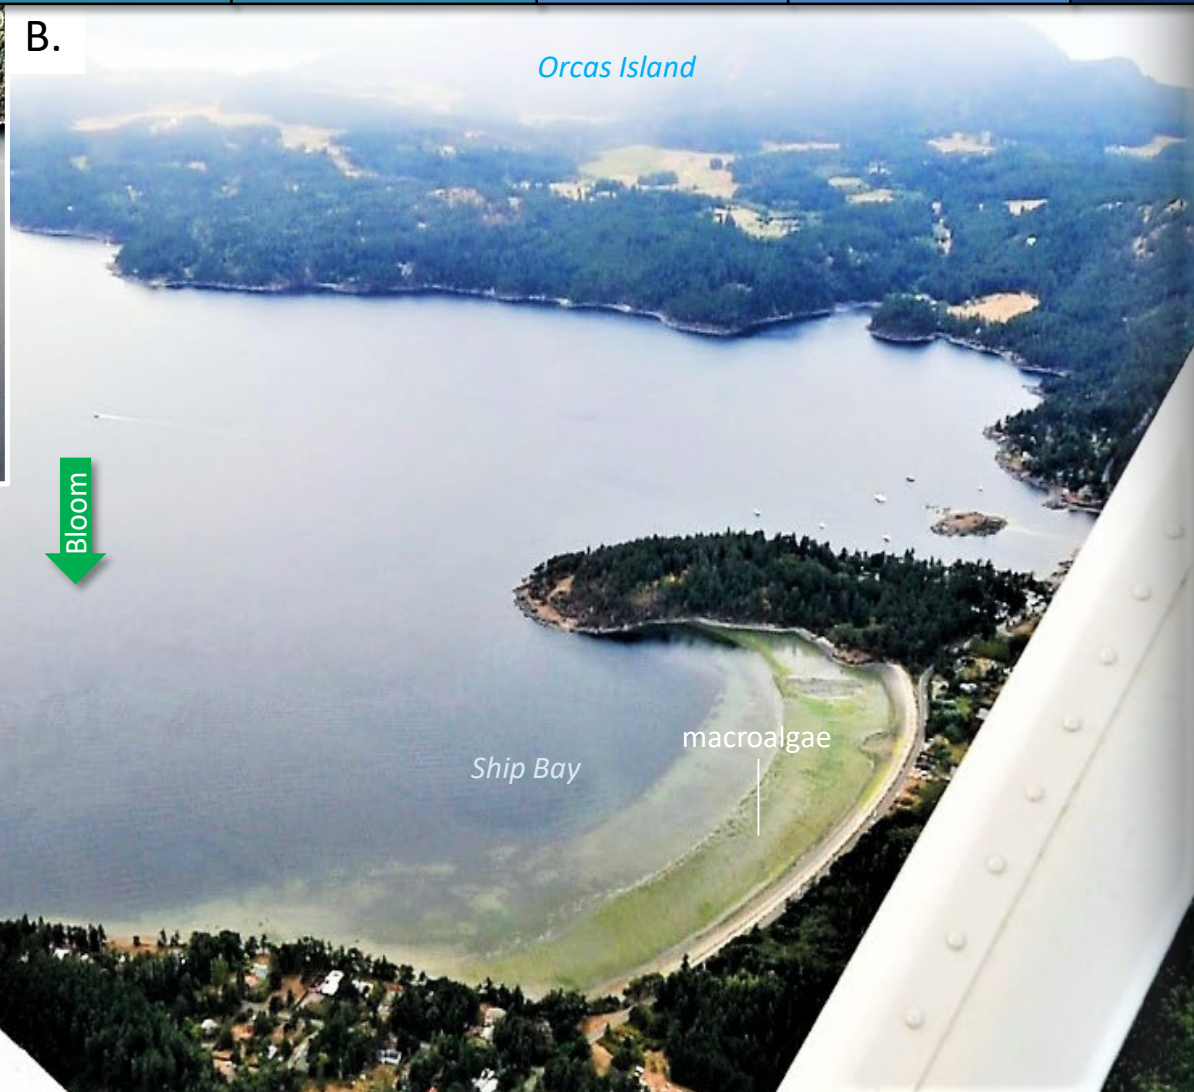
A. Patches of jellyfish, red-brown bloom (low visibility due to rain) and B. macroalgae on beach in Ship Bay.
Location: East Sound, Orcas Island (North Sound), 1:07 PM

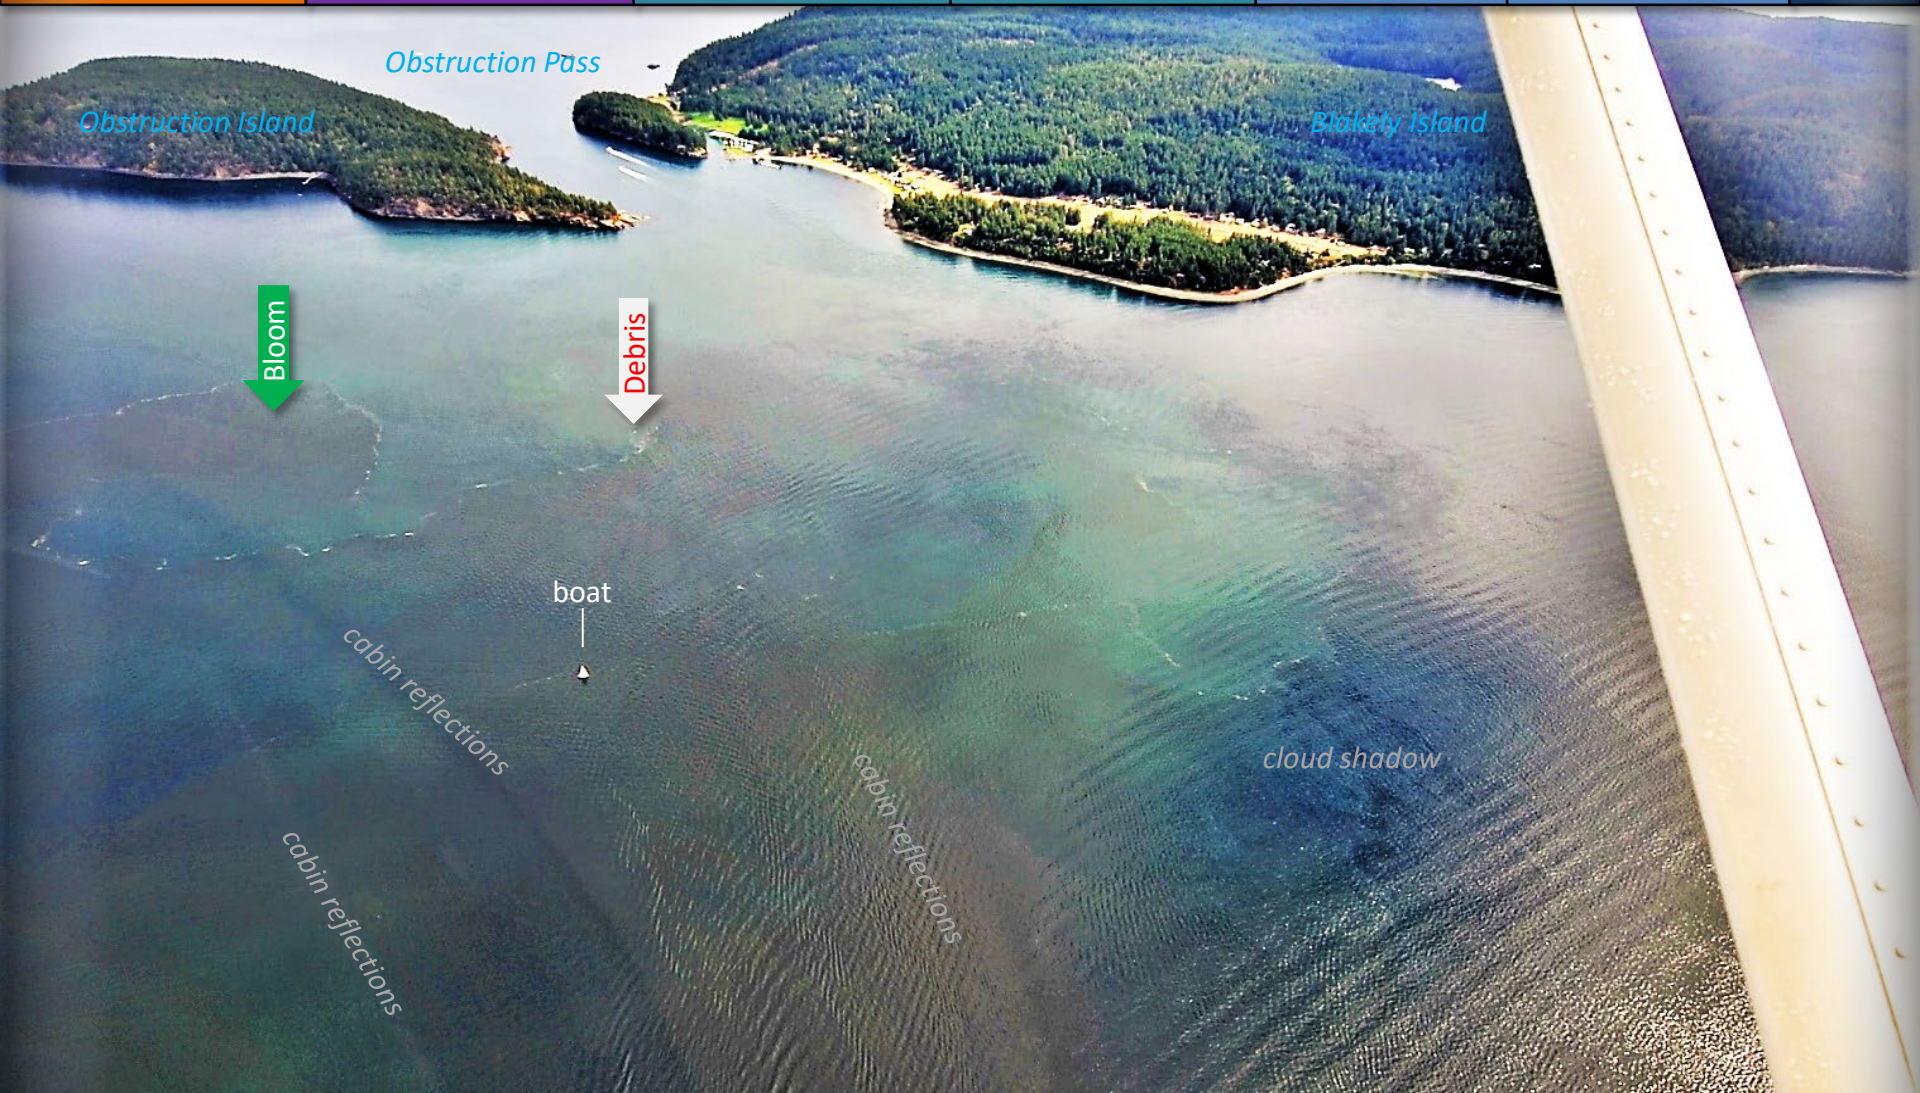
Red-brown algae bloom from East Sound mixing with clearer water entering via Obstruction Pass.
Location: East Sound, Orcas Island (North Sound), 1:12PM

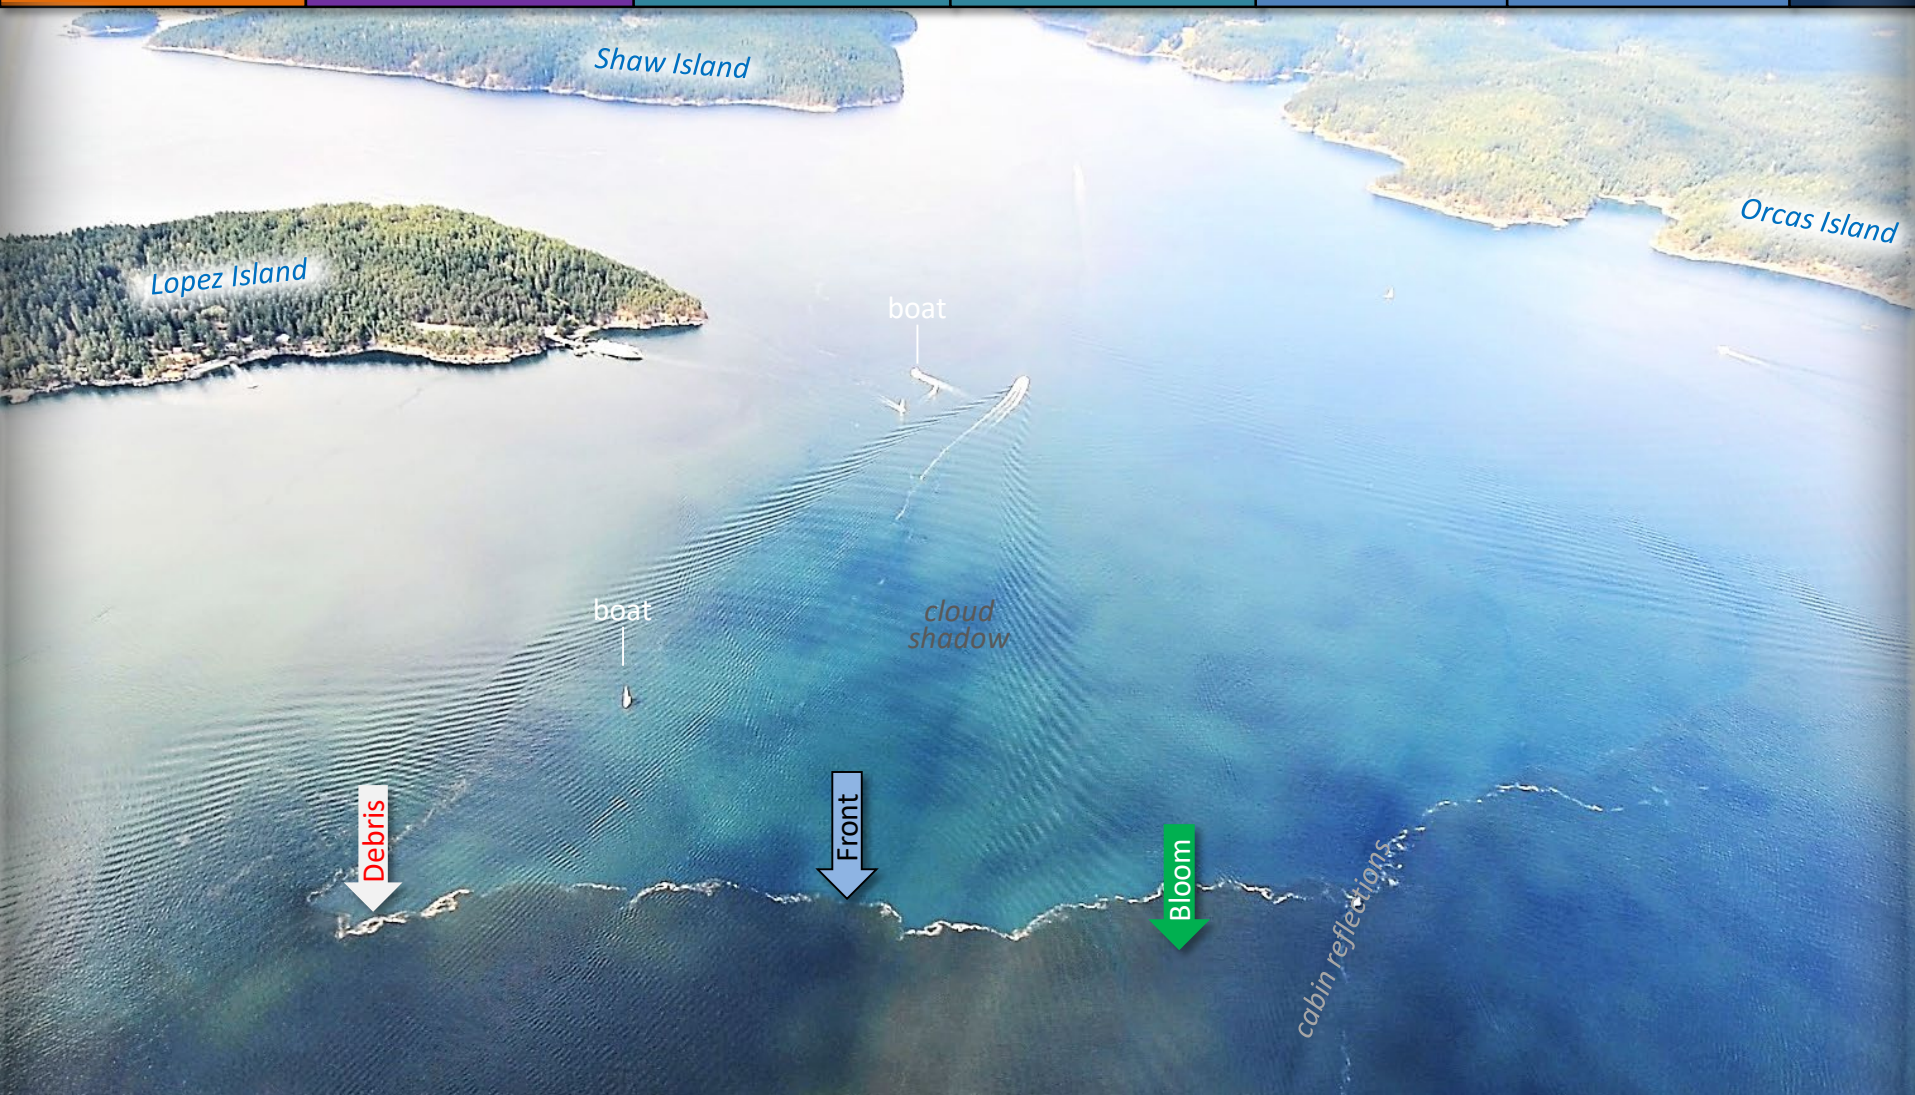
Strong brown bloom and organic material accumulating at a distinct front.
Location: Shoal Bay (North Sound), 1:12 PM

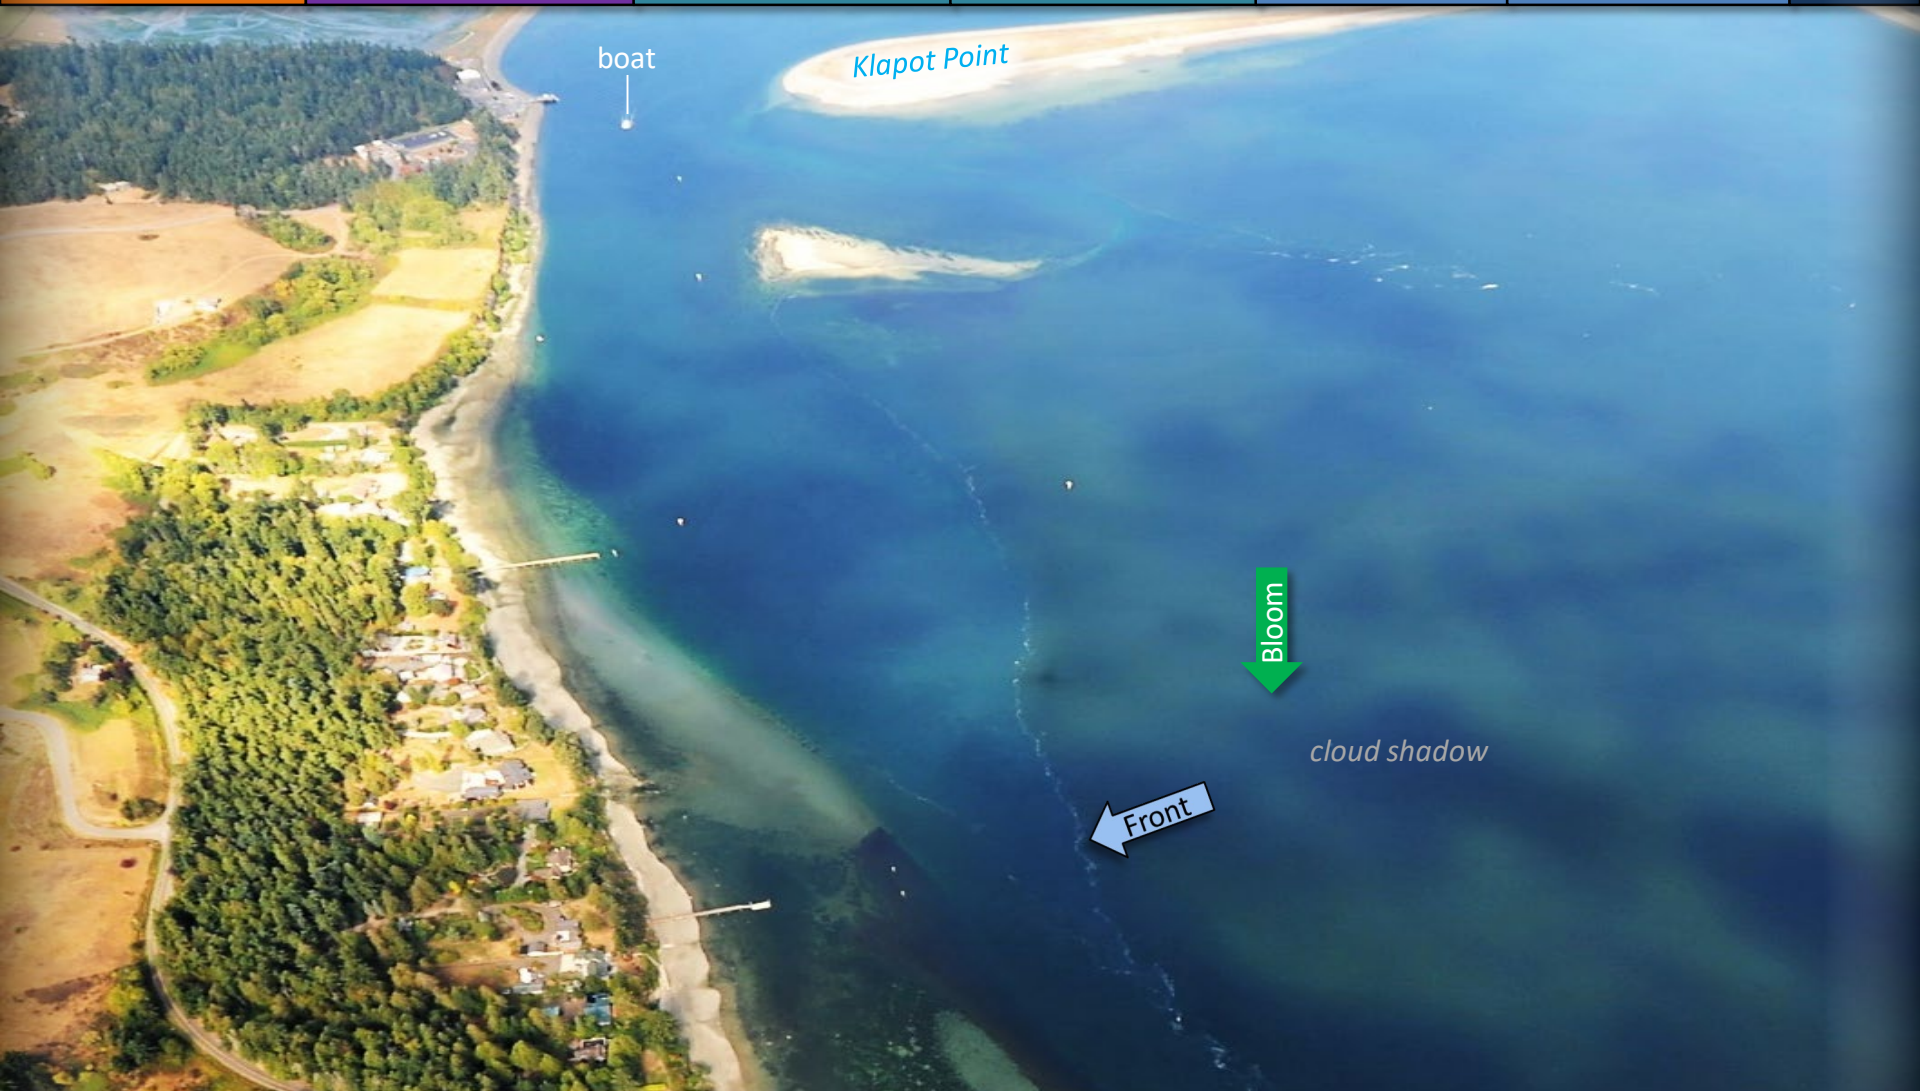
Bloom, tidal front, organic material, and suspended sediment near western shoreline.

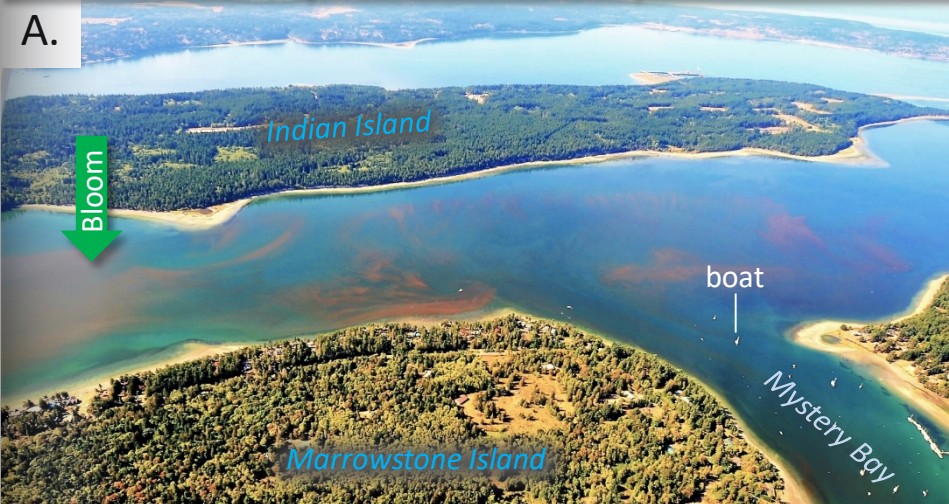
Very red-brown bloom spanning the entire length of Kilisut Harbor, from the entrance of the bay to Scow Bay.
 Location: Marrowstone Island (Central Sound), 1:50 PM

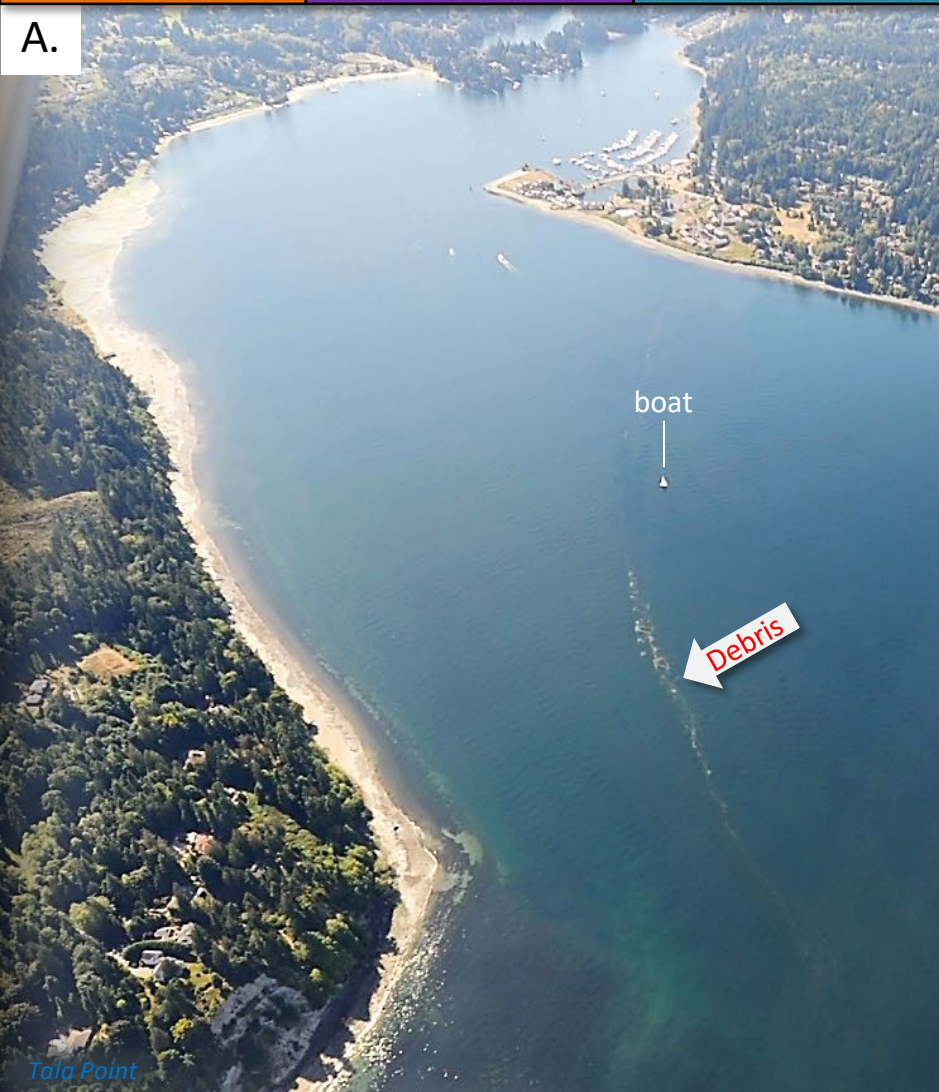
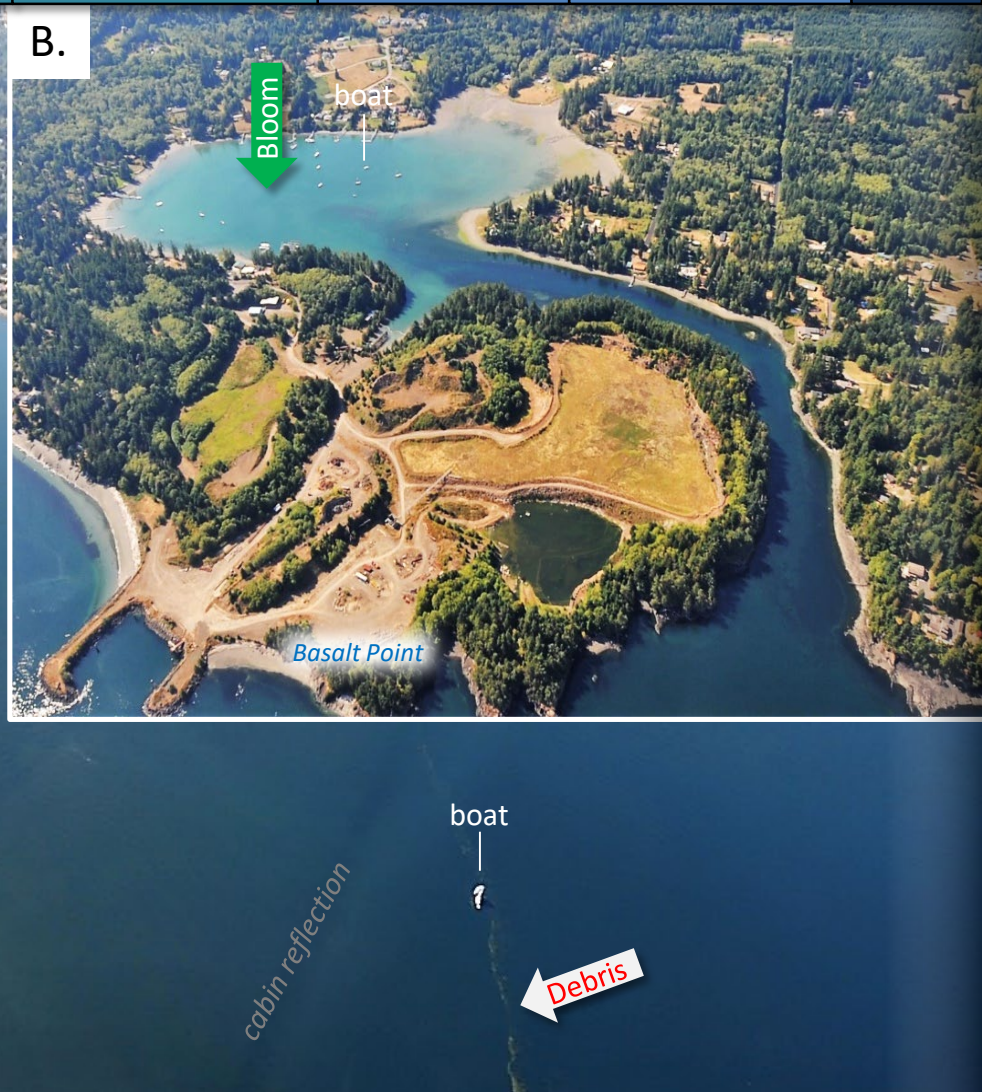
A. Long ribbons of organic material drifting at surface. B. Turquoise-colored water in Mats Mats Bay.
Location: A. Port Ludlow, B. Mats Mats Bay (Central Sound), 1:54 PM

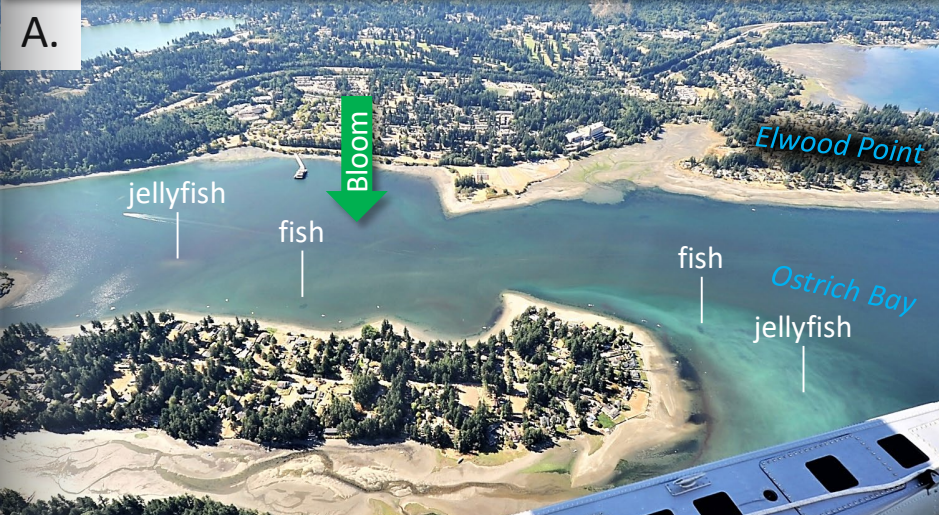
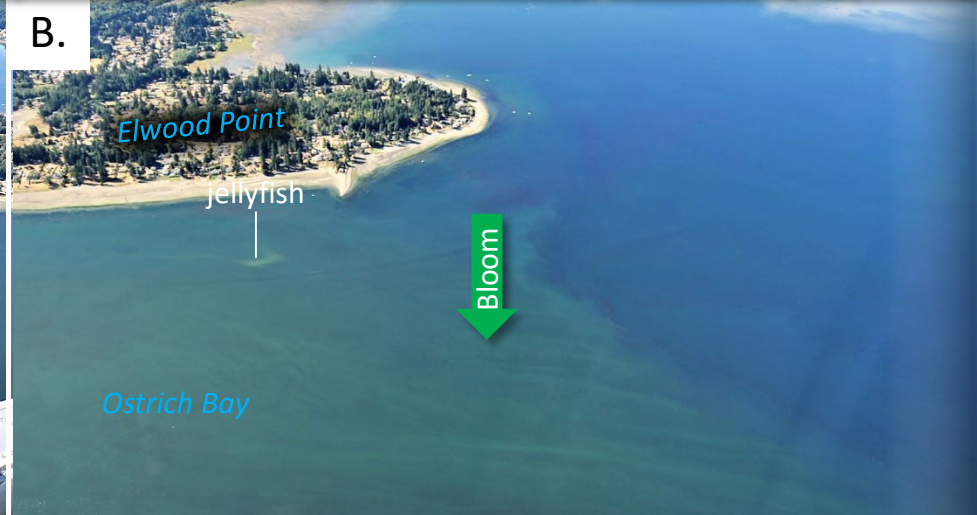
A. Milky-white patches and red-brown bloom in Ostrich Bay. B-D. Jellyfish patches in Ostrich and Oyster Bays.
 Location: Dyes Inlet (Central Sound), 2:08 PM

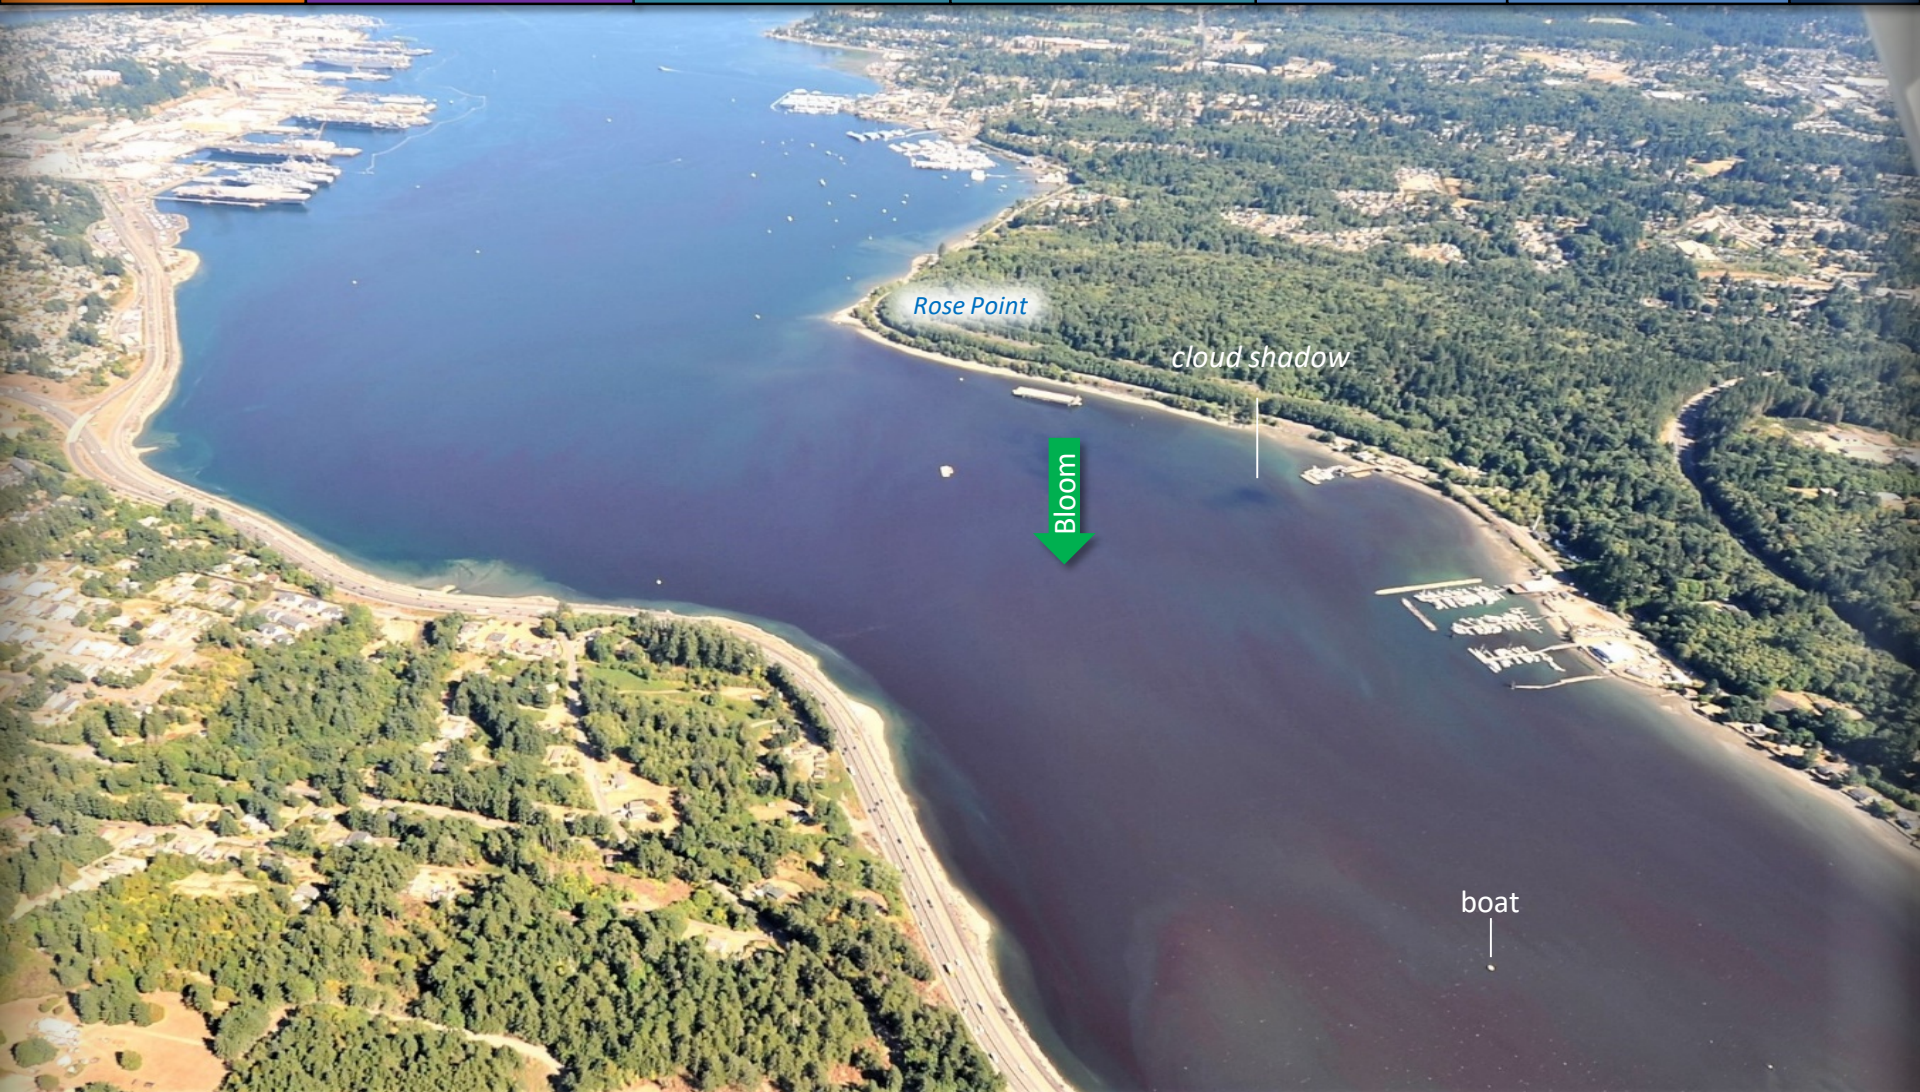
Strong red-brown bloom, but no jellyfish. Location: Sinclair Inlet (Central Sound), 2:11 PM

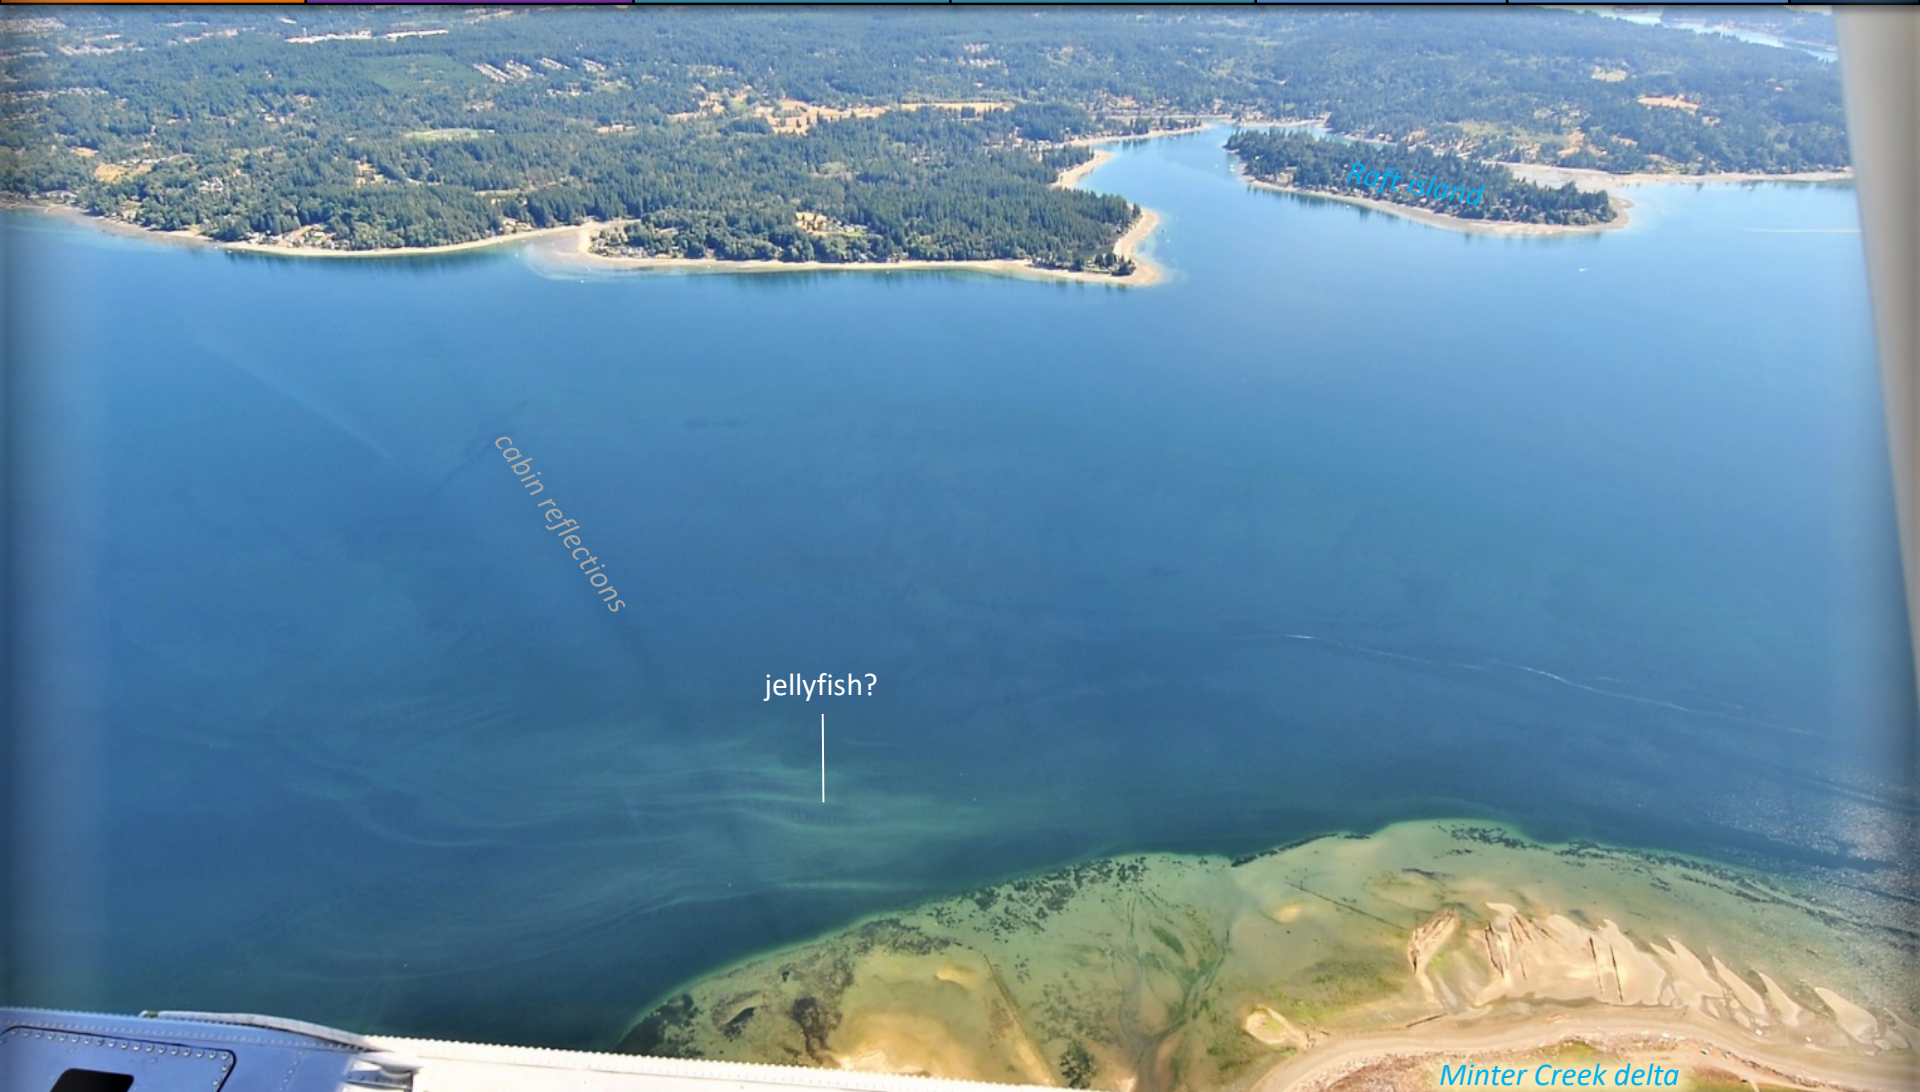
Turquoise patch that appeared granular, which could be a diffuse patch of jellyfish.

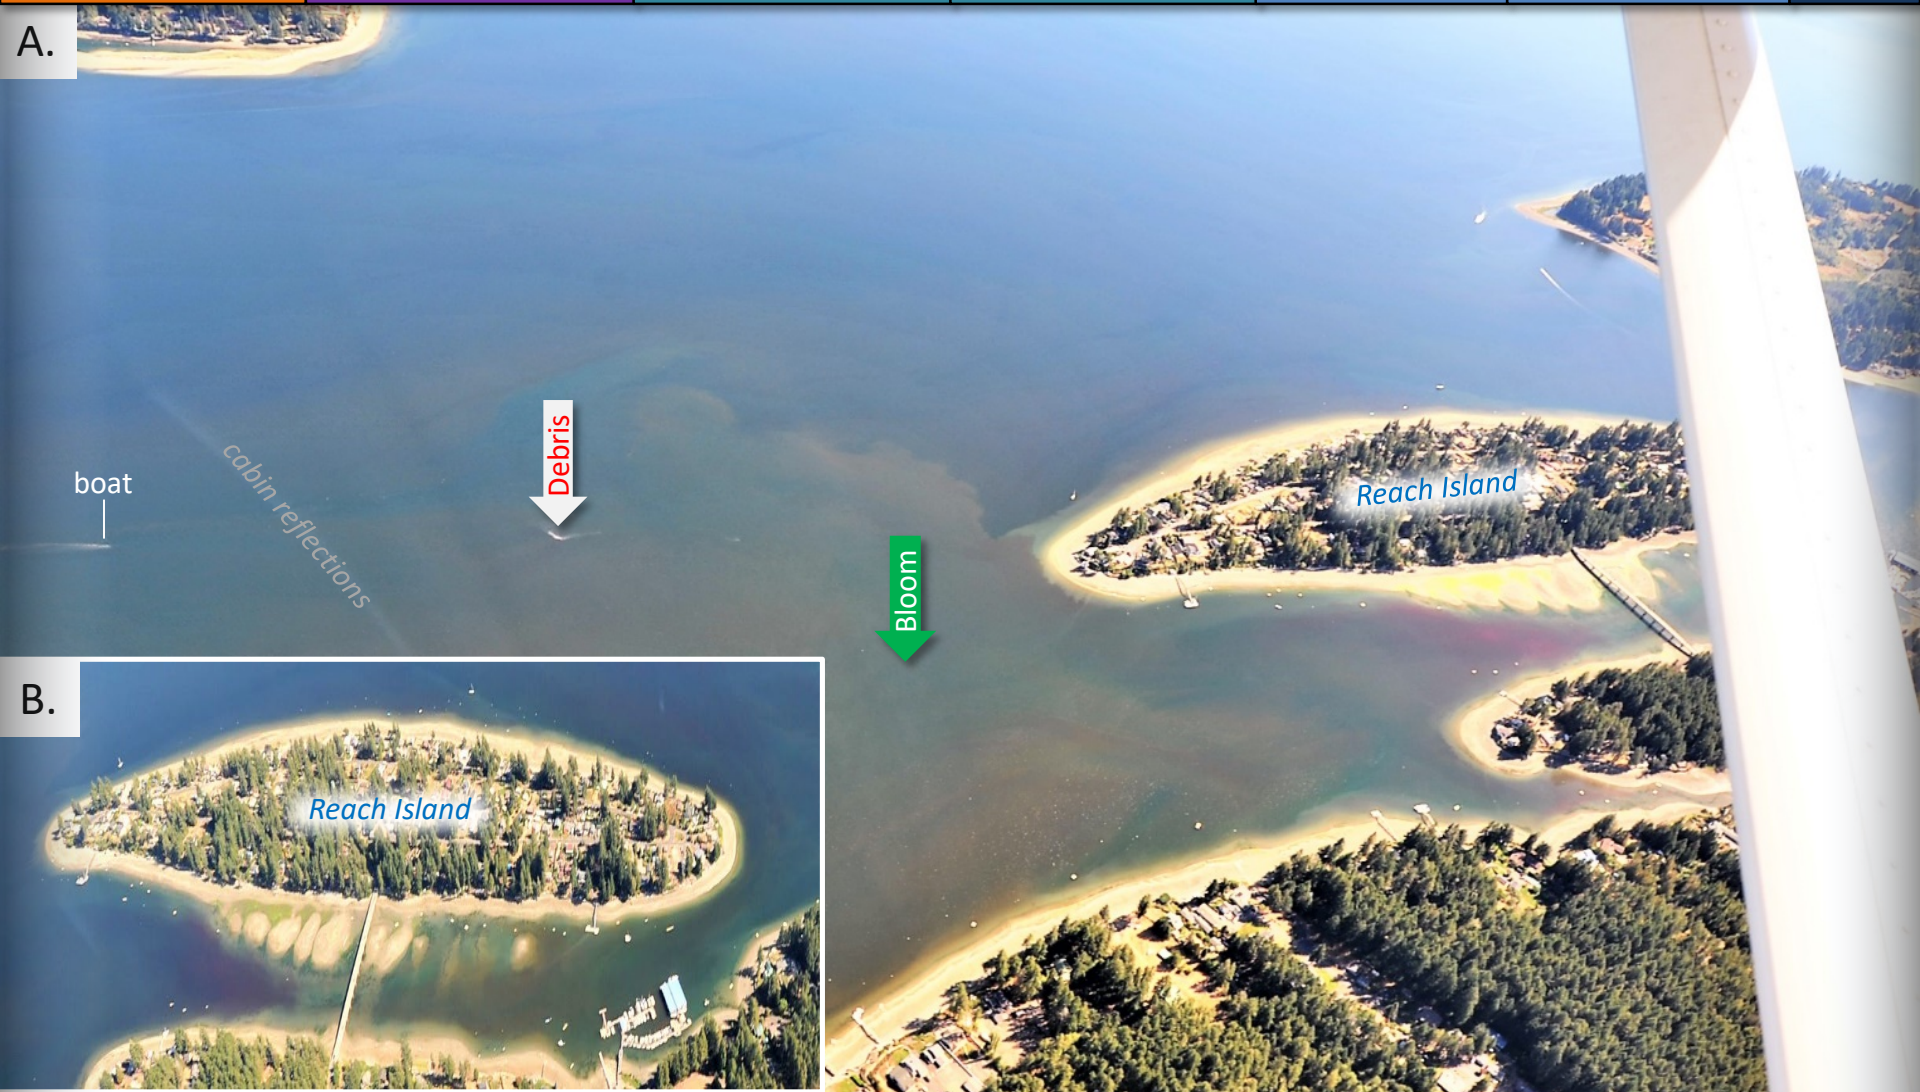
A. Red-brown and red bloom. B. It matters on which side of the bridge one takes a plankton sample!

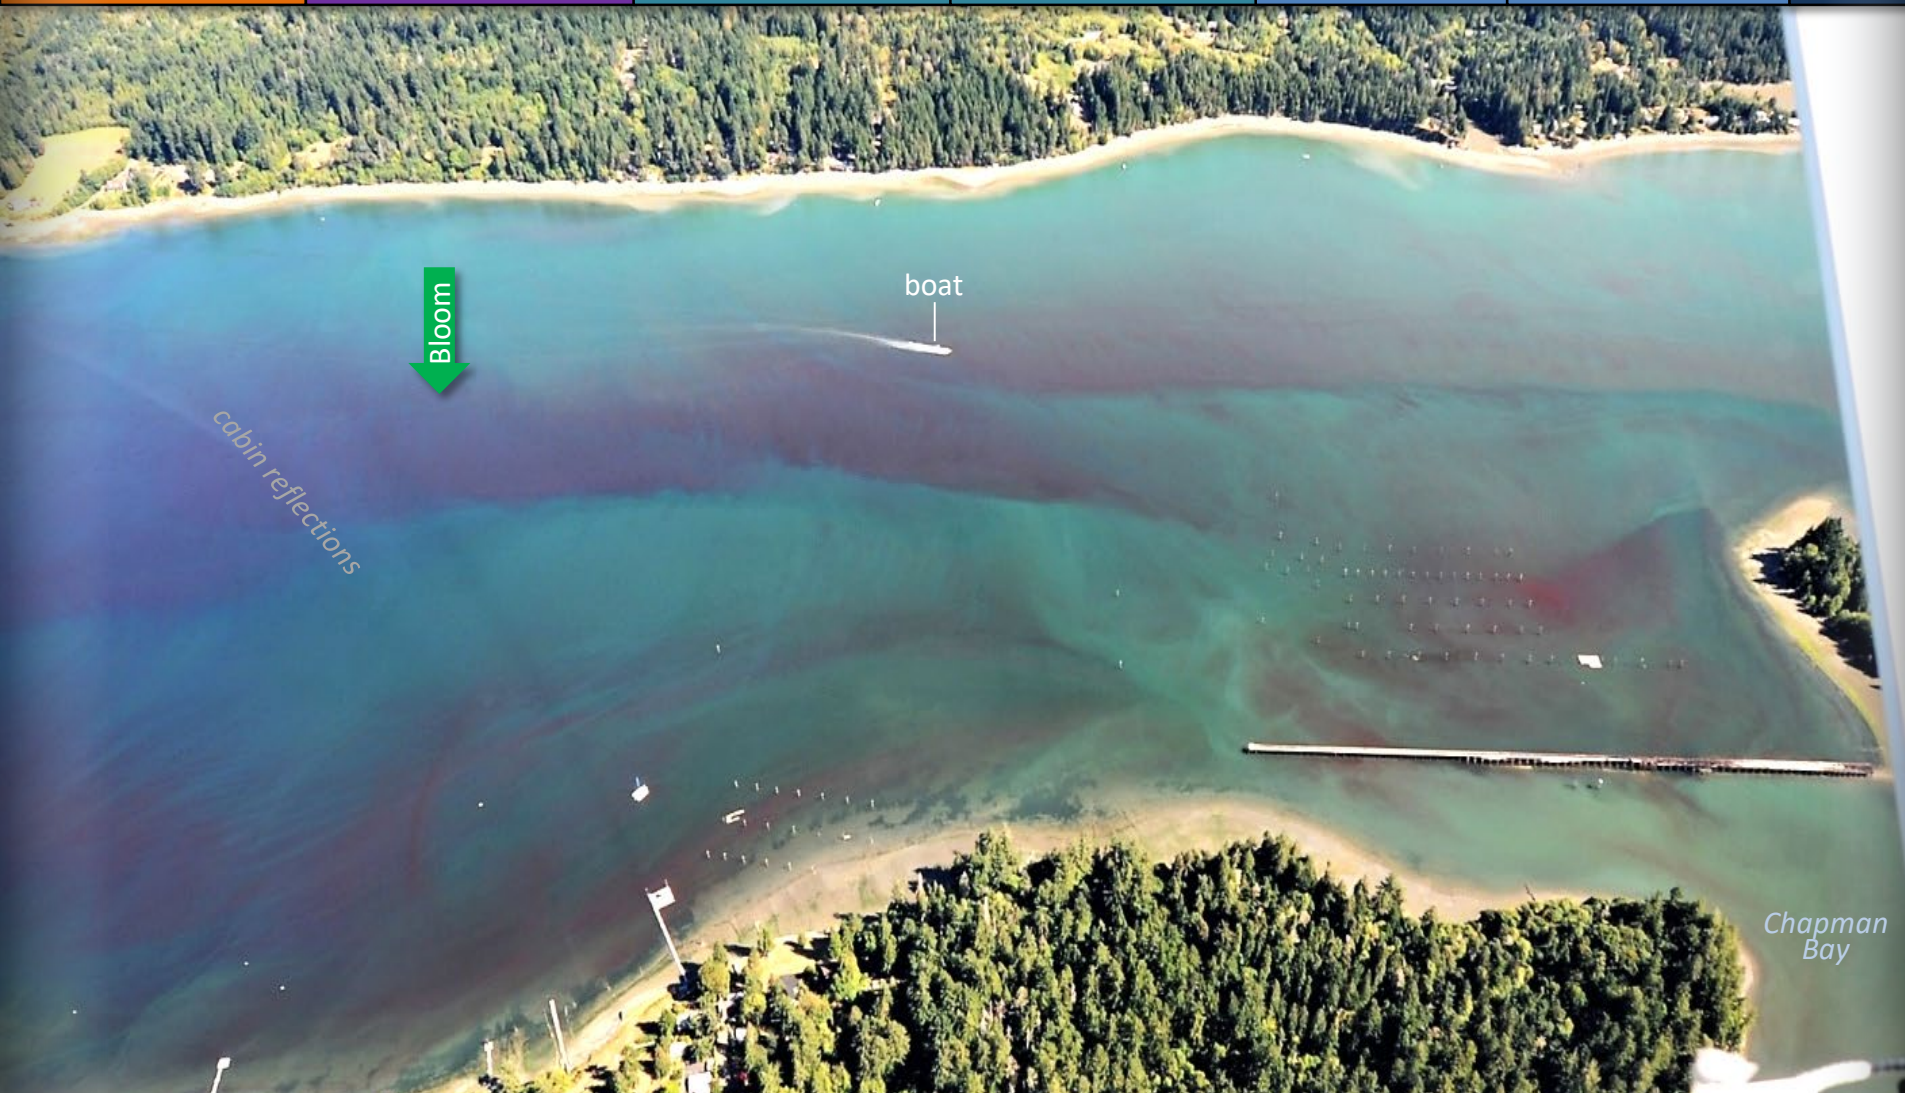
Strong red-brown bloom with turquoise water mixing in from Chapman bay.

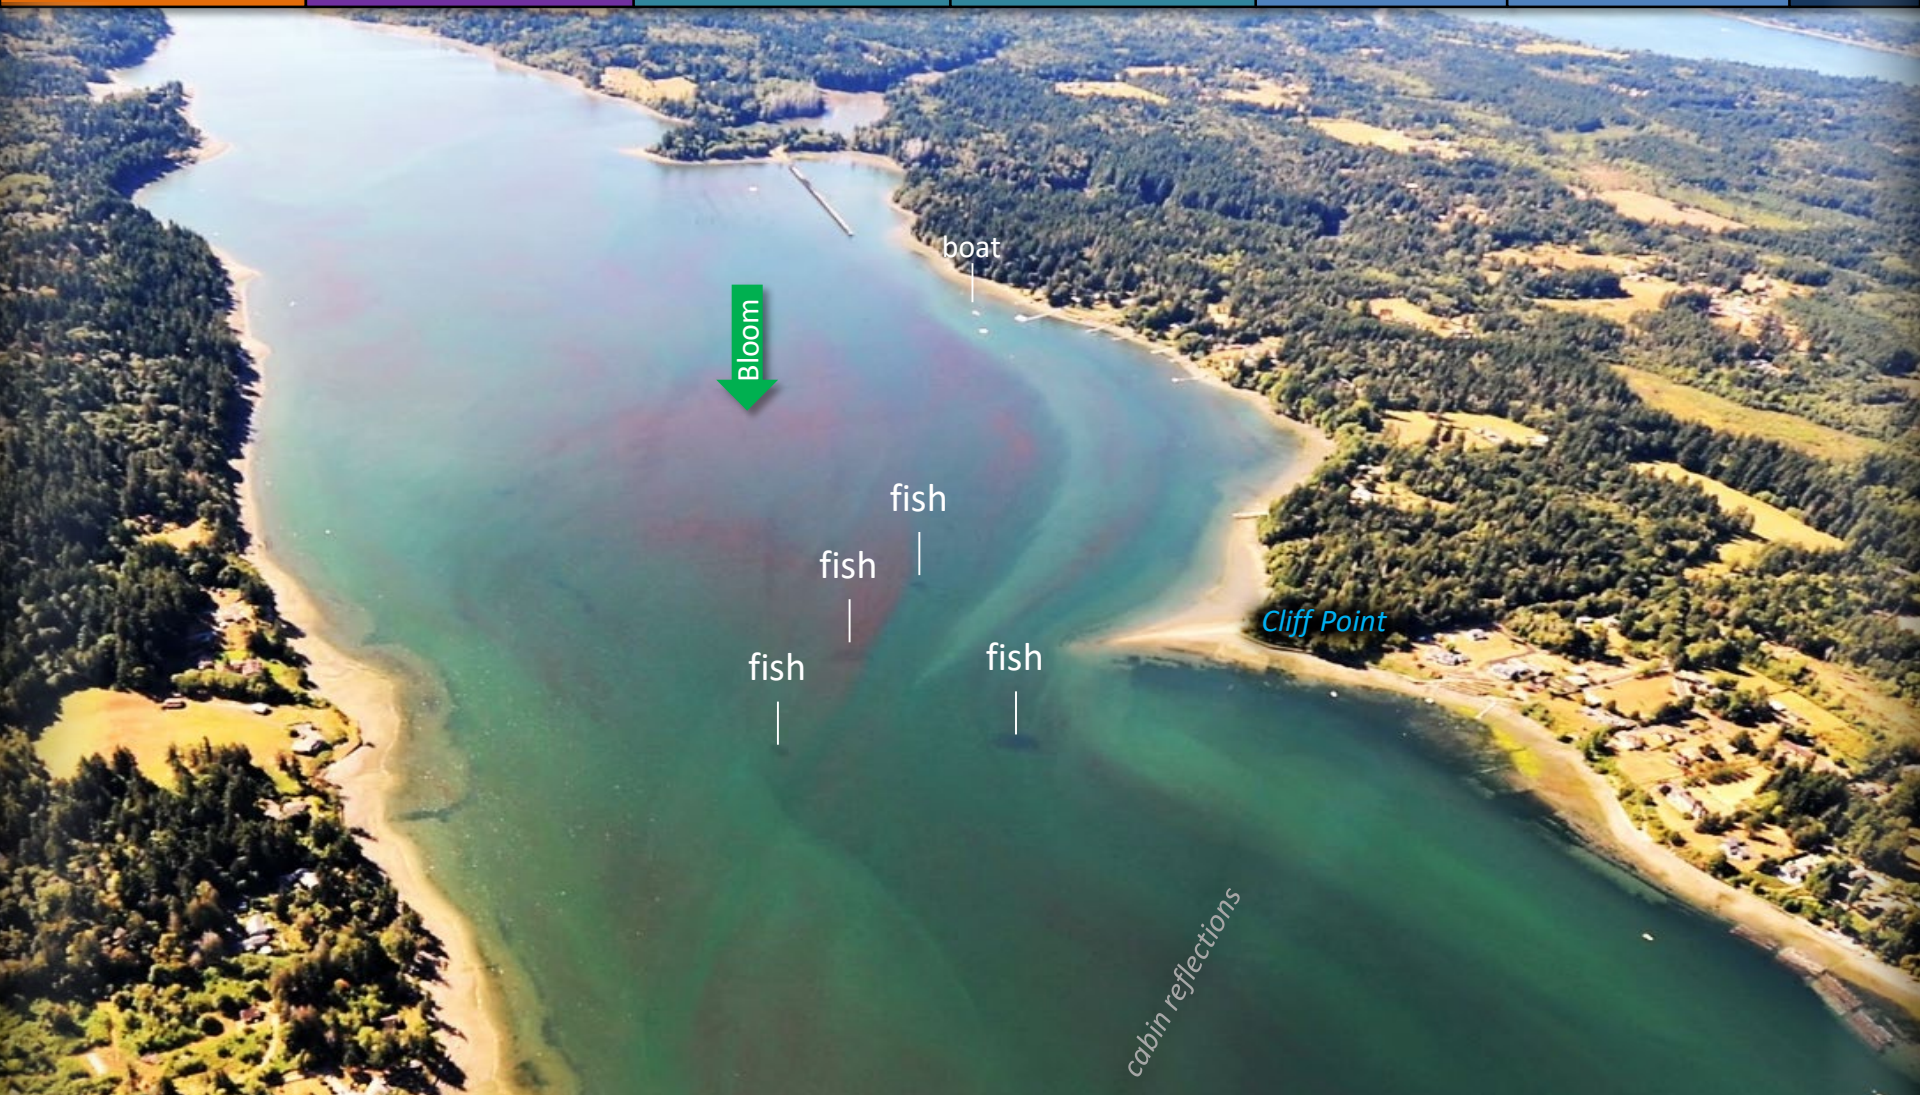
Strong red-brown bloom with turquoise water mixing in from Chapman bay. Schools of fish near Cliff Point.
Location: Henderson Inlet (South Sound), 12:42 PM
