Eyes Over Puget Sound

Surface Conditions Report: Sept 8, 2021

Up-to-date observations of water quality conditions in Puget Sound and coastal bays

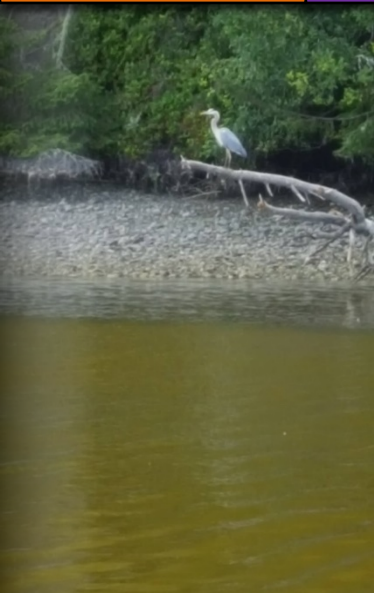
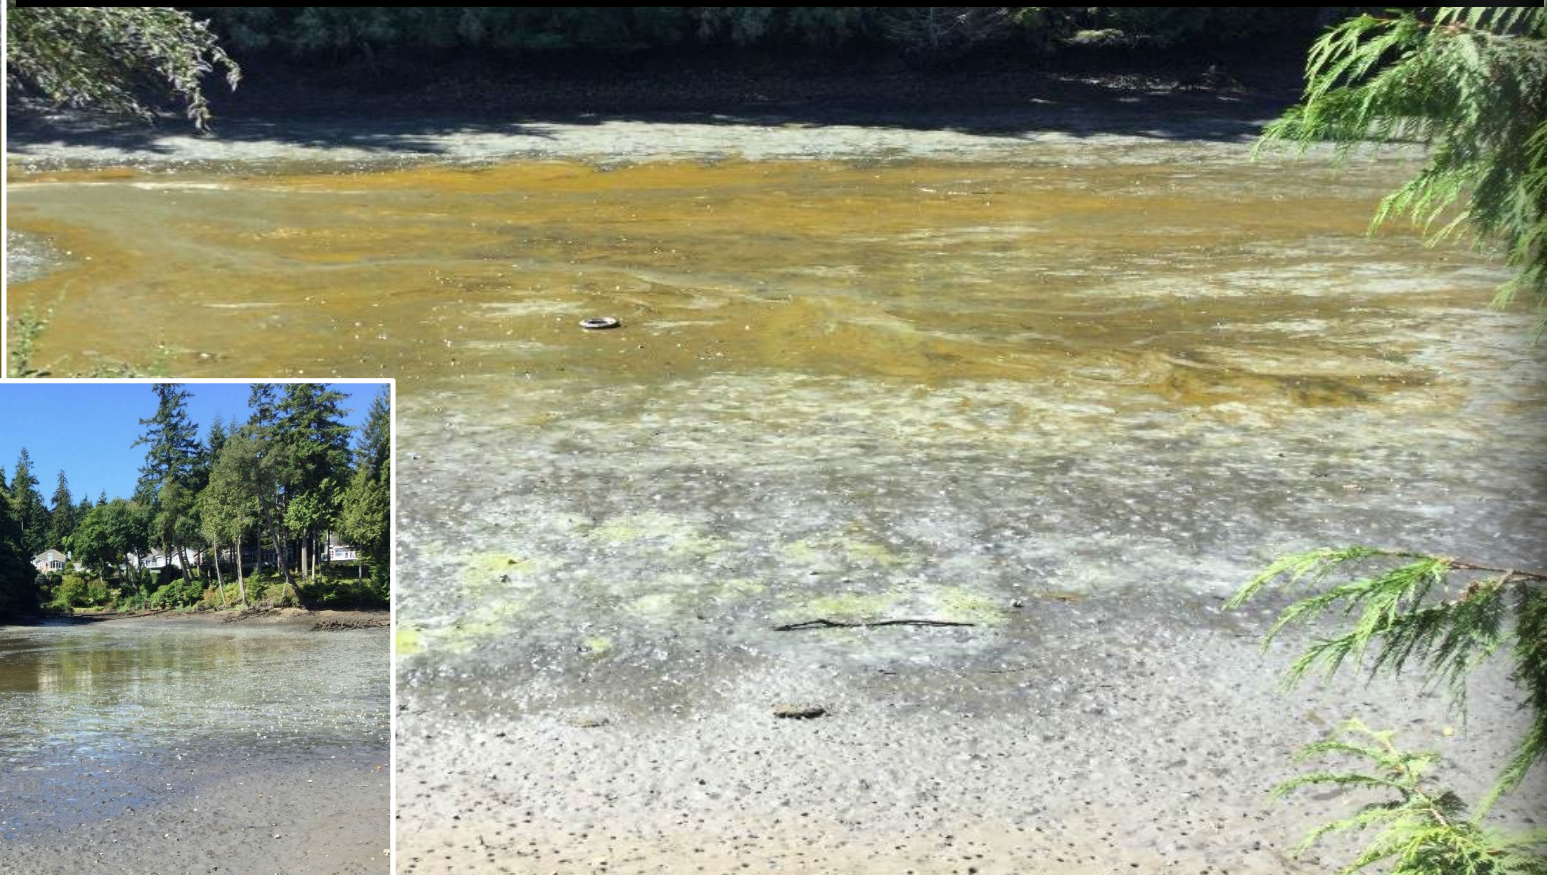
Jacquelyn Stenman and Michael Dawson, 7/20/2021, Port Ludlow, stench complaint (ERTS#708105)

“On July 20, 2021, I visited the Bay Club in Port Ludlow to investigate a citizen complaint (COM2021-00112, ERTS#708105) regarding water quality concerns in Port Ludlow Bay. I observed brown water, floating algae, and a strong dead fish and shellfish odor”.

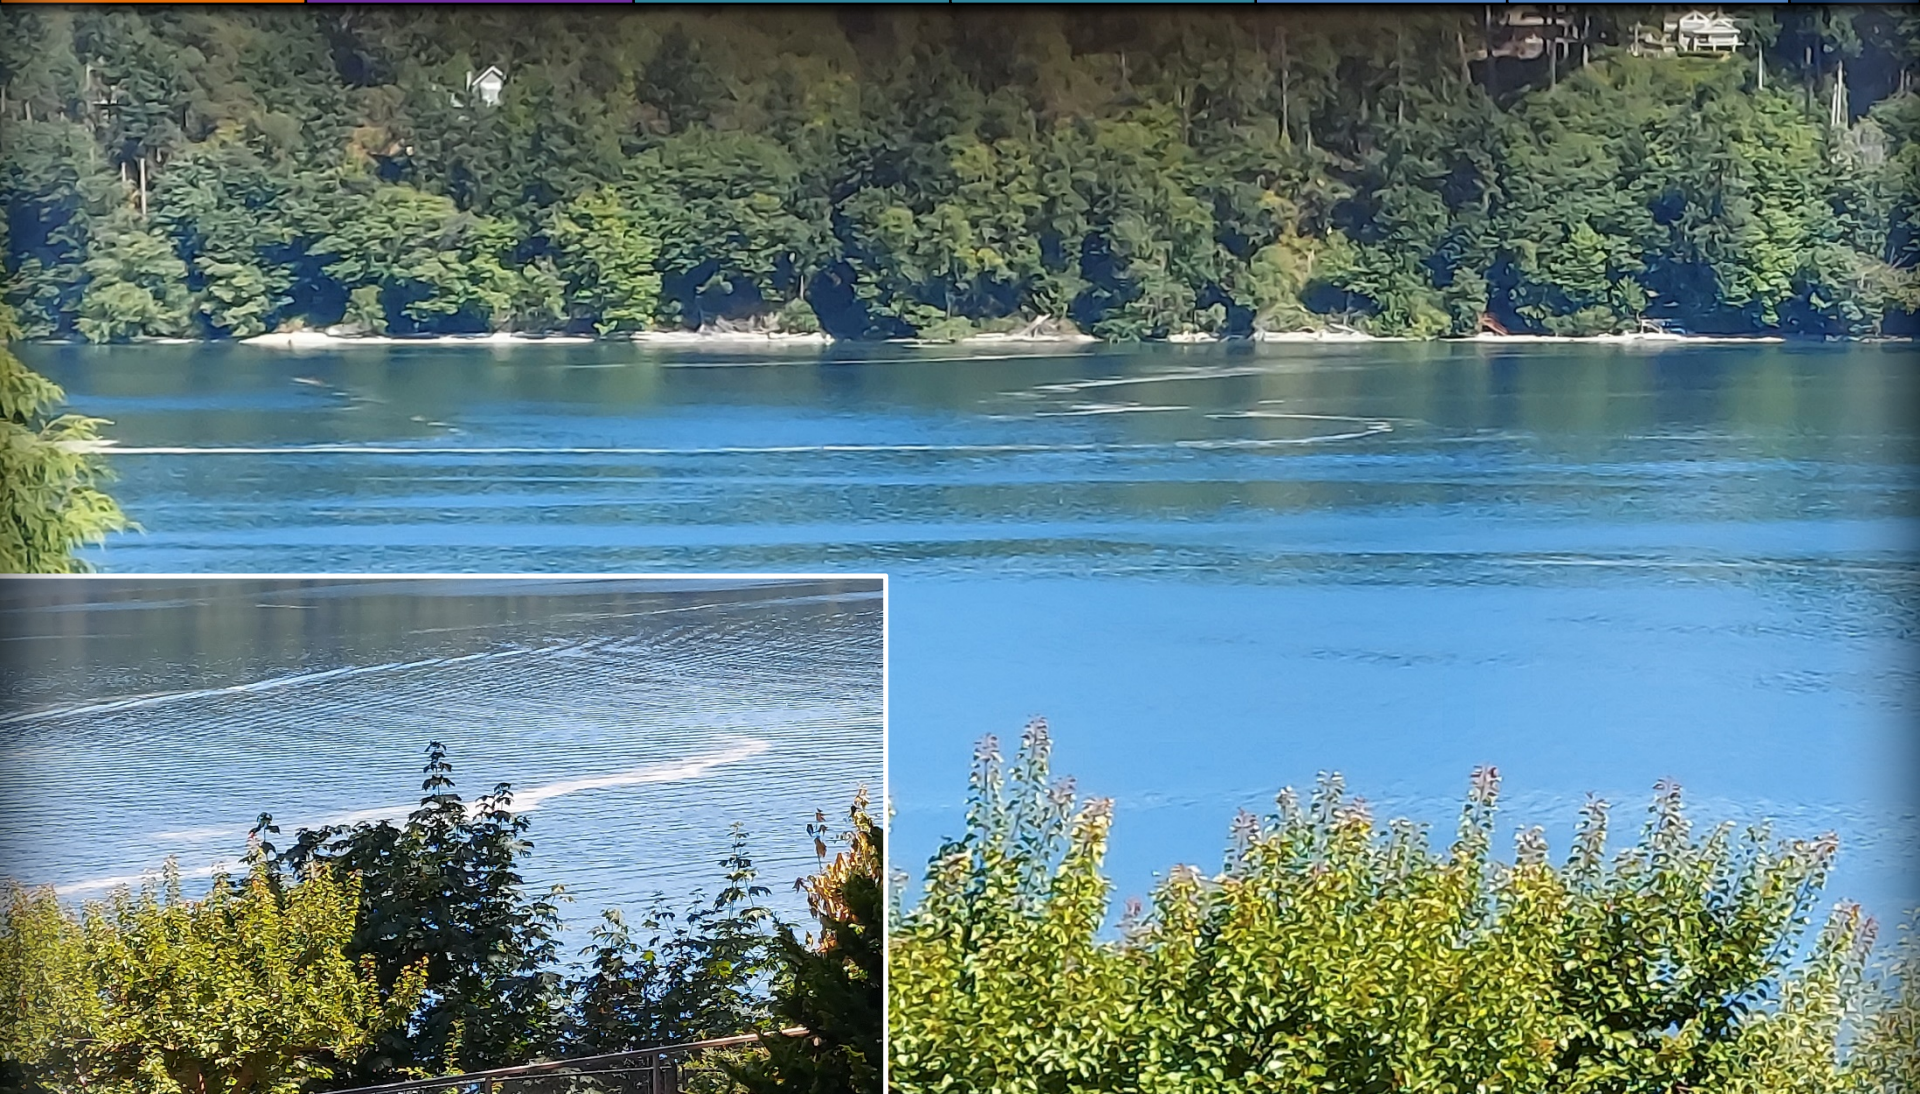
Jim Baker, 8/4/2021, organic material rafts, Port Orchard

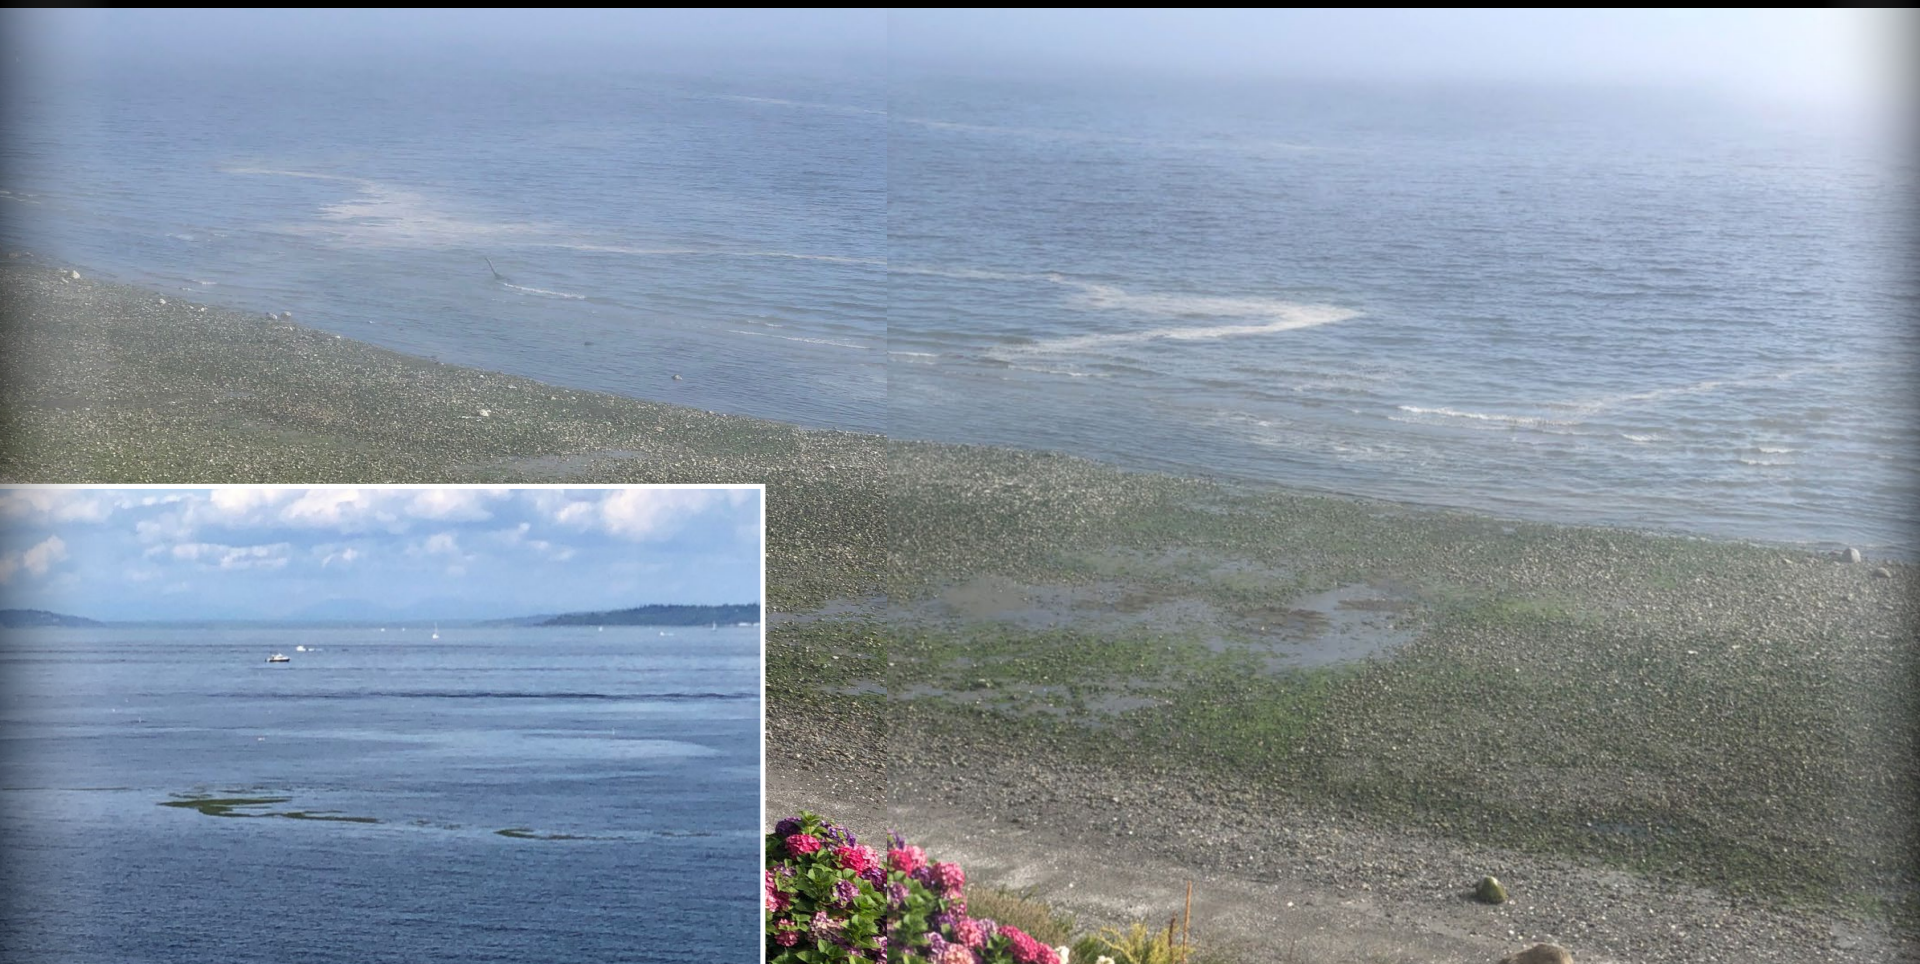
Maria Mason, 8/5/2021, Bainbridge Island facing West Point

“Nearly an everyday occurrence here. The water glowed blue effervescent, probably because of the algae. Never seen that before?”

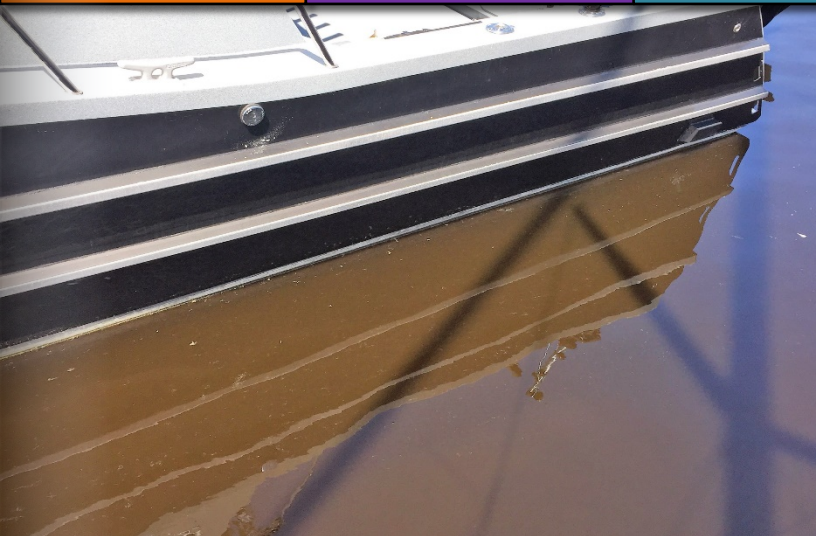
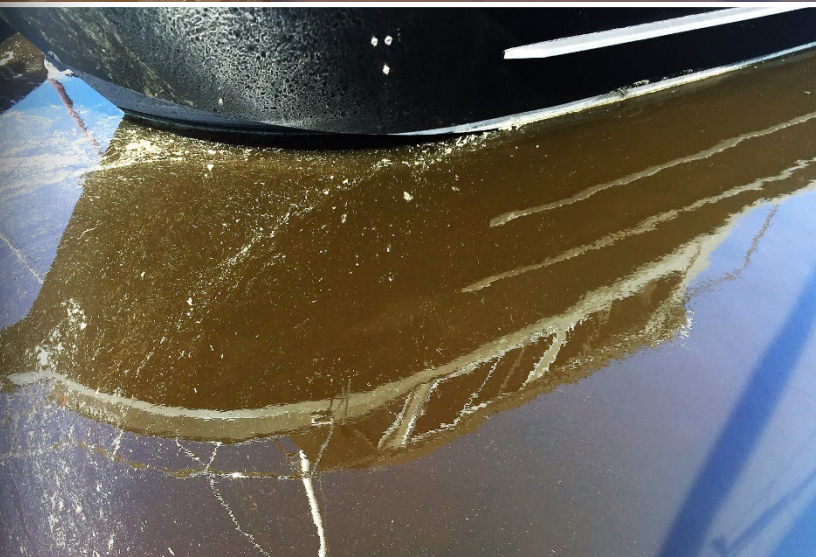
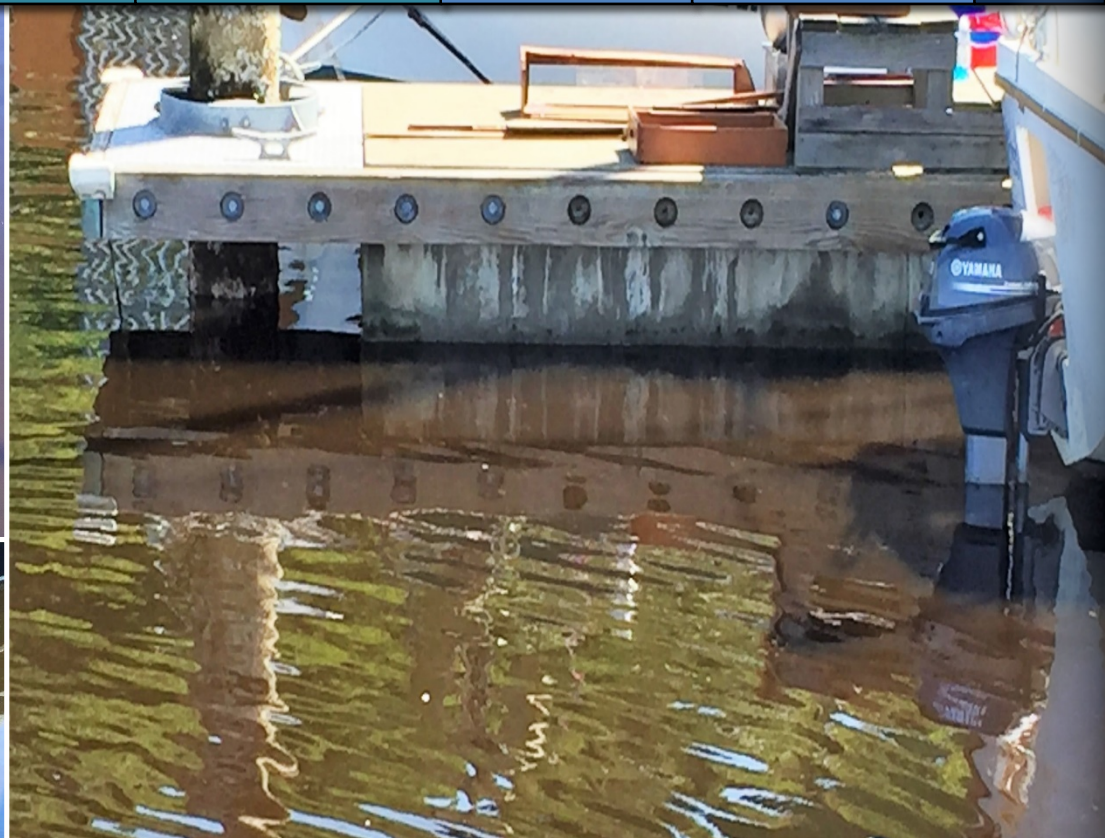
Julia Boss, 8/11/2021, Shilshole Marina

“The bloom extended into Shilshole Bay - West Point and Meadow Point with patches of decaying material at the surface – everywhere! A sailing teammate told me that he and his wife have been going out on their paddleboards at night to see the bioluminescence”. [Click here bioluminescence in Puget Sound](#)

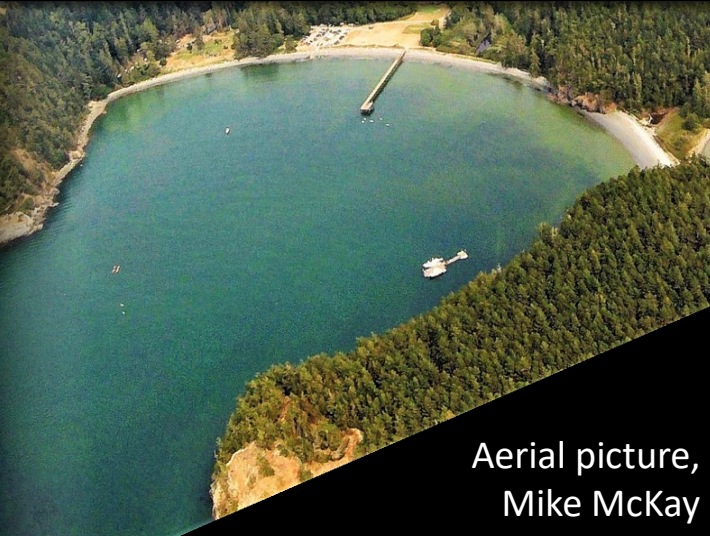
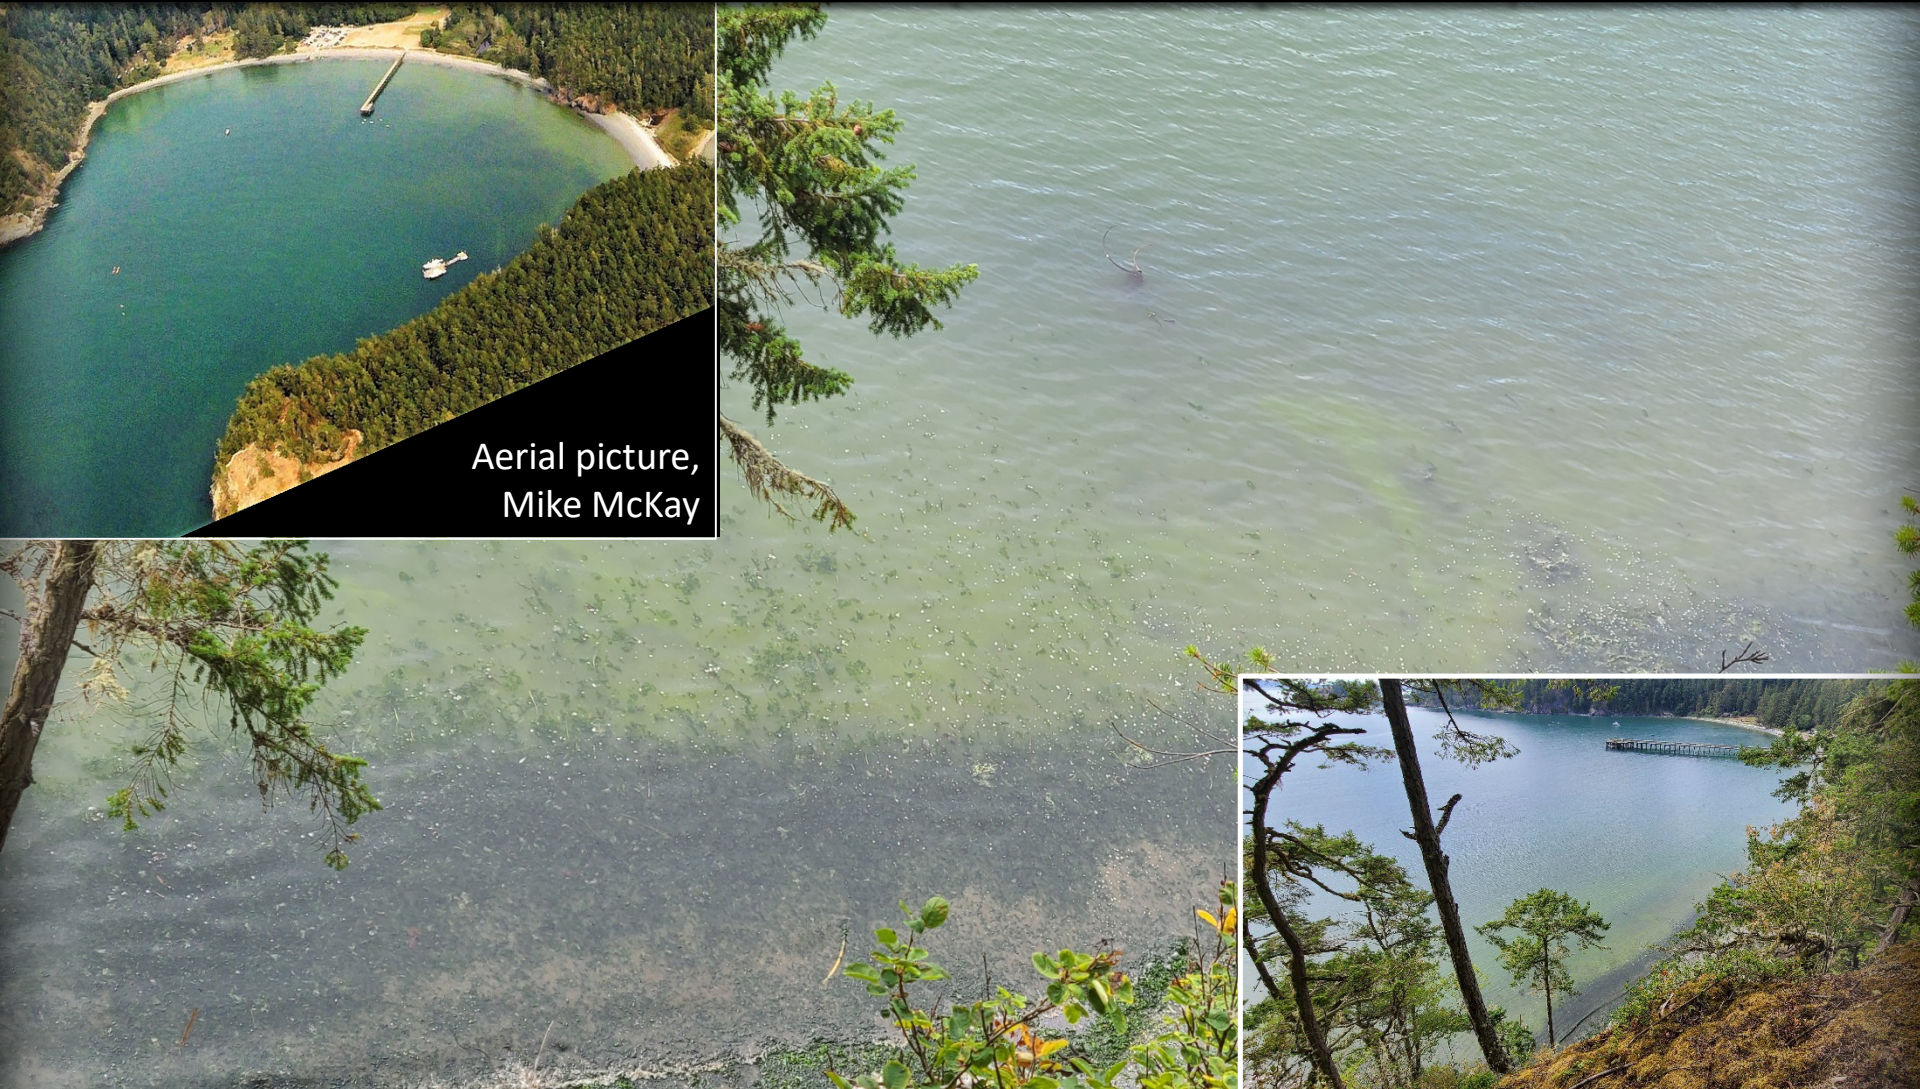
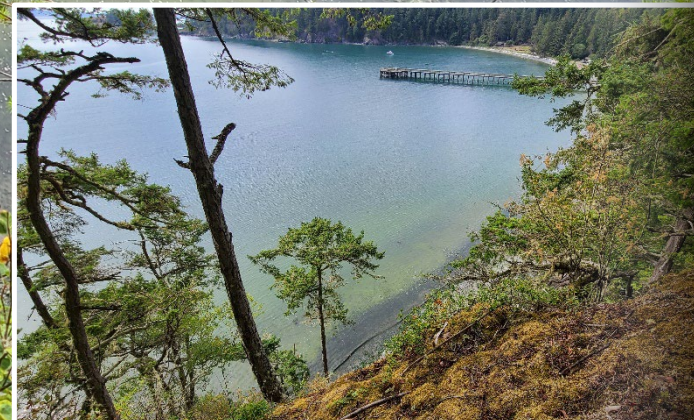
Grace McKenney, 8/12/2021, green bloom in Bowman Bay

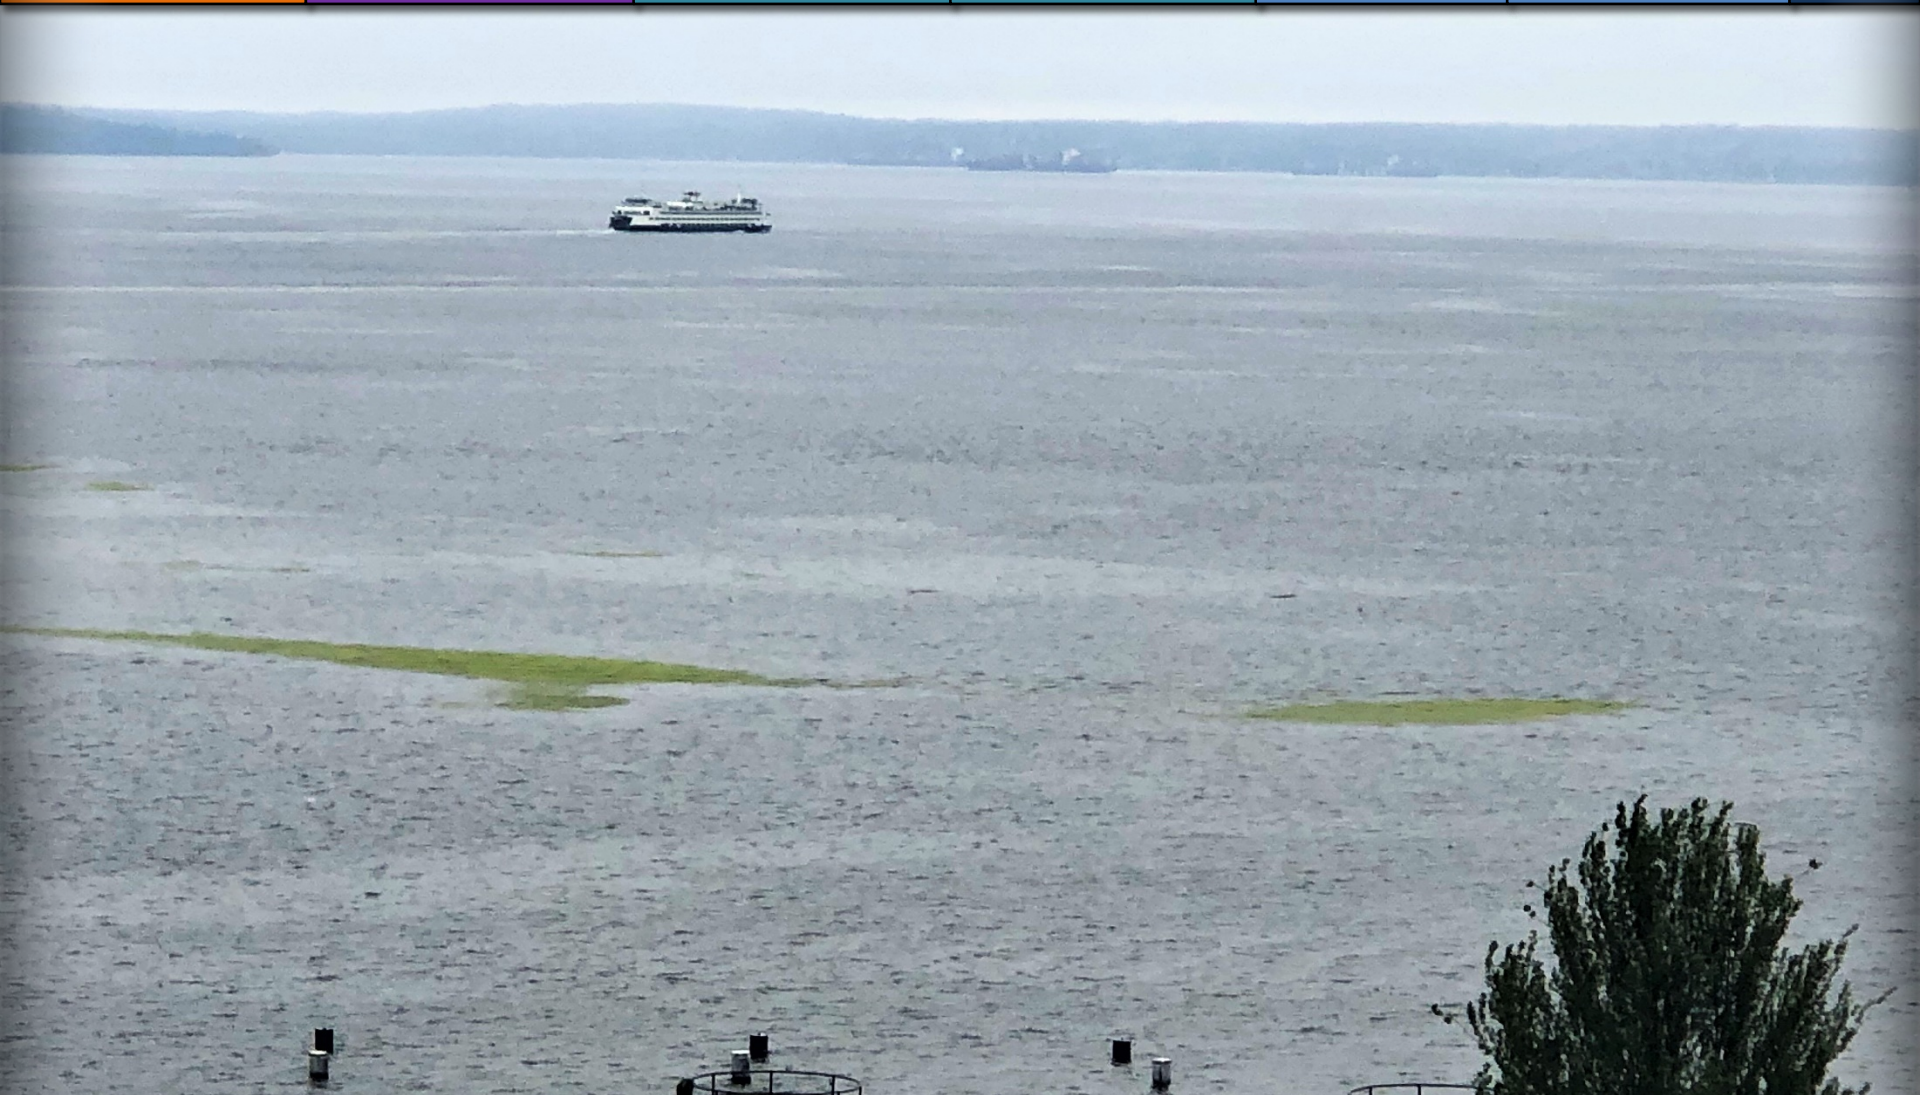
Alysha Dotson, 8/16/2021, macroalgae in Elliott bay
