The WRIA 9 Marine Shoreline Monitoring and Compliance Pilot Project

April 2014

King County

Department of Natural Resources and Parks
Water and Land Resources Division

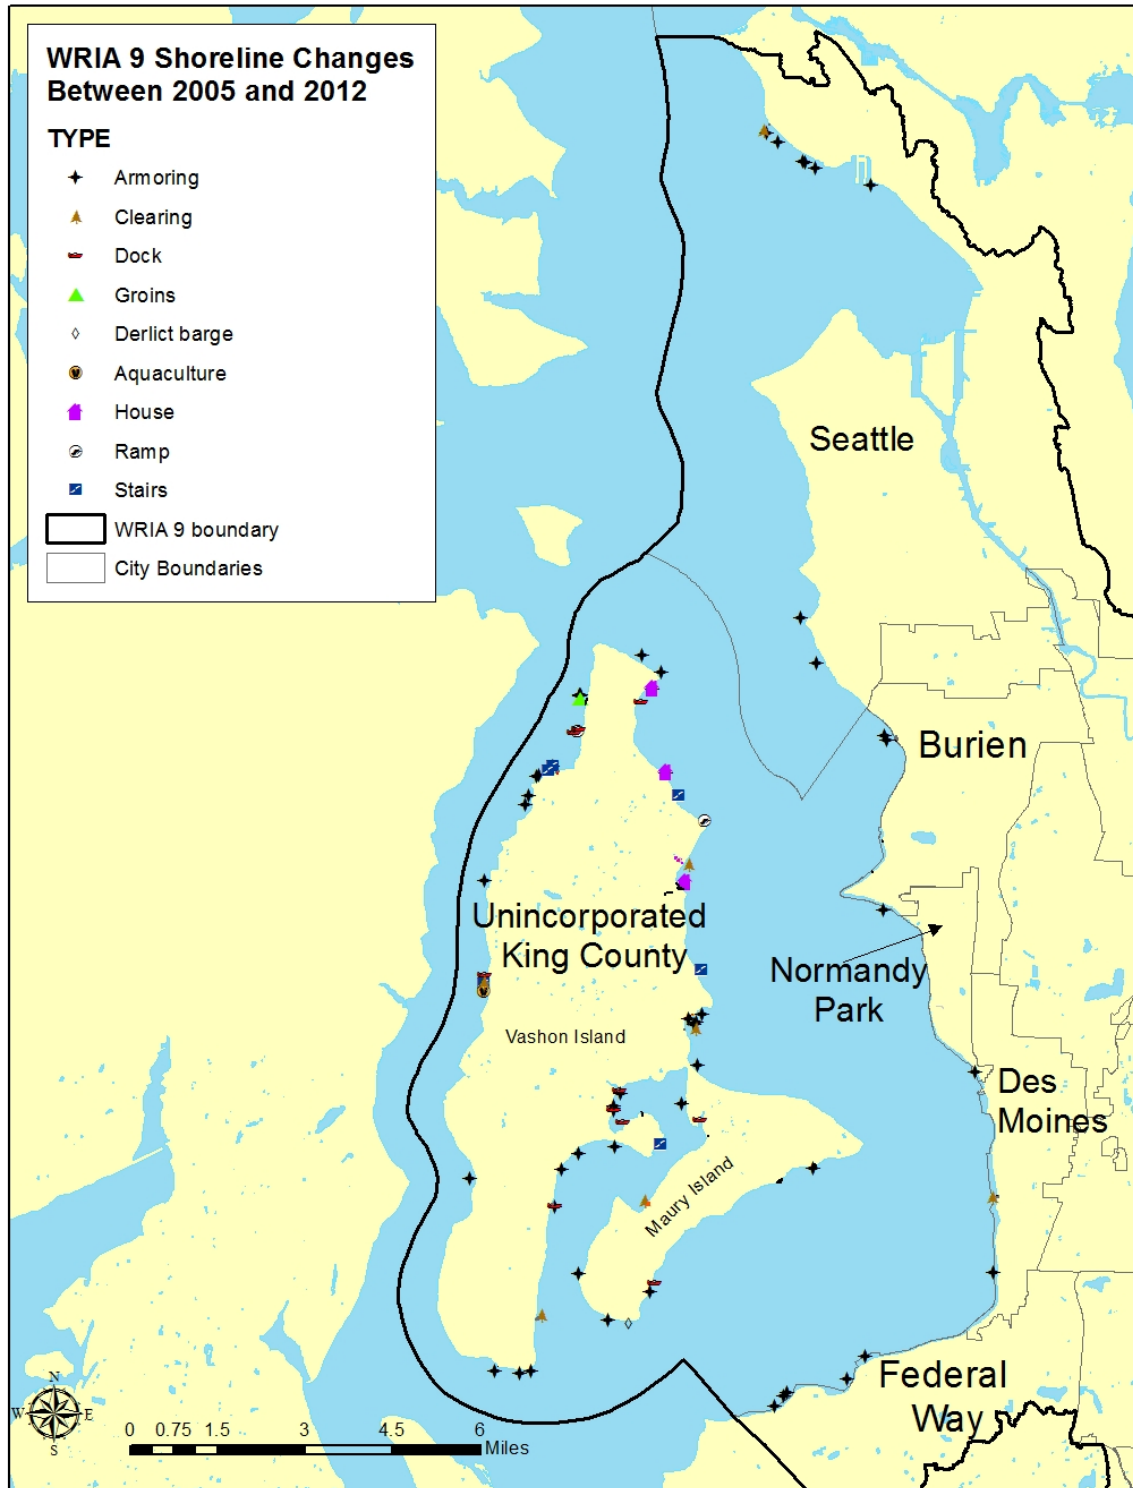
Figure 2. Locations of changes in shoreline condition in 2012.

Surveys of the entire WRIA 9 shoreline took place on Sept 10 and 12 of 2012. Over 900 photographs were taken of various shoreline changes. There were 85 distinct changes noted in shoreline condition (Figure 2 and Table 3). Photographs of example changes can be found in Appendix B. Seventy percent of the changes found were repairs or complete rebuilds to existing infrastructure. Changes associated with shoreline armoring accounted for 63% of the changes noted, with most changes associated with repairs to existing shoreline armoring infrastructure. Only 4 of the 53 changes in shoreline armoring were new bulkheads which didn't exist in 2004 or where it was no longer functioning. Almost 12% of the changes noted were associated with docks and other overwater structures, while another 10% were associated with the clearing of vegetation along the shoreline. Most of clearing changes occurred in unincorporated King County. The remainder of the changes were composed of a mixture of alterations to the shoreline including new or substantially altered buildings, staircases, aquaculture facilities and ramps.

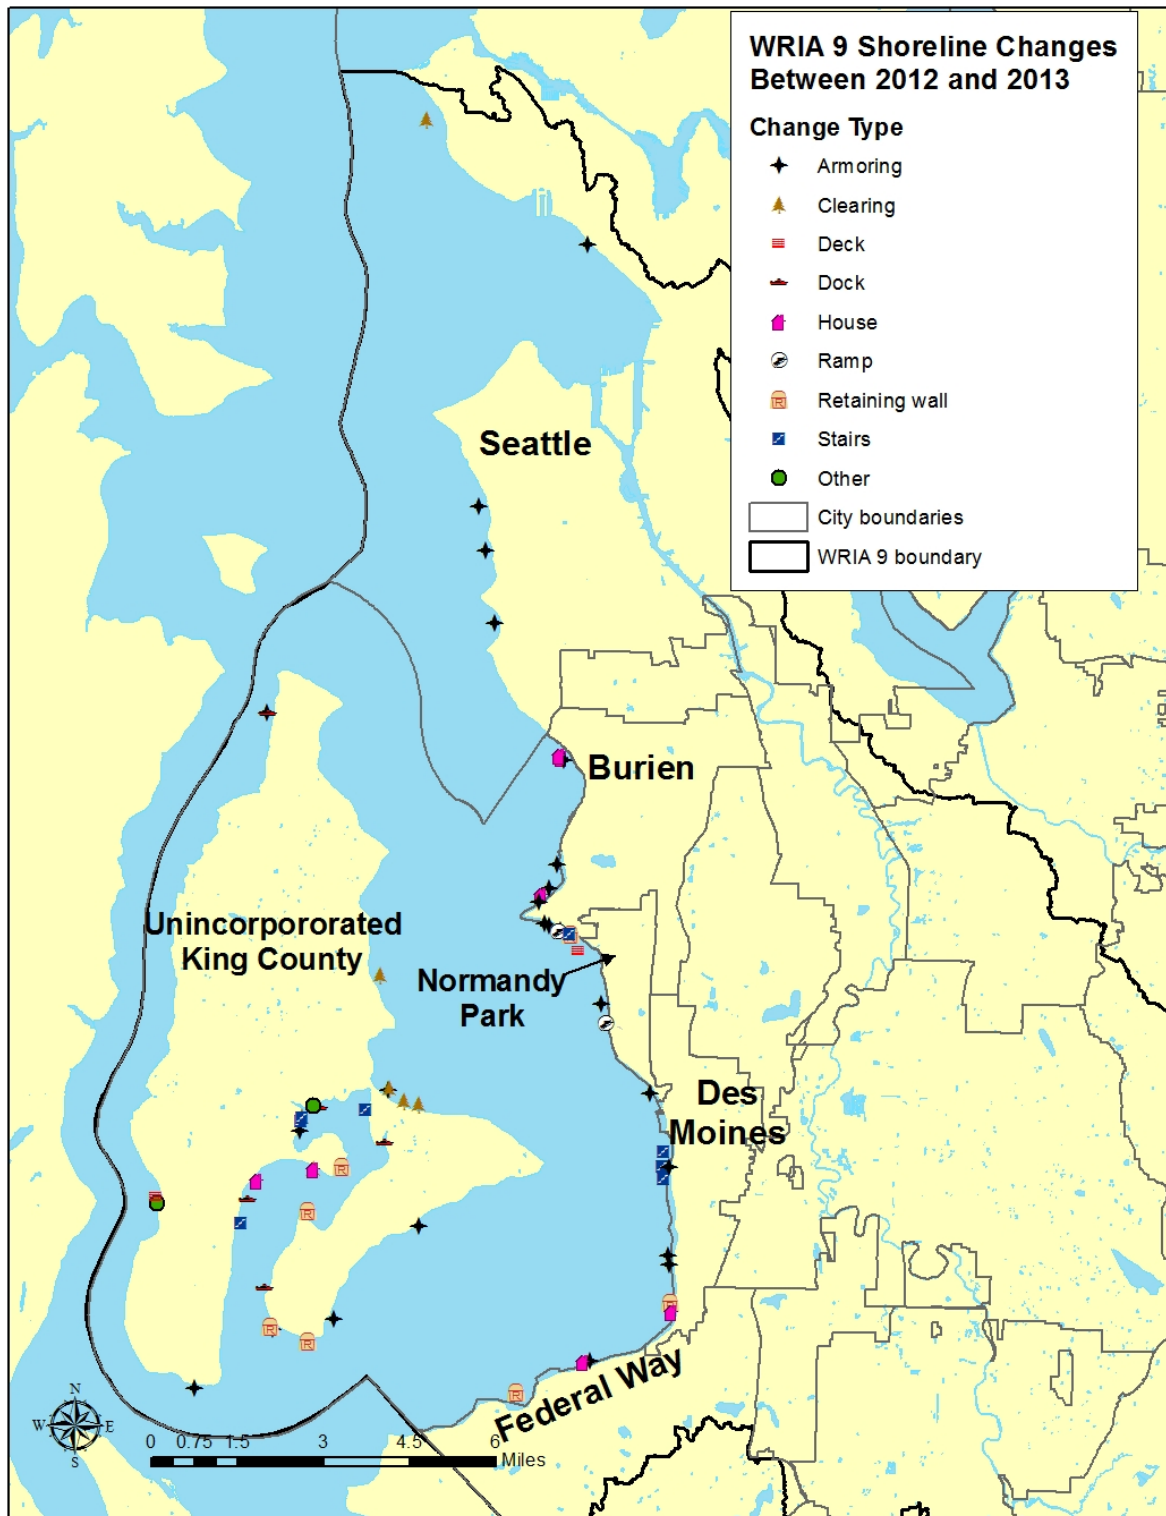
Figure 3. Locations of changes in shoreline condition in 2013.

There were 60 changes noted in shoreline condition in 2013 (see Figure 3 and Table 3). Example photographs of changes can be found in Appendix B. When establishing the approximate date of when the change occurred, it was noted that some of the changes occurred prior to the 2012 survey, but were not noted during that survey. Thirty-three percent of the changes found were associated with shoreline armoring. Increases in the proportions of new houses, clearing, and retaining walls offset the decreases in changes to shoreline armoring. Changes in shoreline armoring accounted for 24 of the changes noted. Only 2 of the 24 changes in shoreline armoring were new bulkheads where one didn't exist previously. All of the changes in overwater structures (e.g. docks and decks) occurred in unincorporated King County. There was one new dock observed in Raab's Lagoon. Two of docks had their creosote pilings replaced with steel pilings along with minor modifications to the dock footprints. As with 2012, the majority of the observations of clearing occurred in unincorporated King County.

The largest number of changes (48%) occurred in unincorporated King County (see Table 4), which was a dramatic decrease from representing 78% of changes noted in 2012. Given that unincorporated King County accounts for 56% of the shoreline of WRIA 9, it accounted for a smaller share of the changes in shoreline condition per mile of shoreline. There were relatively large increases in the proportion of shoreline changes in the cities of Burien, Normandy Park and Des Moines between 2012 and 2013.
