Eyes Over Puget Sound

Surface Conditions Report: March-June 2022

Up-to-date observations of water quality conditions in Puget Sound and coastal bays

LONG-TERM MARINE MONITORING UNIT

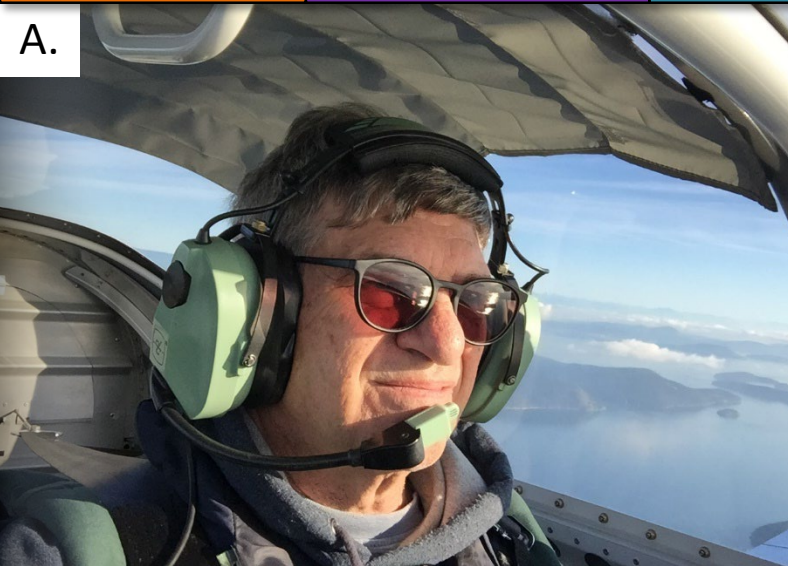
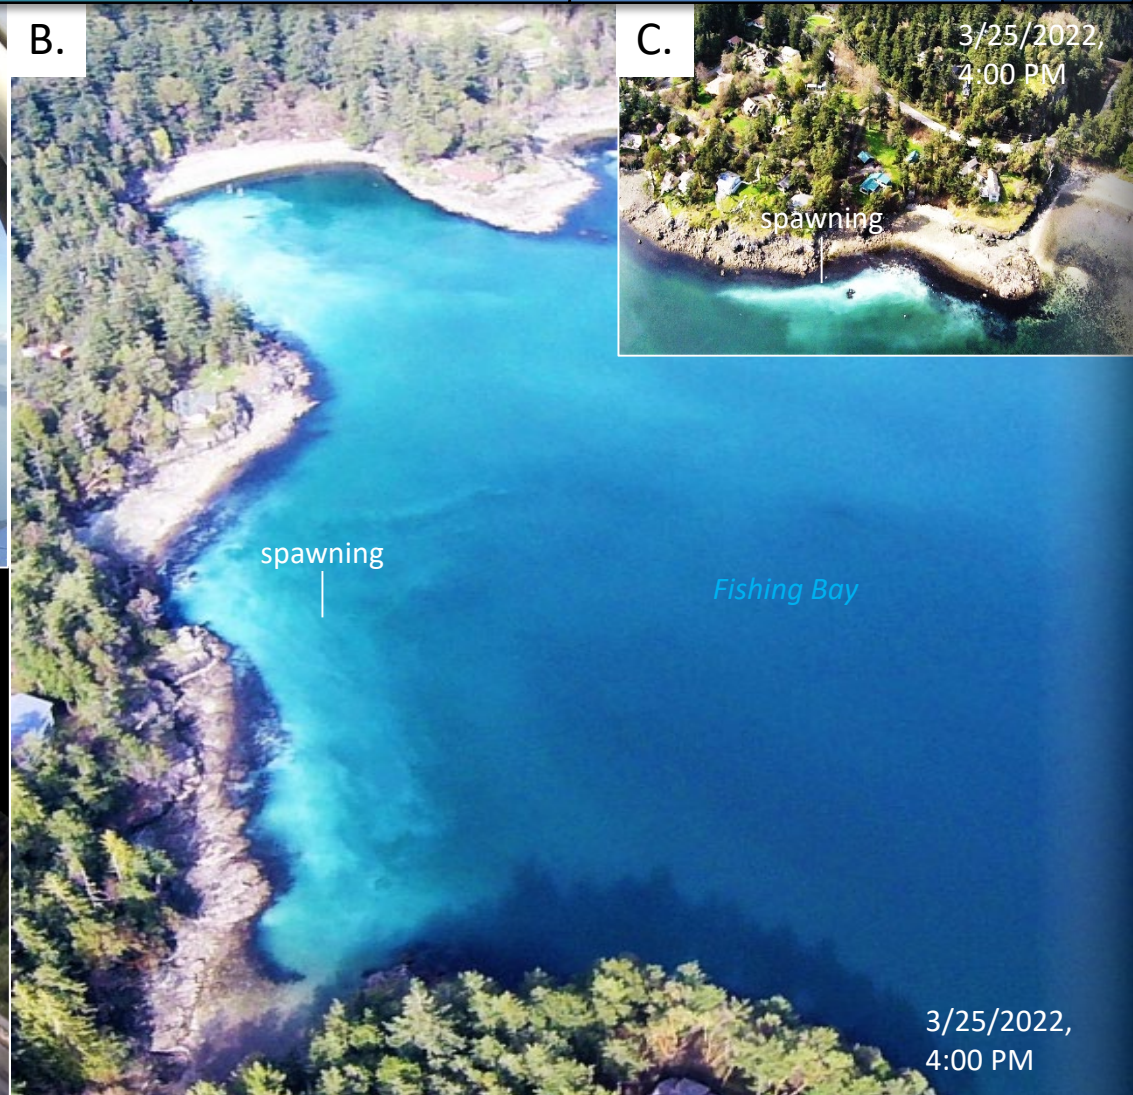
A. Pilot Mike MacKay monitoring regions around the San Juan Islands. B-C. Spawning herring in East Sound. D. Noctiluca bloom, Crescent Beach. Location: B-C. Orcas Island, D. Strait of Juan de Fuca (North Sound), 11:32 AM

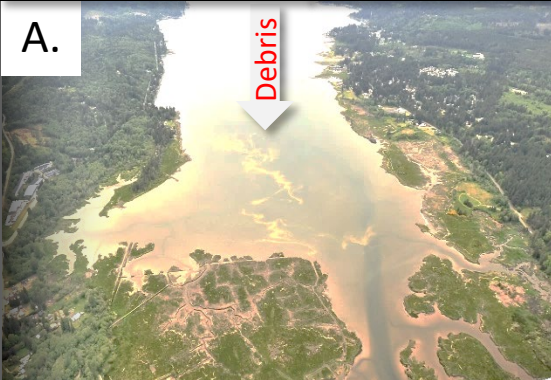
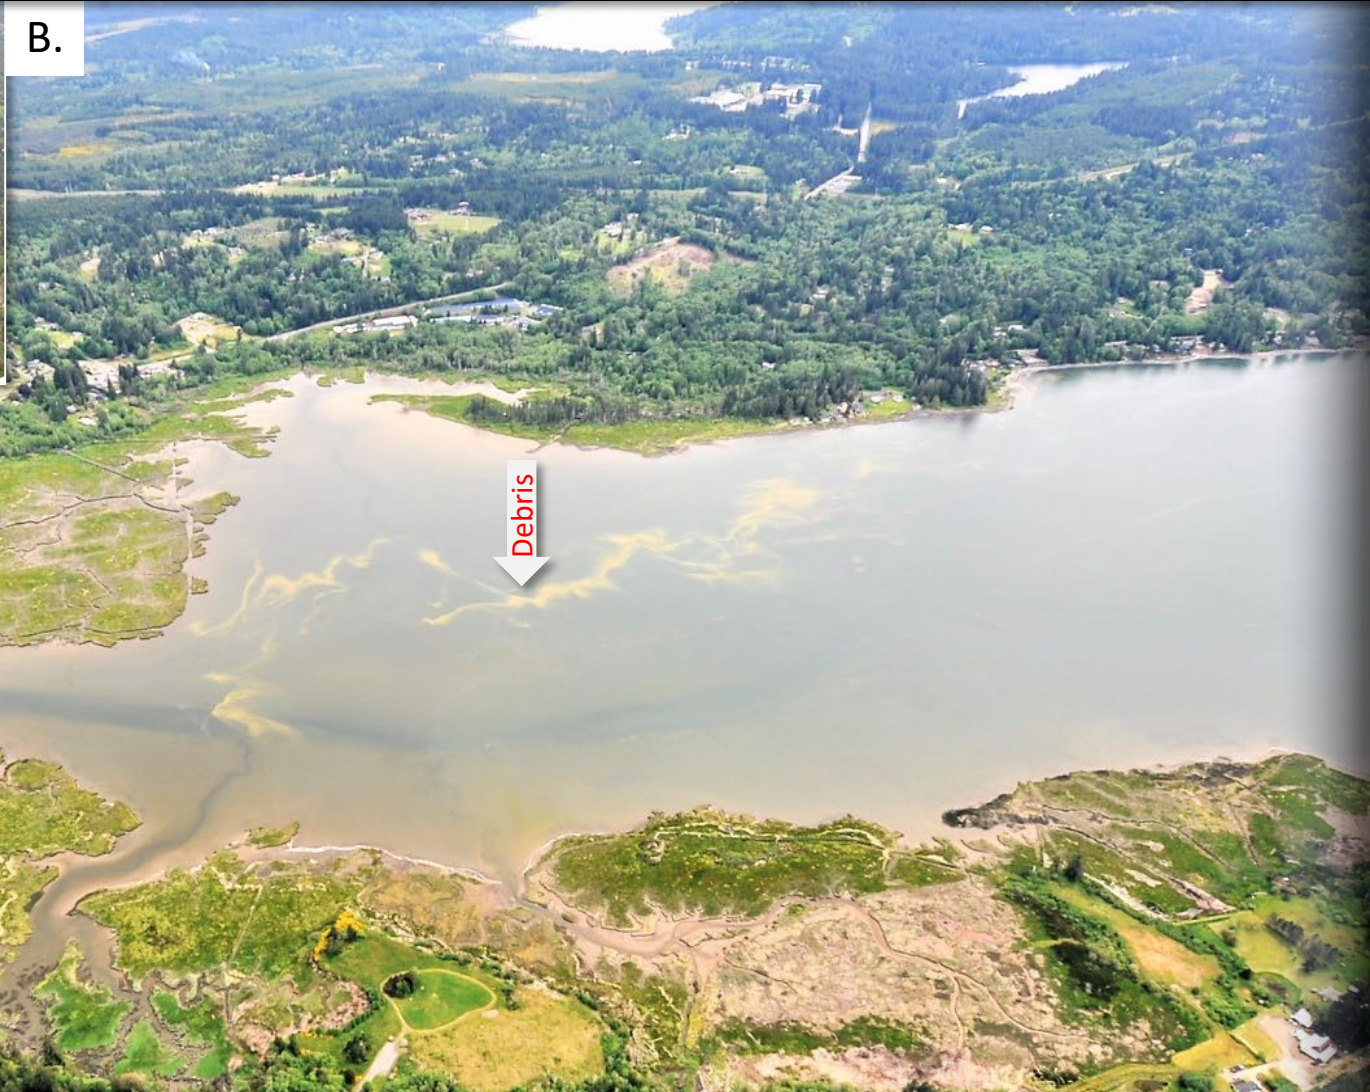
Organic material floating at surface. A. Looking west, B. looking south.

Location: Lynch Cove (Hood Canal), 2:13 PM

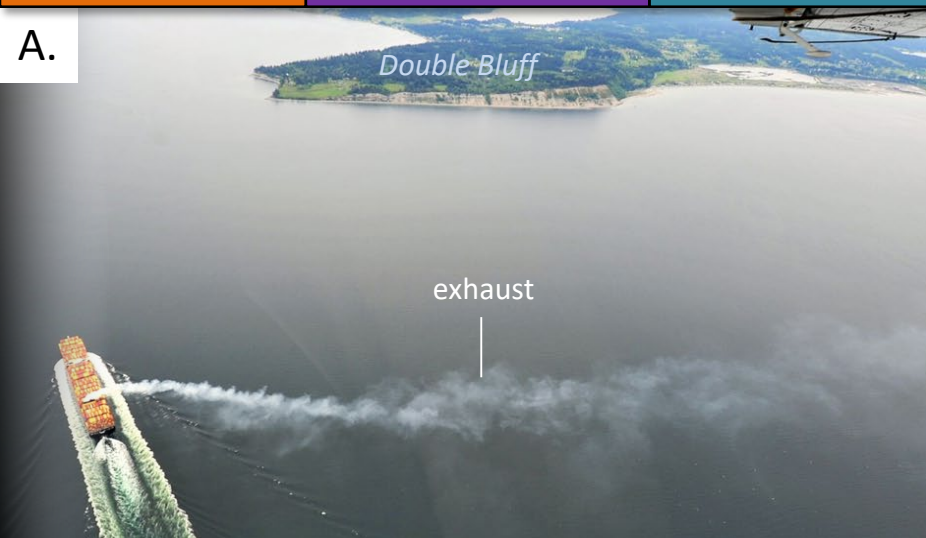
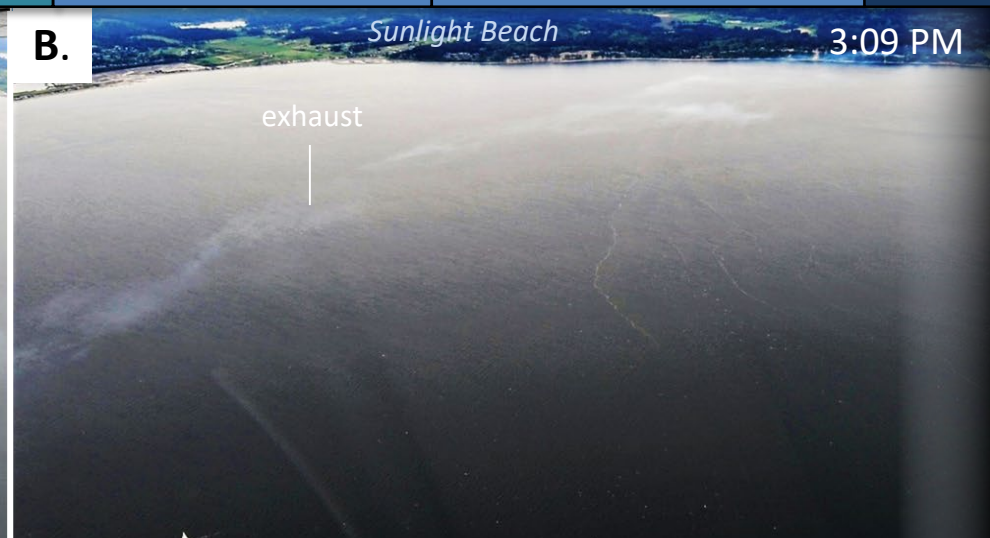
A-B. Exhaust from container ship visible for 5 miles. C-D. Blooms and fronts in bays.
Location: A-B. Admiralty Reach, C. Nisqually Reach, D. Port Townsend (Central and South Sound).

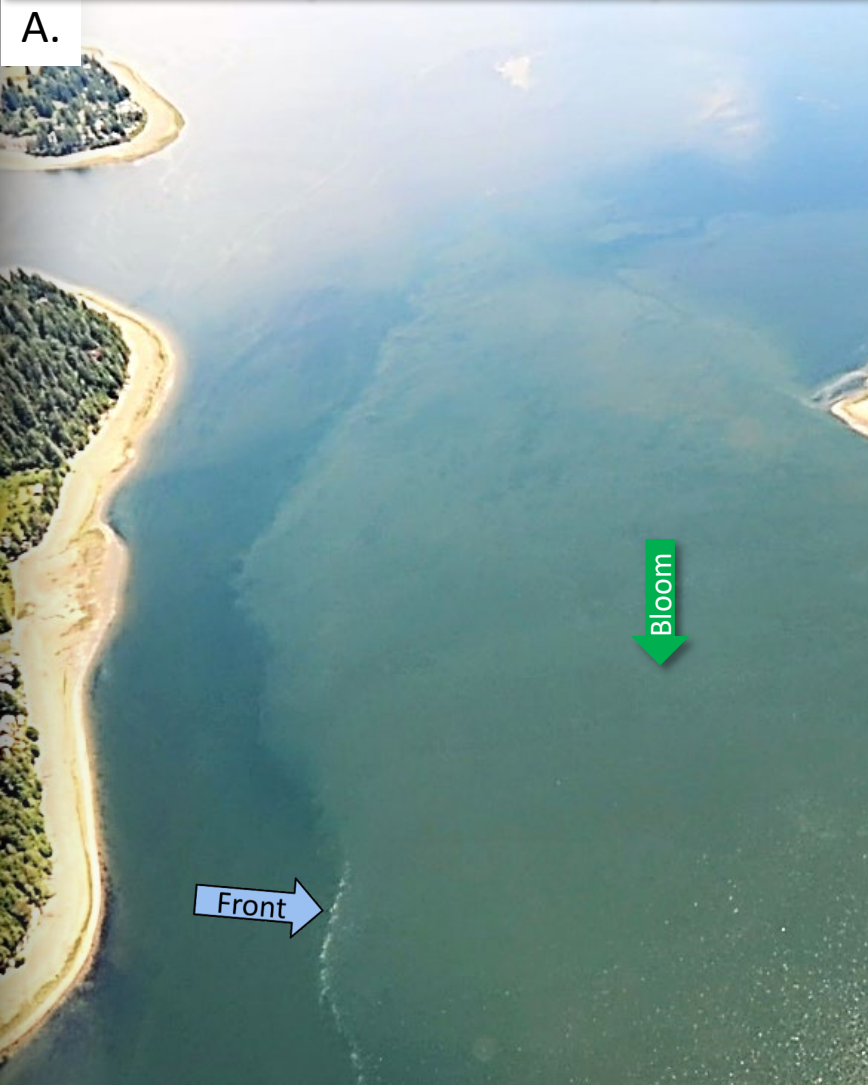
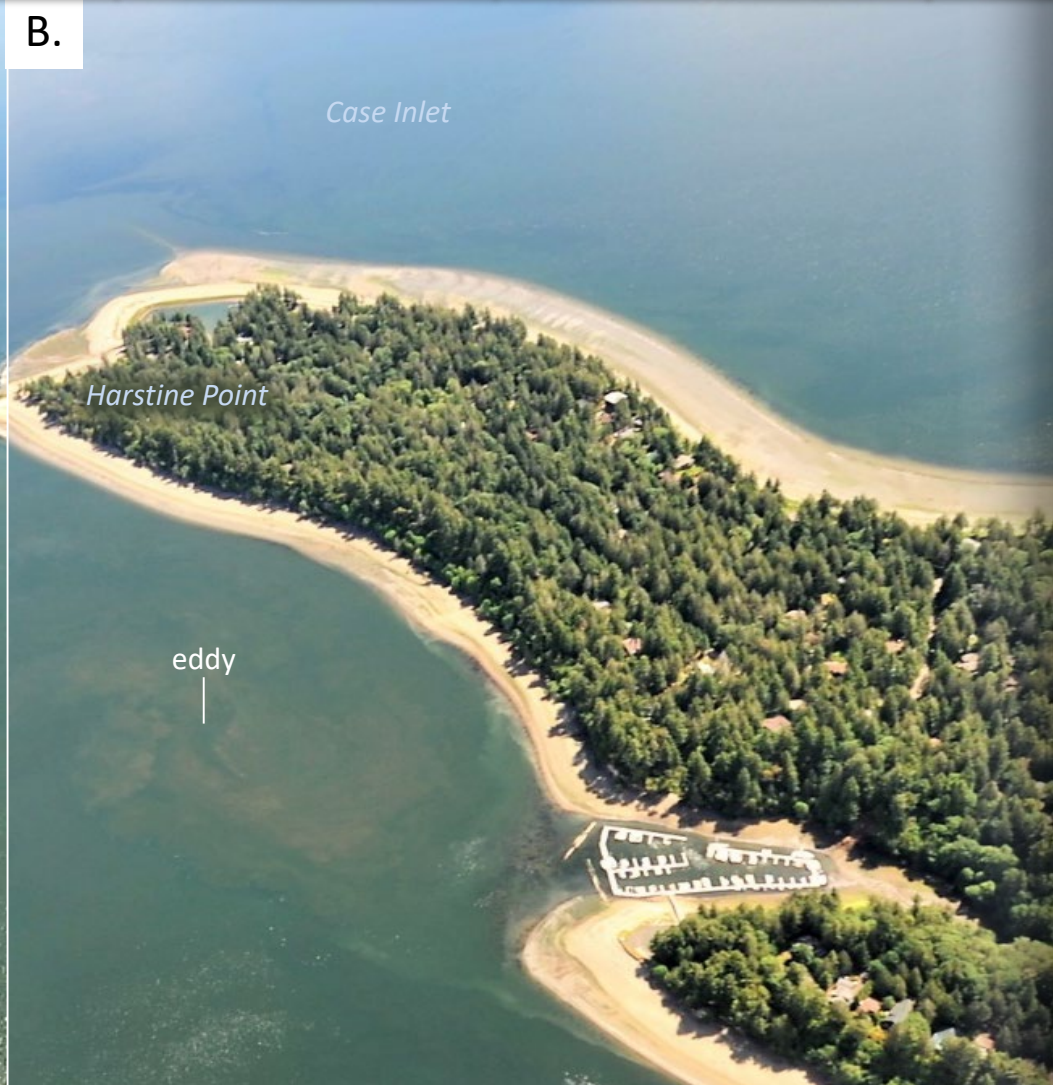
A. Front and B. tidal eddy at the entrance to Case Inlet made visible by discoloration from algal bloom.
Location: Northern tip of Harstine Island (South Sound), 12:03 PM

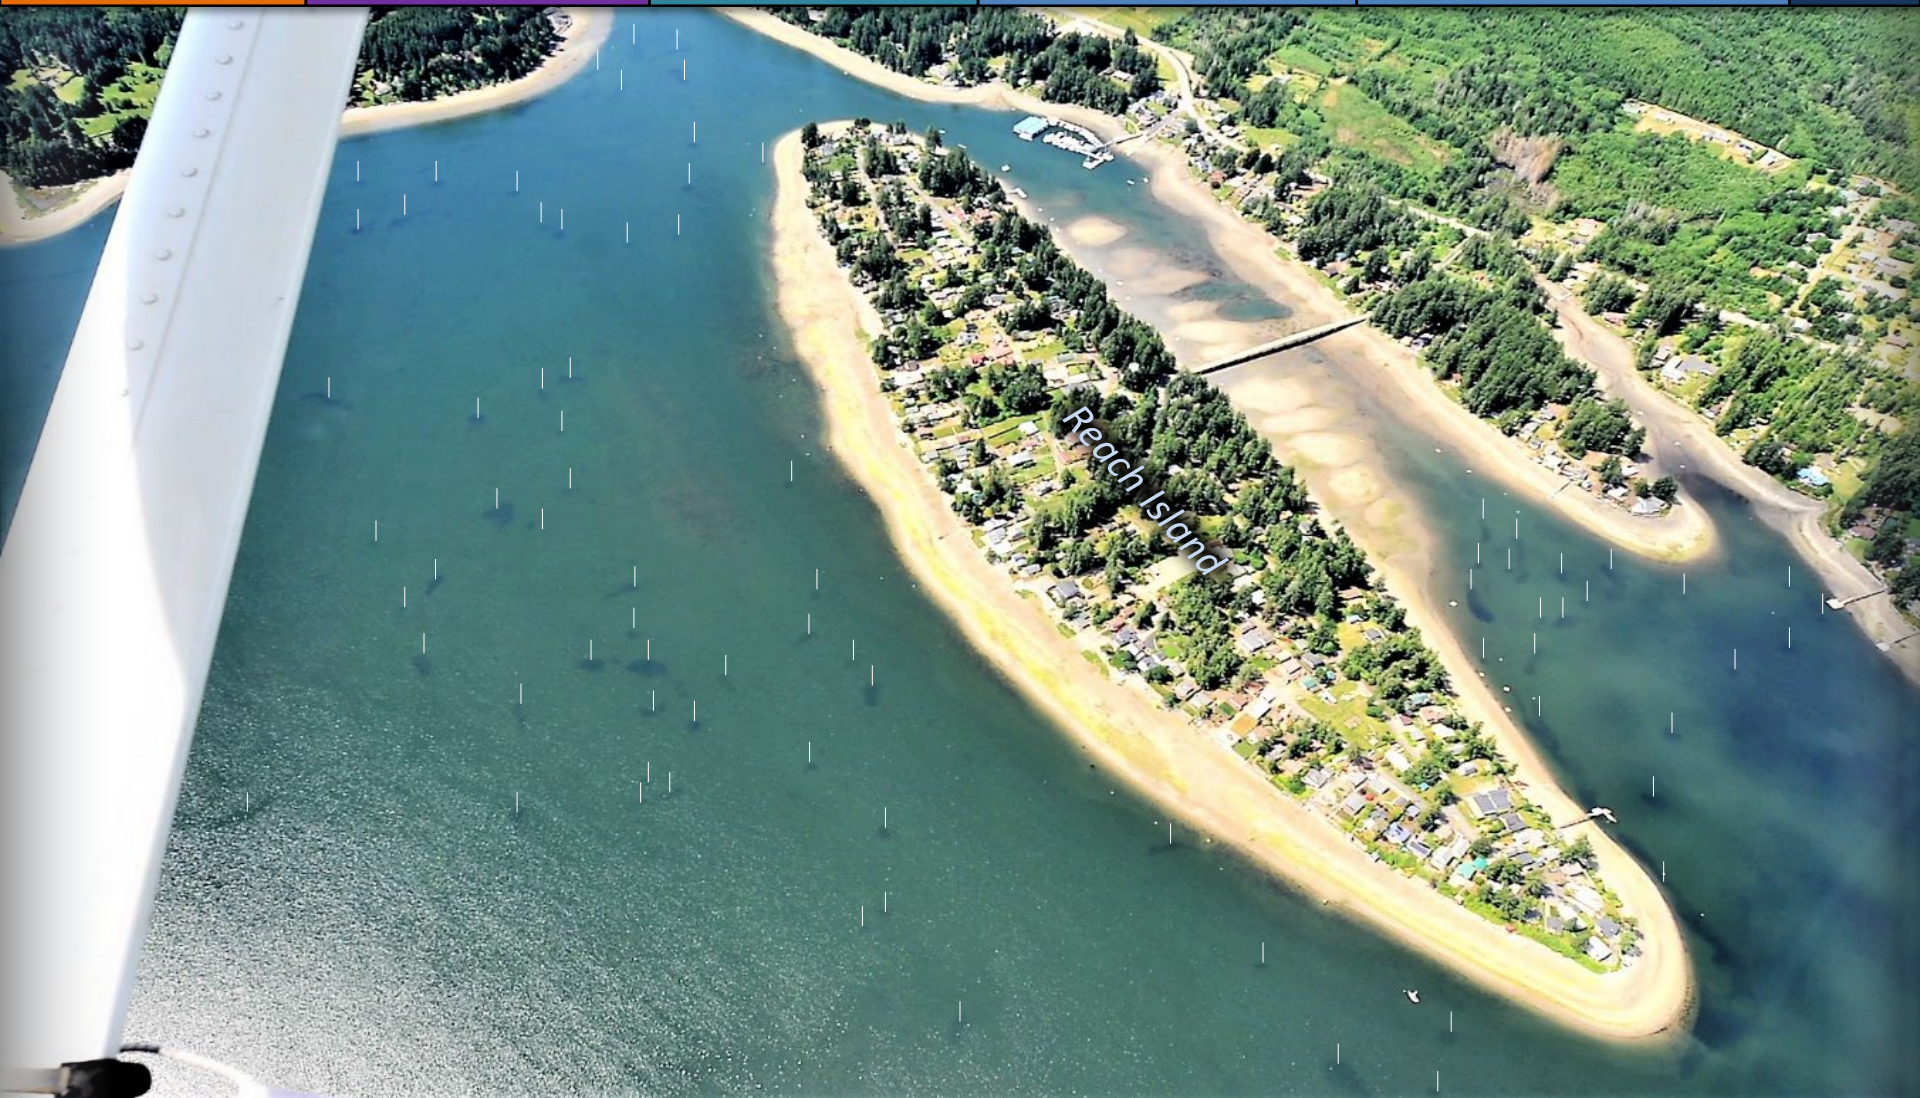
High number of schooling fish. On the image, we count more than 85 schools (marked with white vertical lines).

Location: Case Inlet (South Sound), 12:05 PM

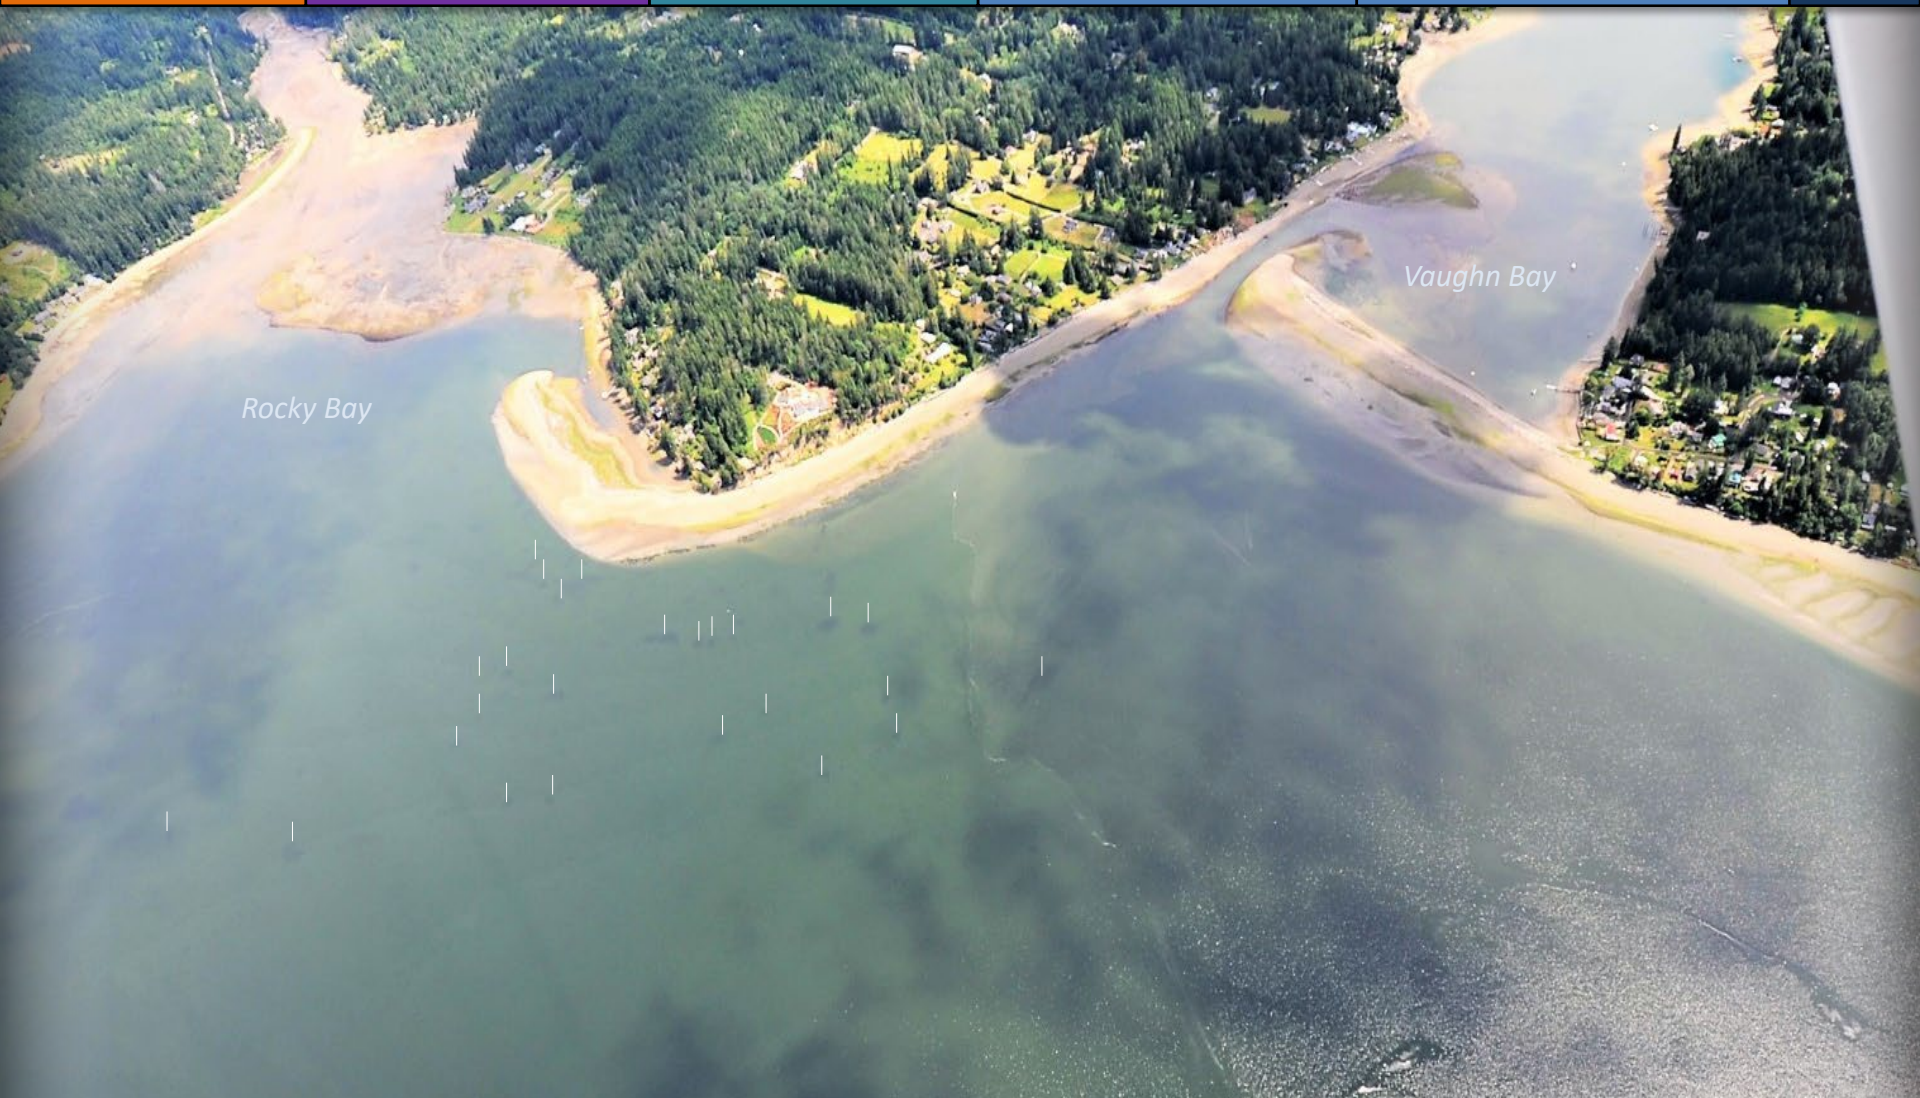
High number of schooling fish. On the image, we count more than 25 schools (marked with white vertical lines).

Location: Case Inlet (South Sound), 12:05 PM

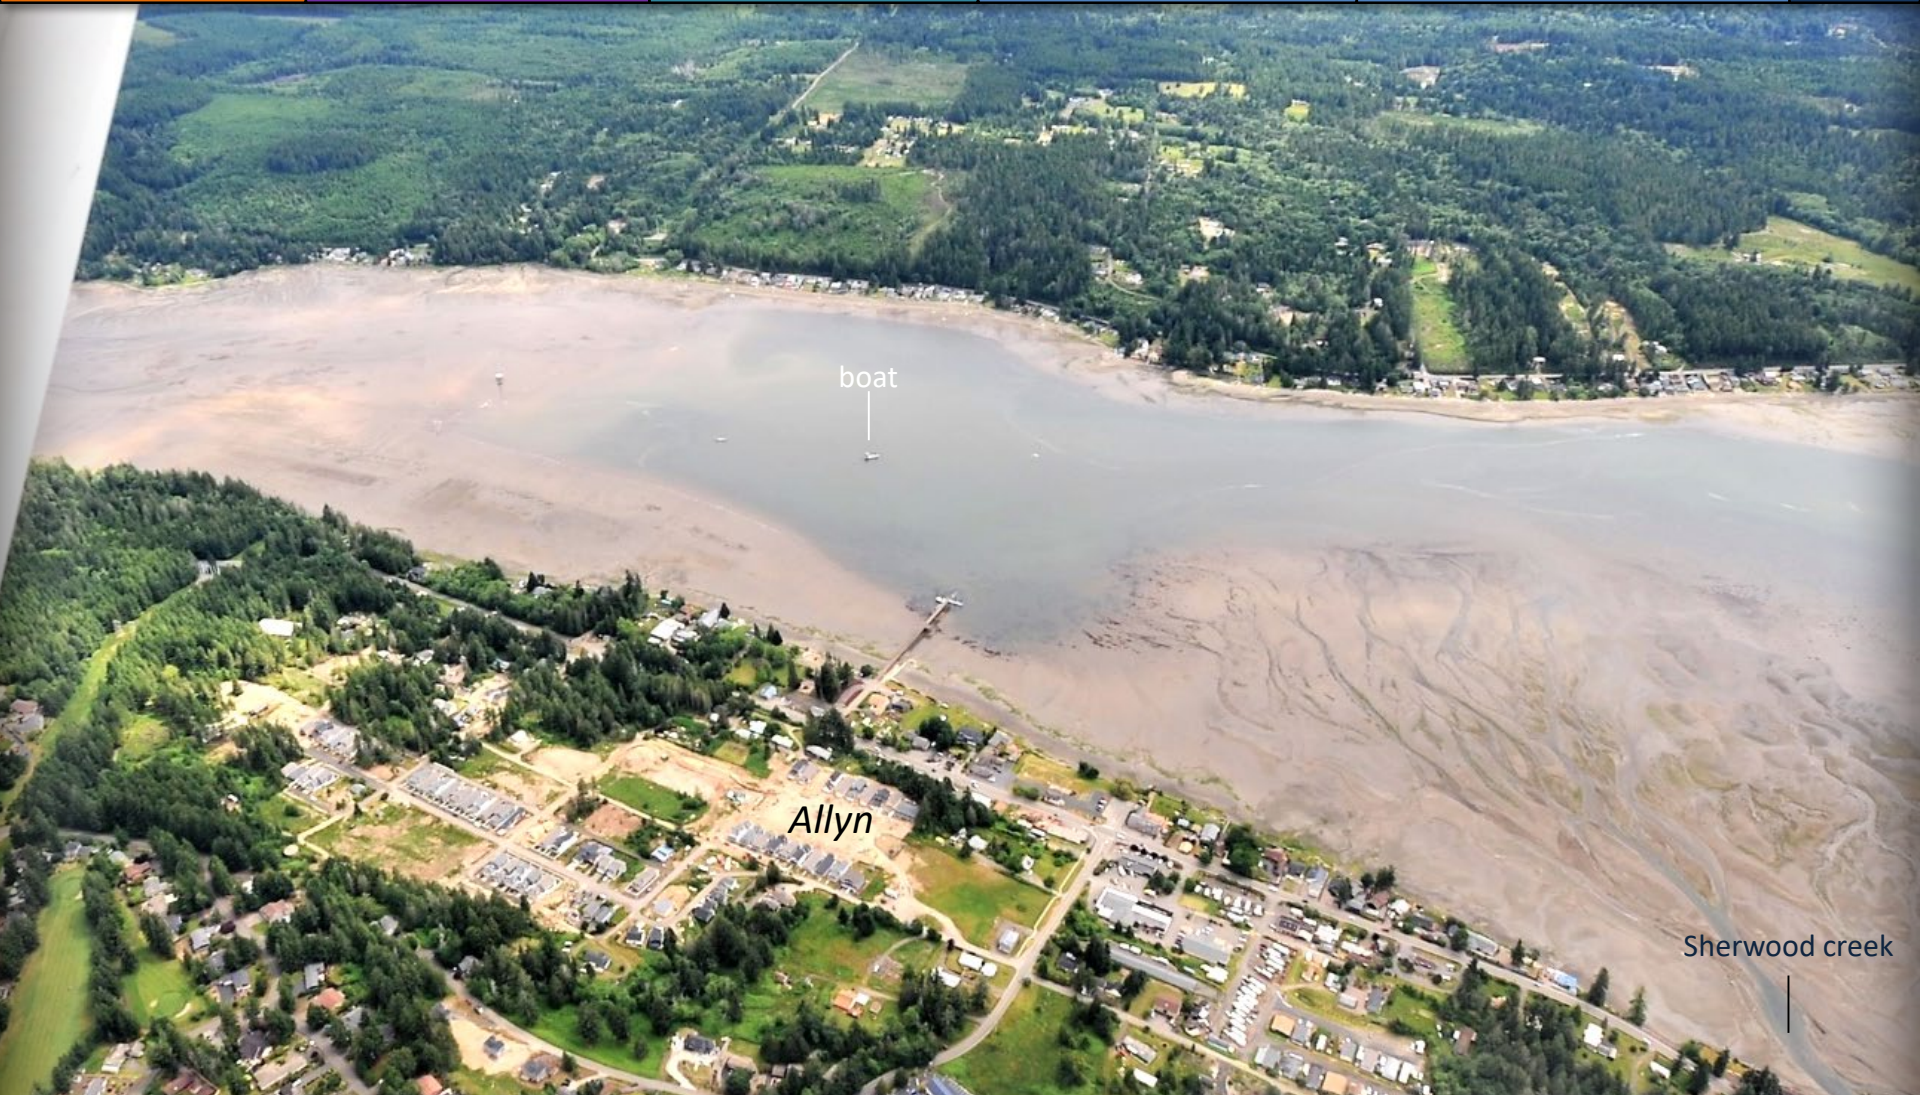
Extremely low tide exposes much of the sediment in North Bay.

Location: Case Inlet (South Sound Basin), 12:06 PM

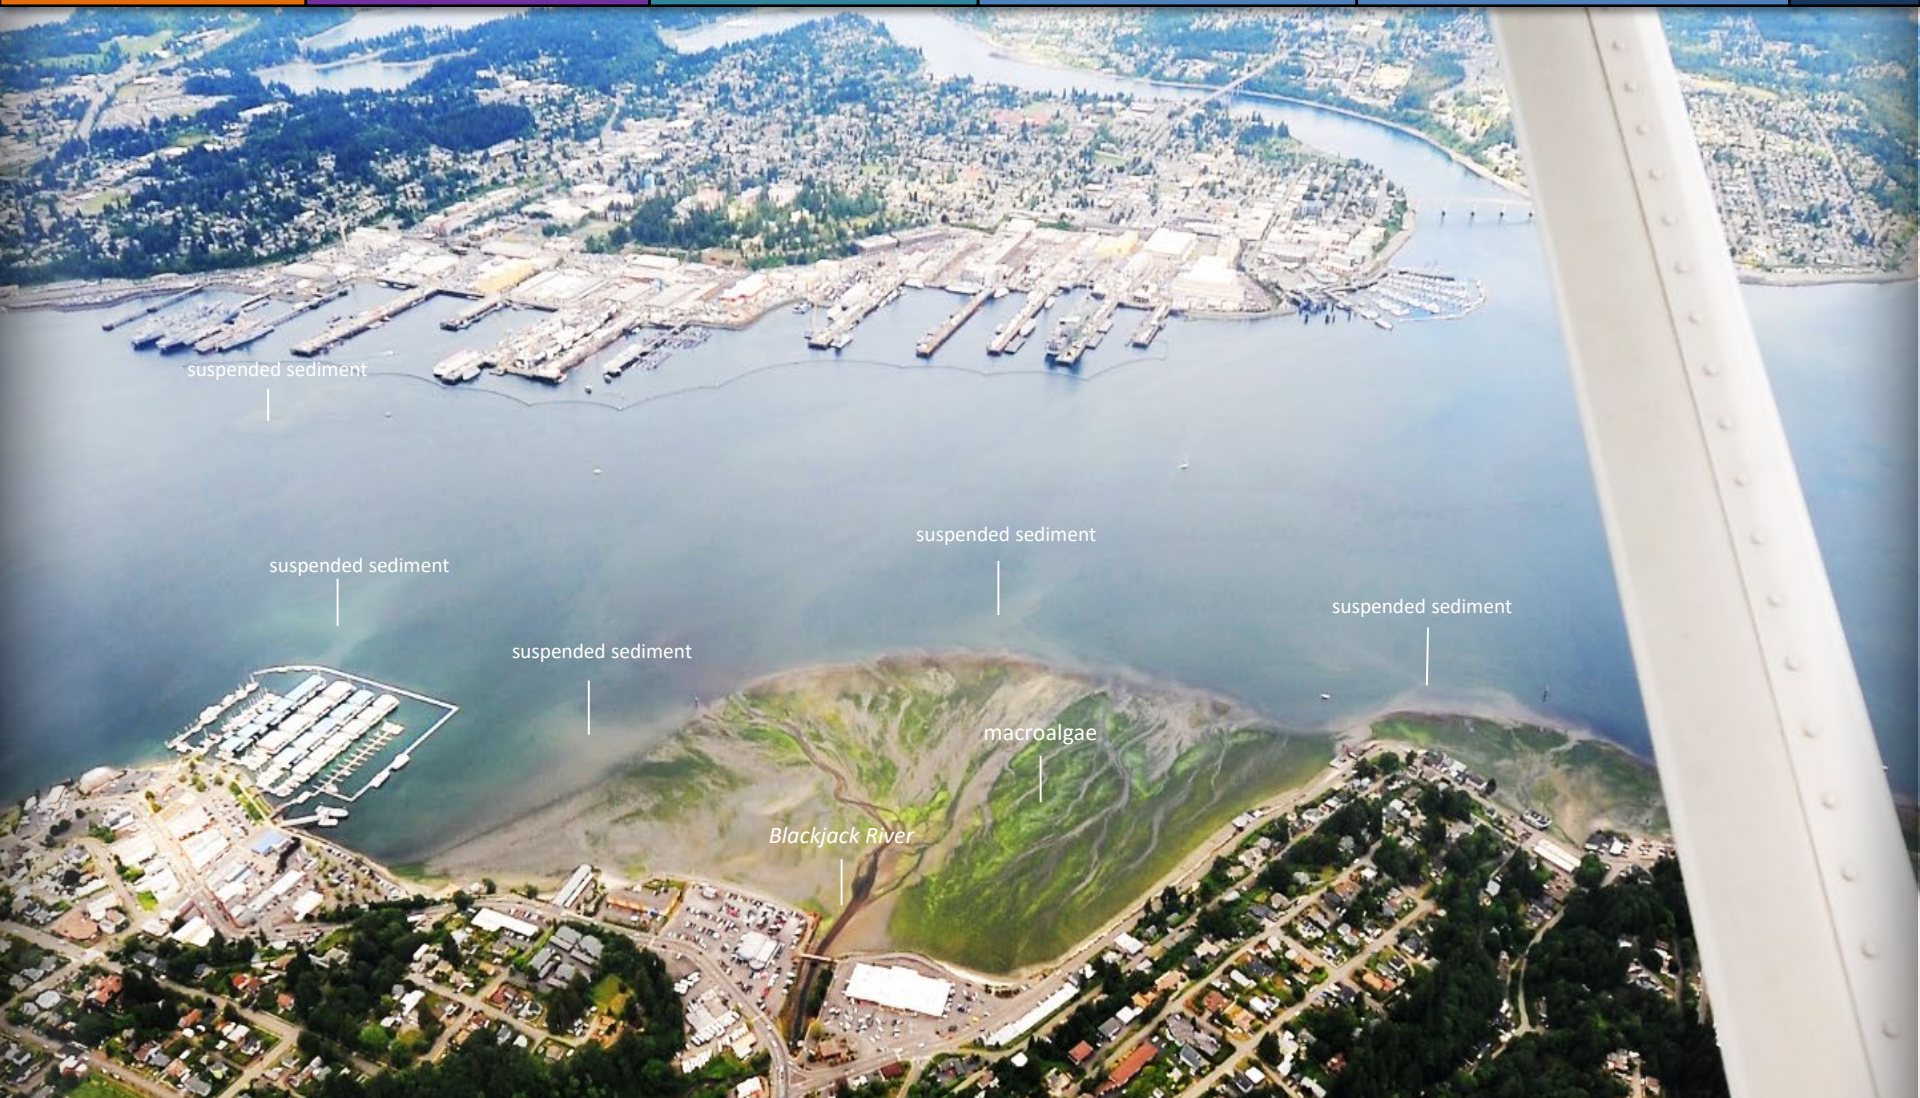
Suspended sediment in Sinclair Inlet at a very low tide. Many macroalgae growing in Blackjack River estuary.
Location: Sinclair Inlet (Central Sound), 12:18 PM

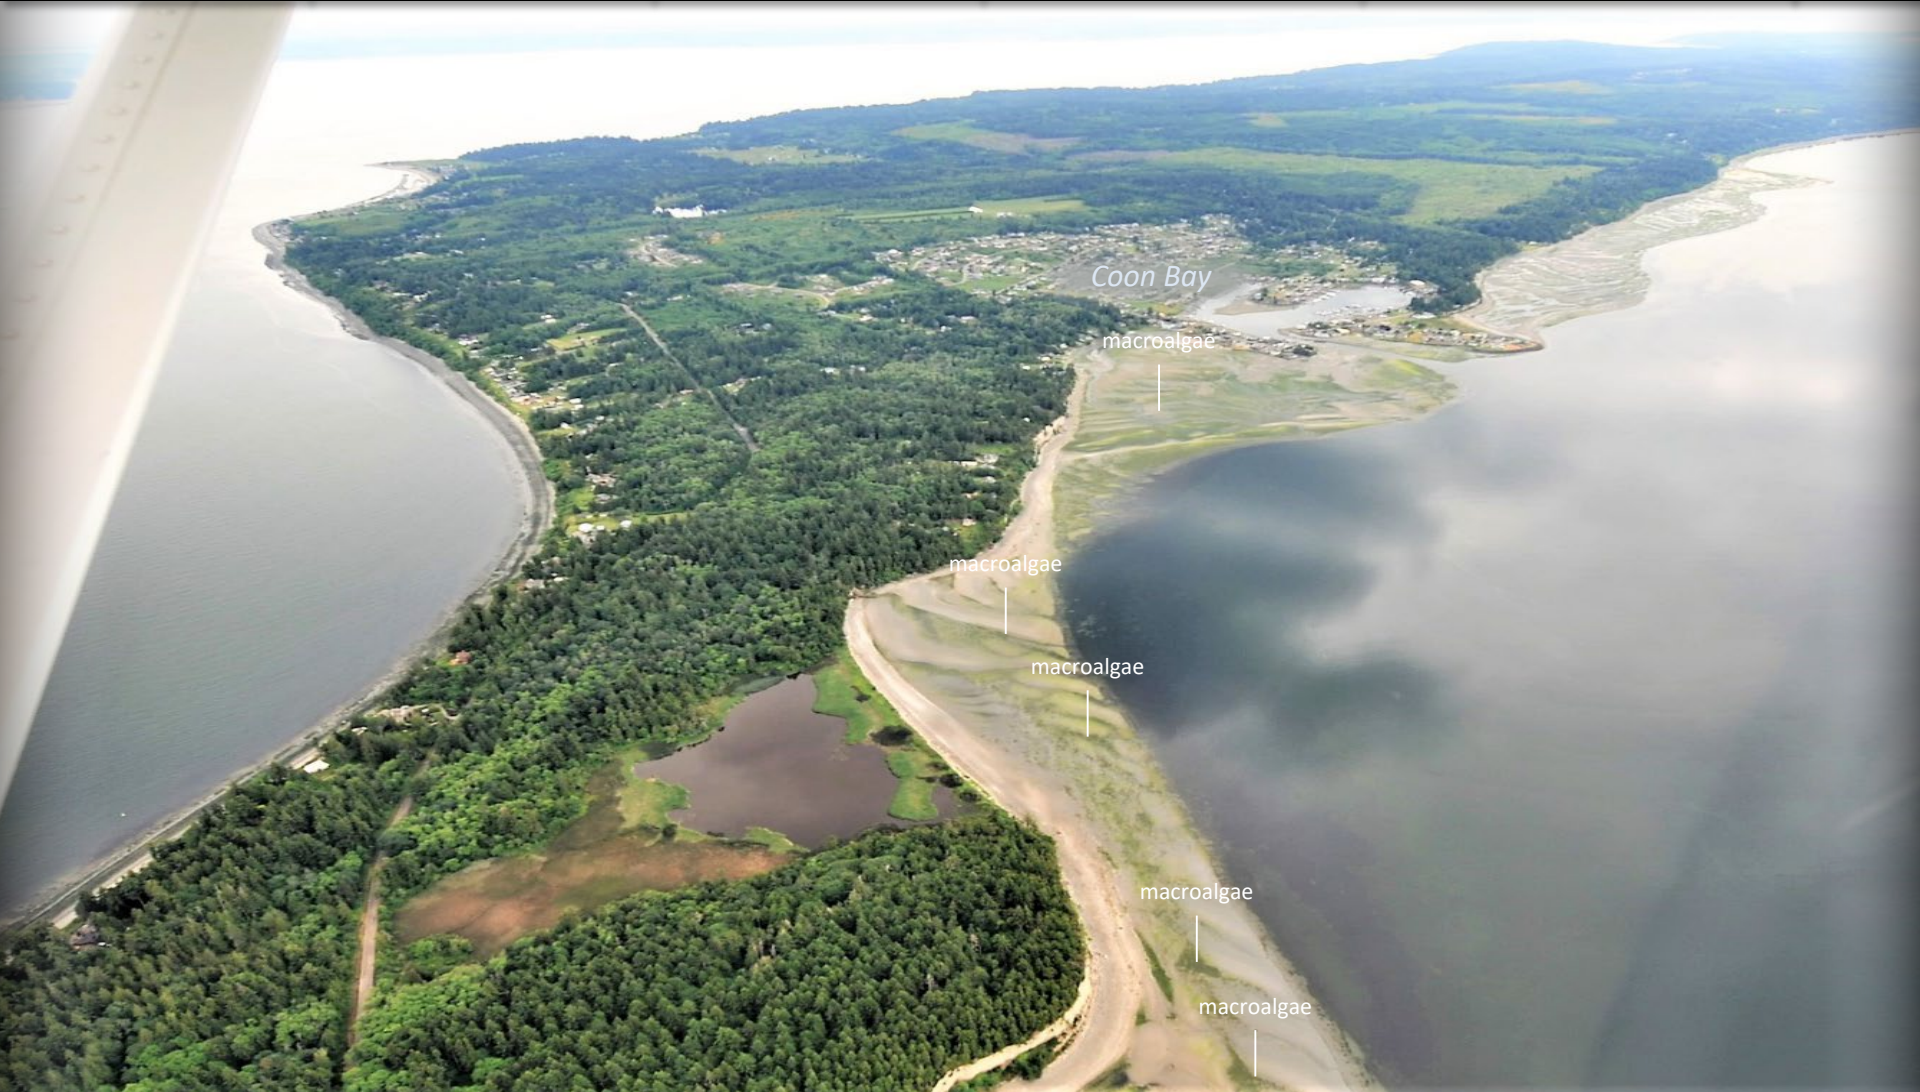
Macroalgae growing on Foulweather Bluff beaches.
Location: Entrance to Hood Canal (Hood Canal), 12:35 PM

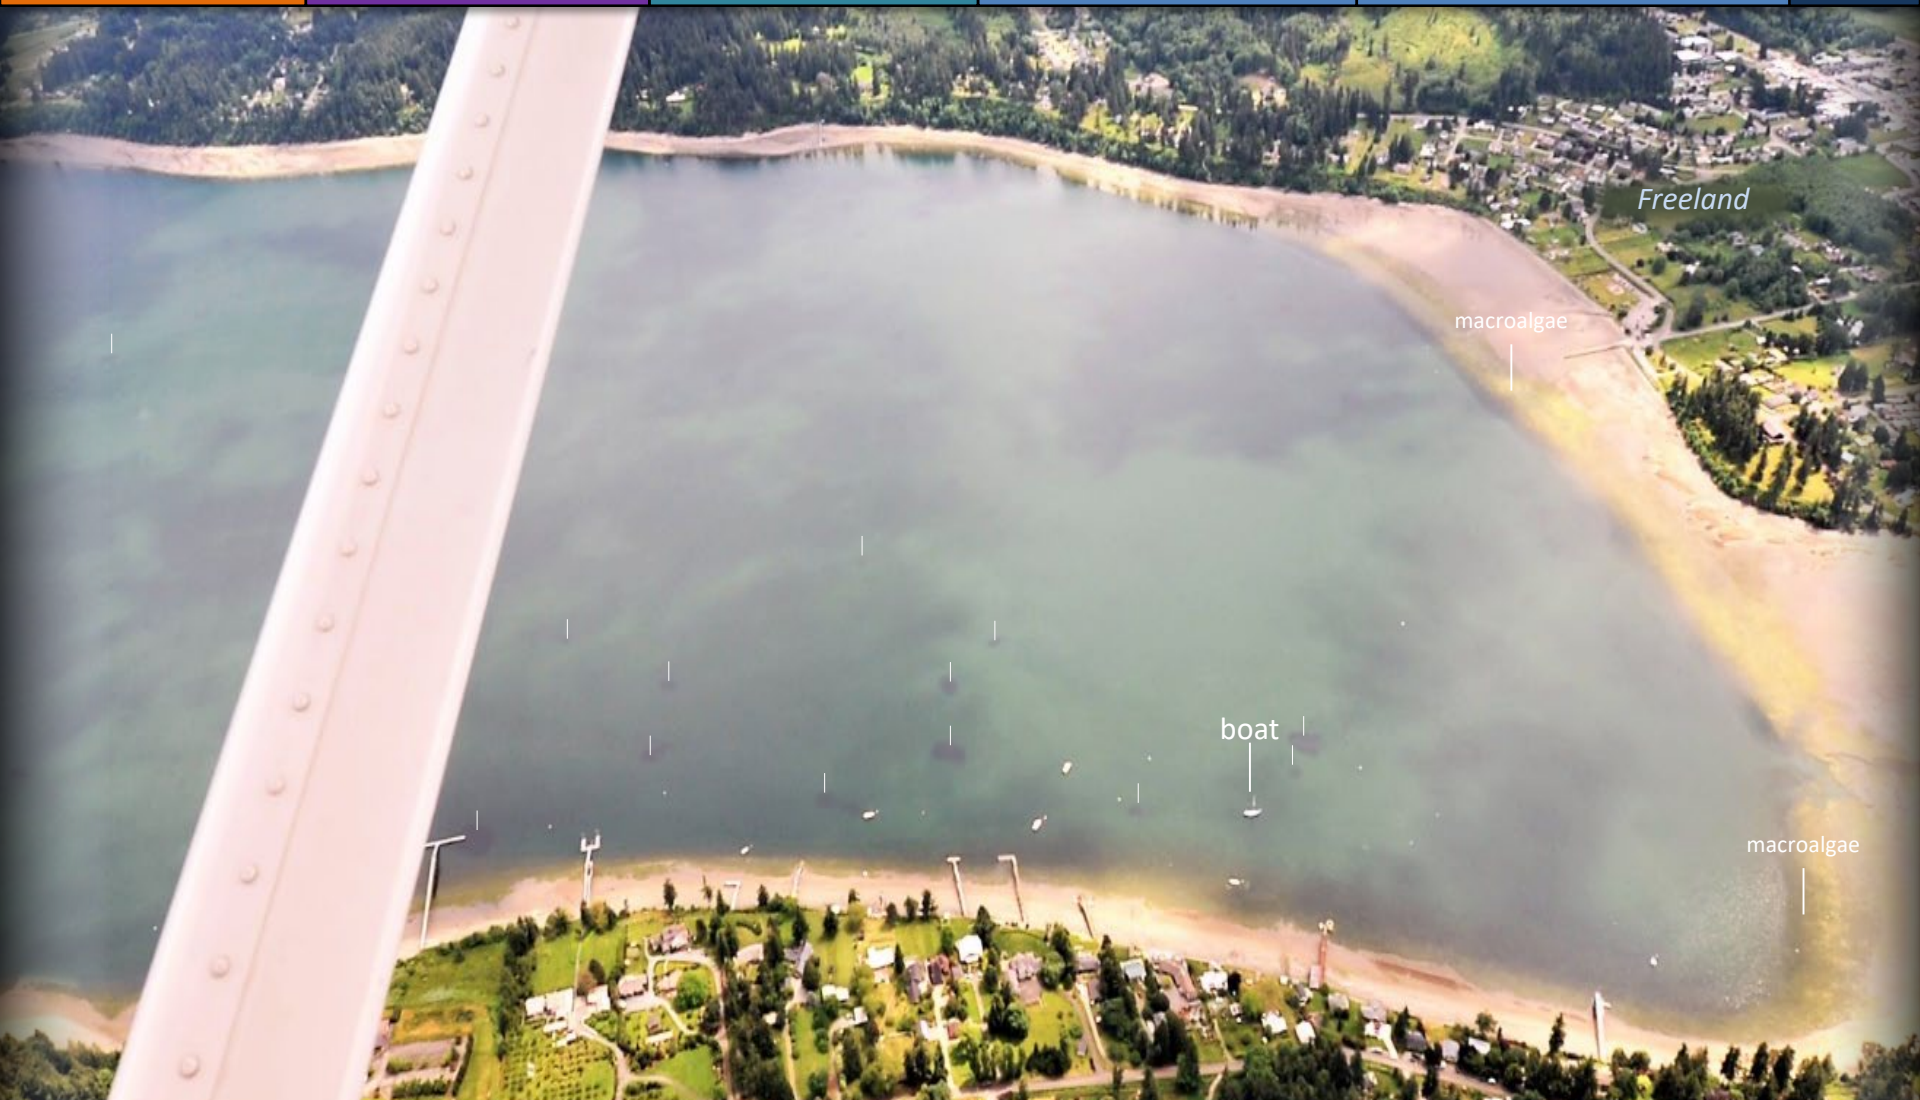
Location: Holmes Harbor (Whidbey Basin), 12:39 PM

High number of schooling fish. We count more than 13 schools on this image (marked with white vertical lines).

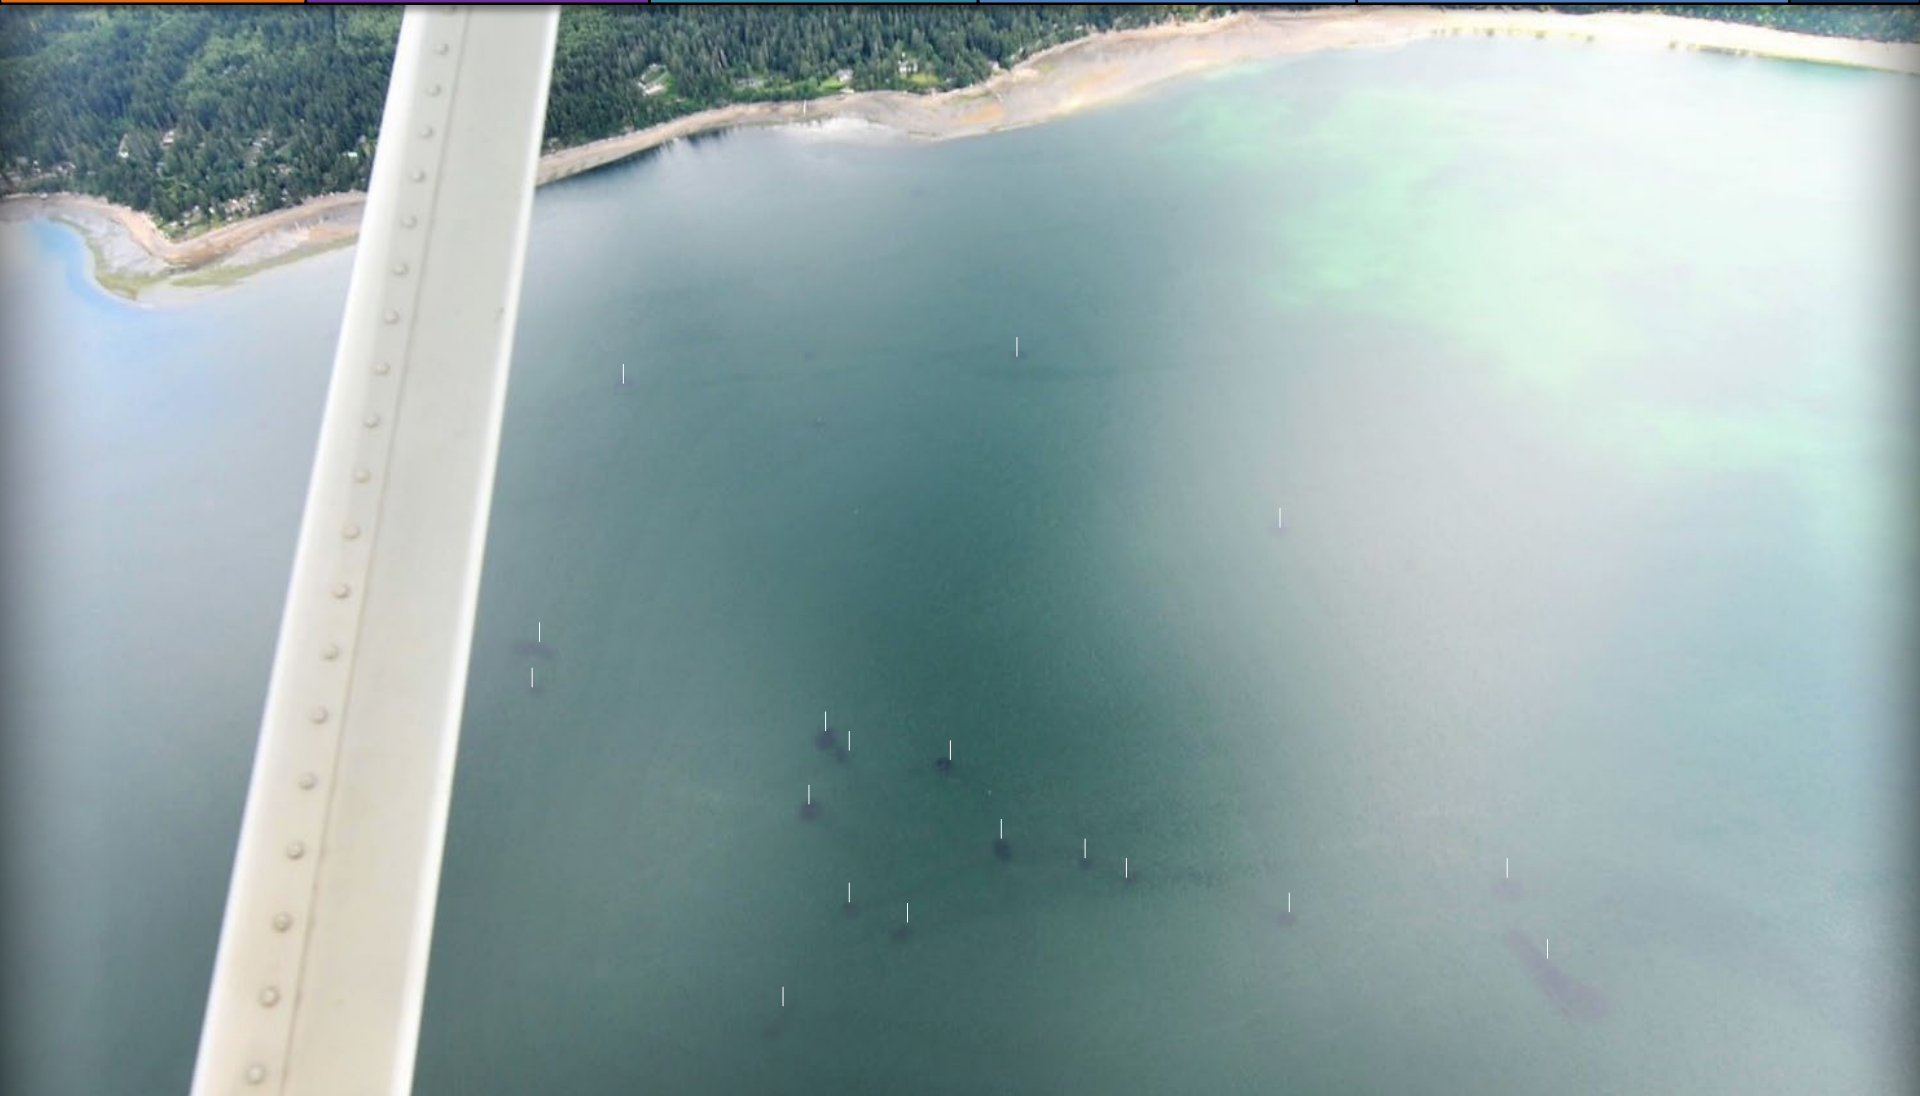
Location: Holmes Harbor (Whidbey Basin), 12:40 PM

High number of schooling fish. We count more than 17 schools on this image (marked with white vertical lines).
