Eyes Over Puget Sound

Surface Conditions Report: March-June 2022

Up-to-date observations of water quality conditions in Puget Sound and coastal bays

LONG-TERM MARINE MONITORING UNIT

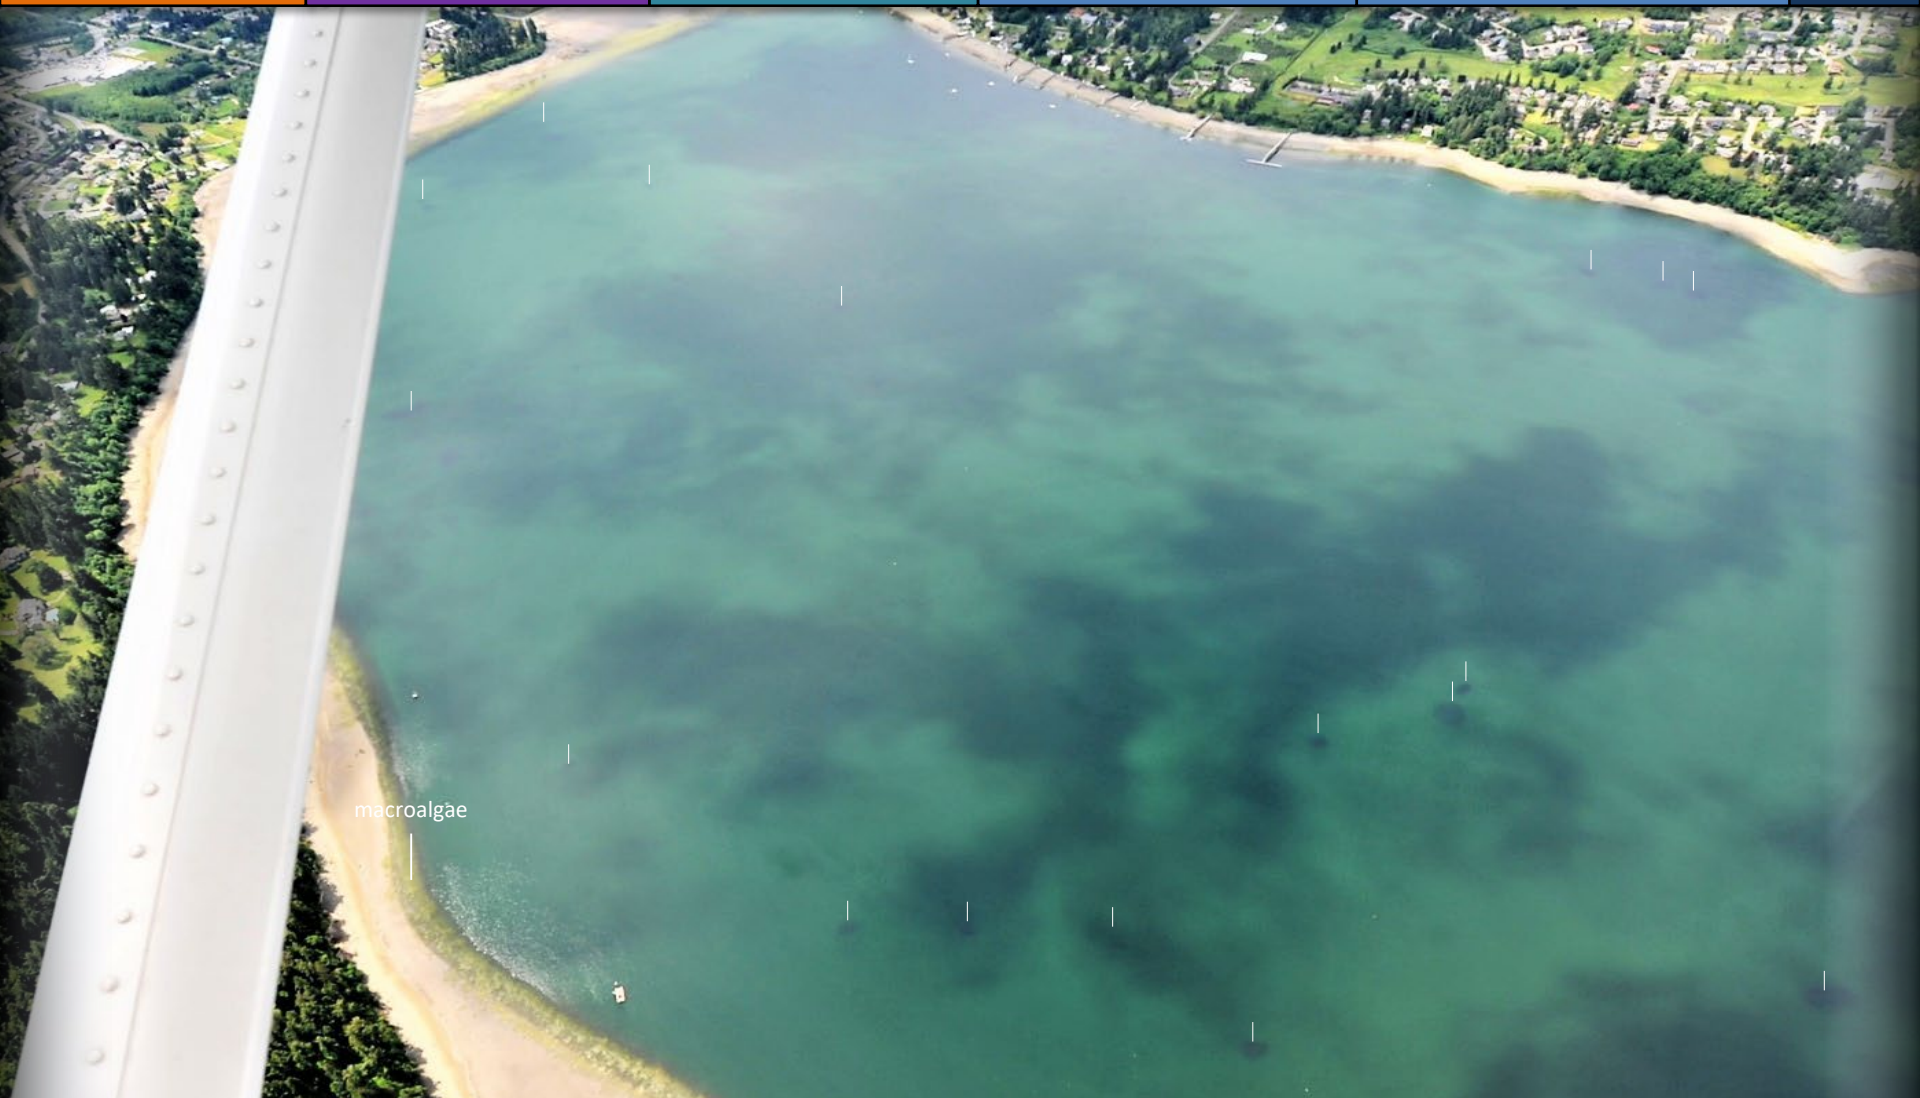
Location: Holmes Harbor (Whidbey Basin), 12:40 PM

High number of schooling fish. We count more than 13 schools on this image (marked with white vertical lines).

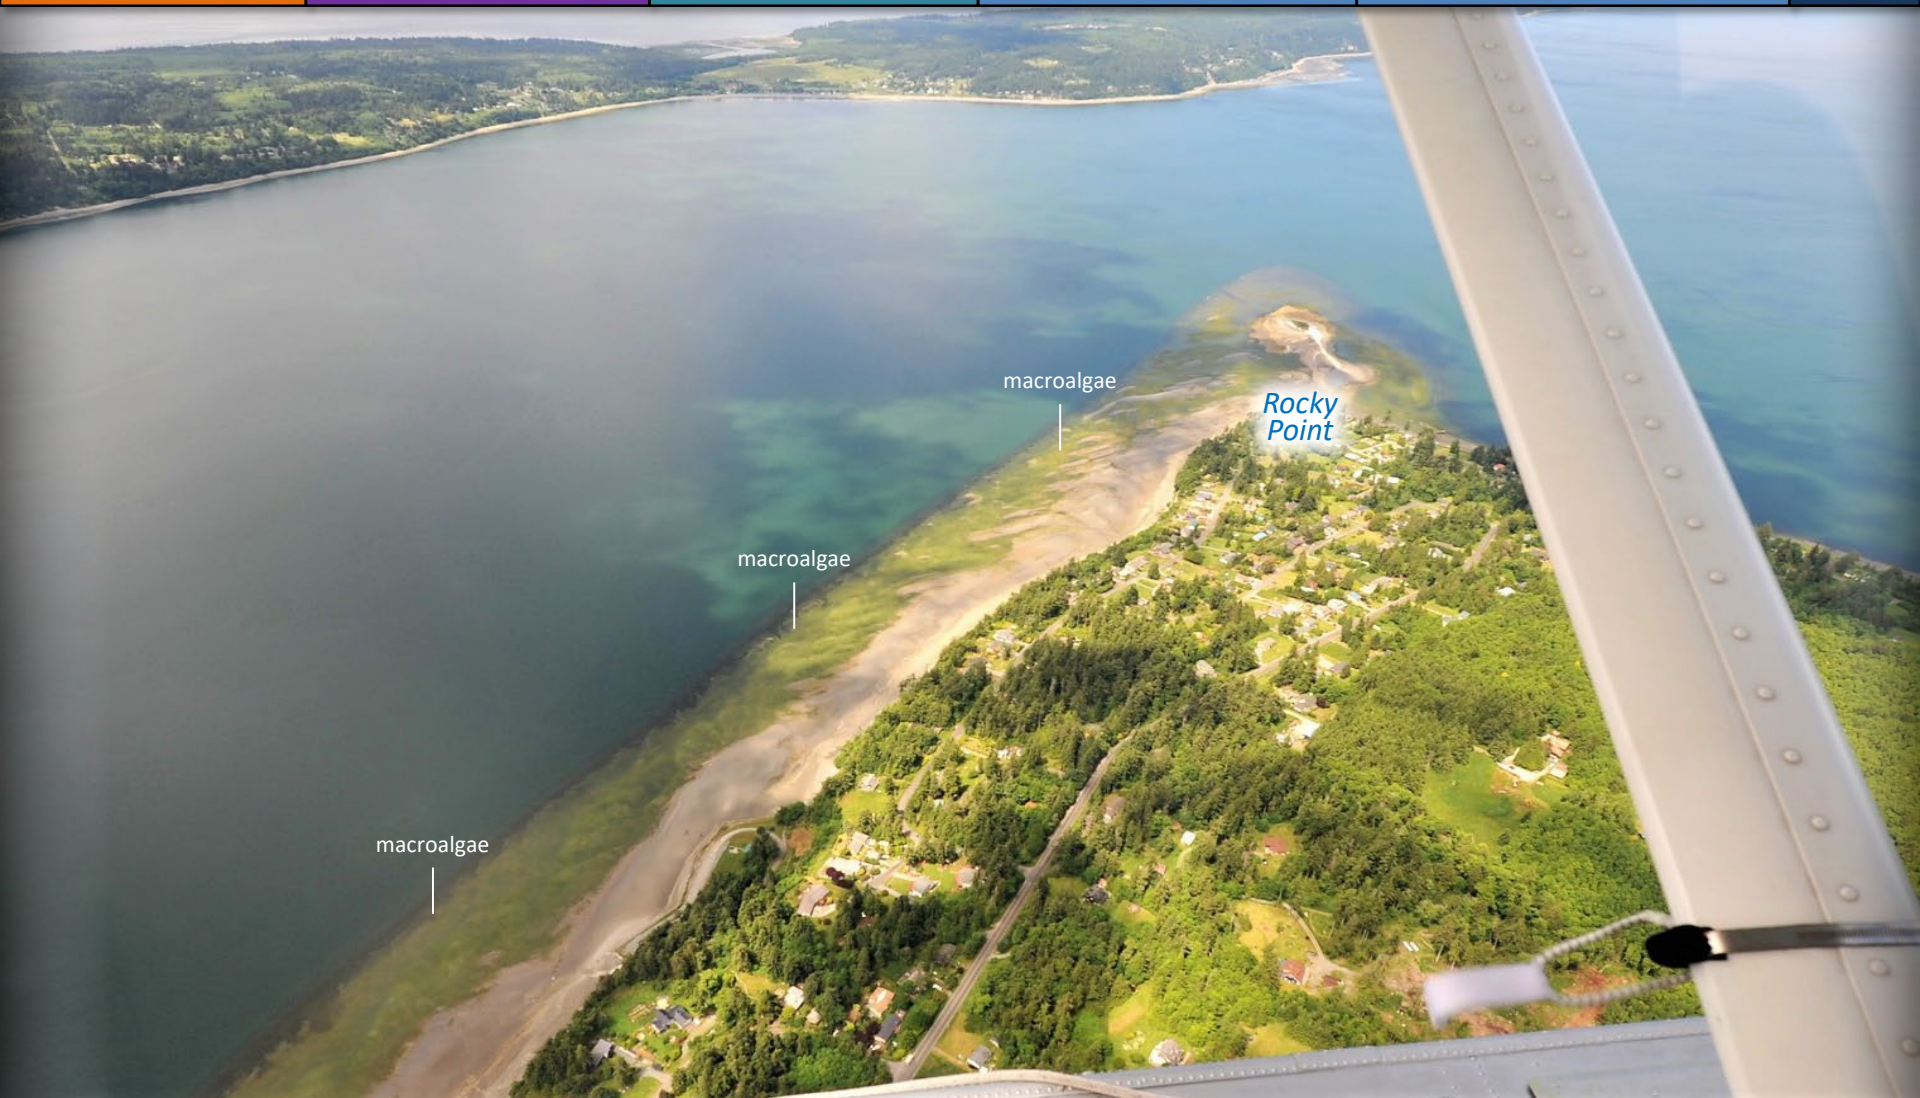
*Macroalgae growing in thick layers on eastern shores of Holmes Harbor.
Location: Baby Island Heights, (Whidbey Basin), 12:43 PM*

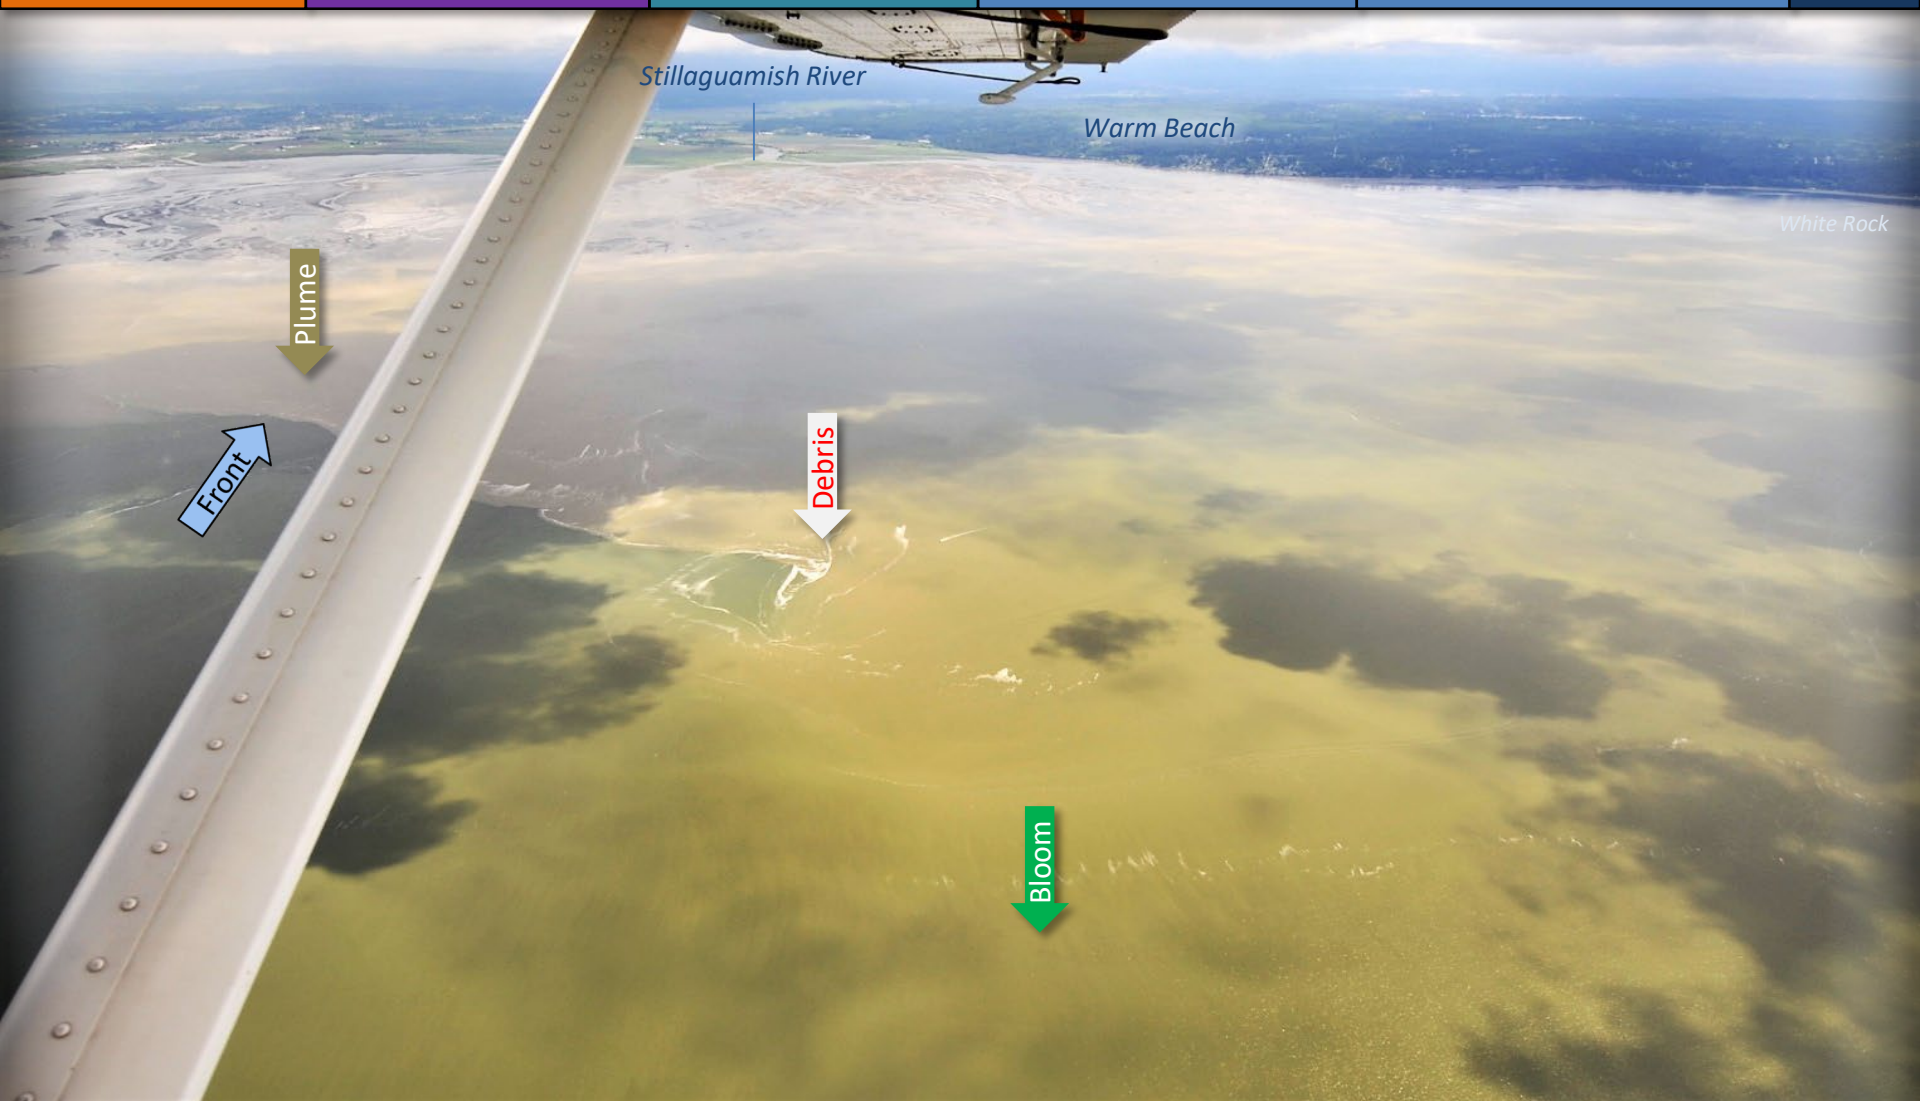
Strong discoloration of water in Port Susan by bloom and sediment. Fronts surrounding the Stillaguamish River plume. Location: Port Susan (Whidbey Basin), 12:46 PM

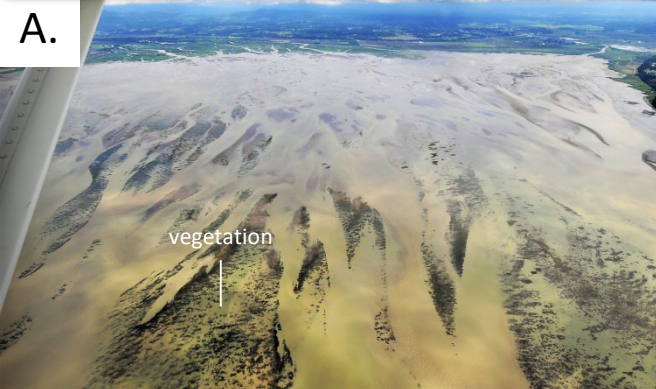
*A. Very low tide exposes large areas of the mudflats and vegetation. B. Little water remains in the bay.
Location: Skagit Bay (Whidbey Basin), 12:52 PM*

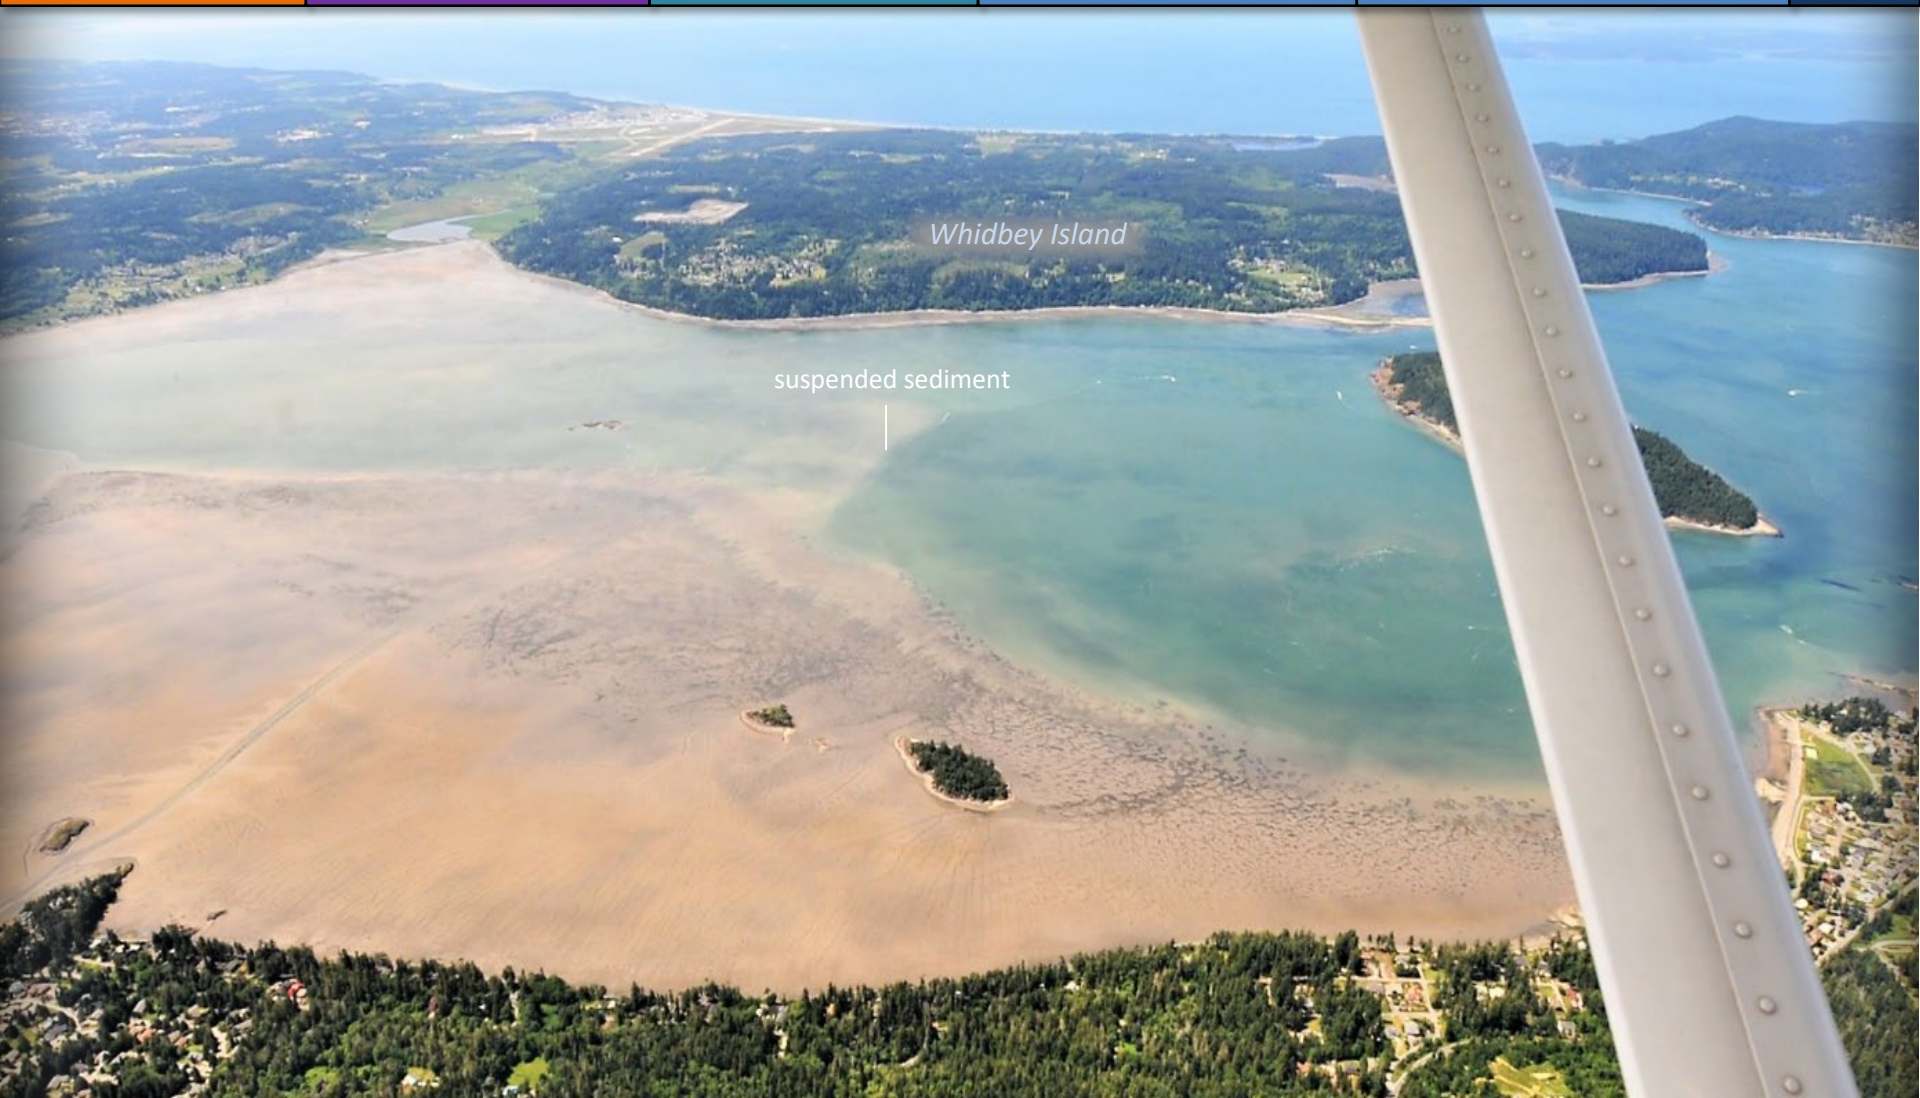
Very low tide exposes large areas of the mudflats collecting sunlight, while little water remains in the bay.
Location: Skagit Bay (Whidbey Basin), 12:55 PM

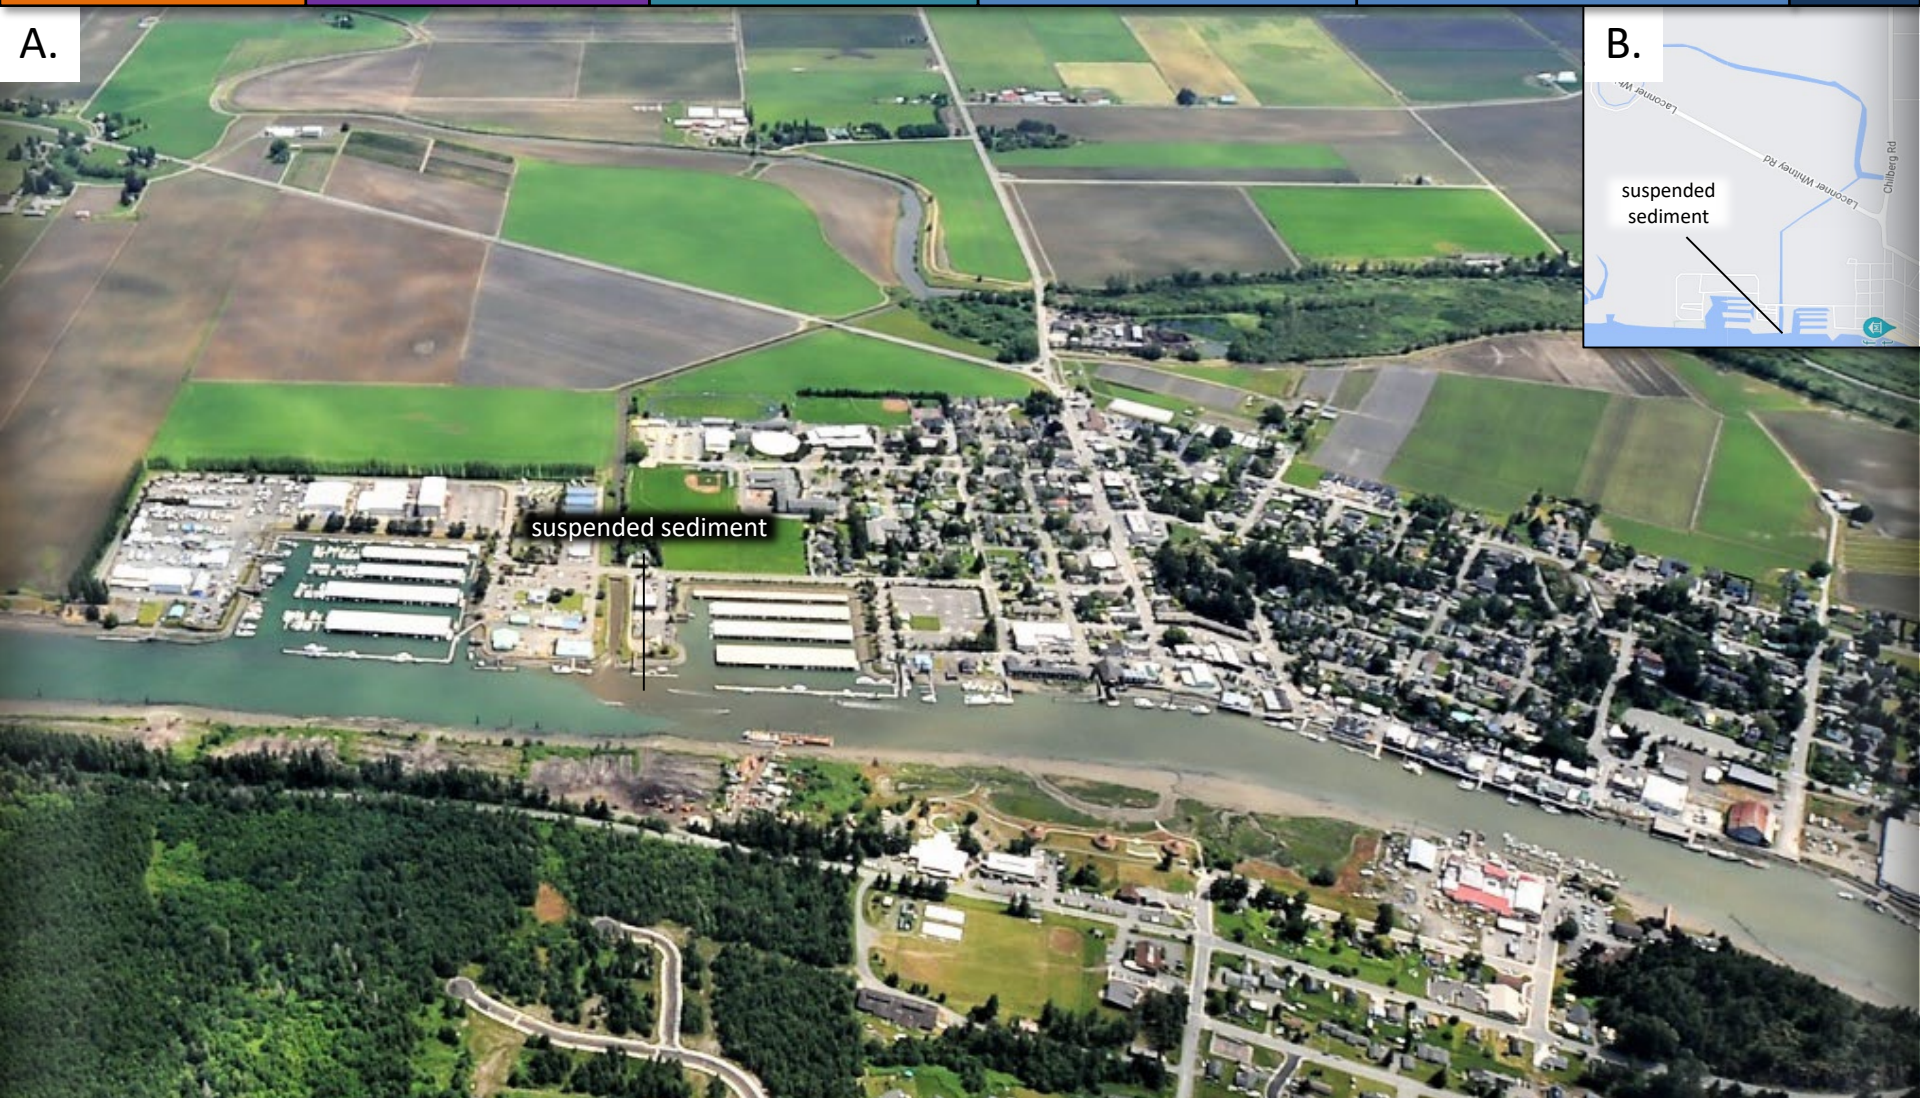
*A. Very brown water entering the Swinomish Channel from a B. drainage channel next to La Conner Marina.
Location: Whidbey Basin (North Sound), 12:55 PM*

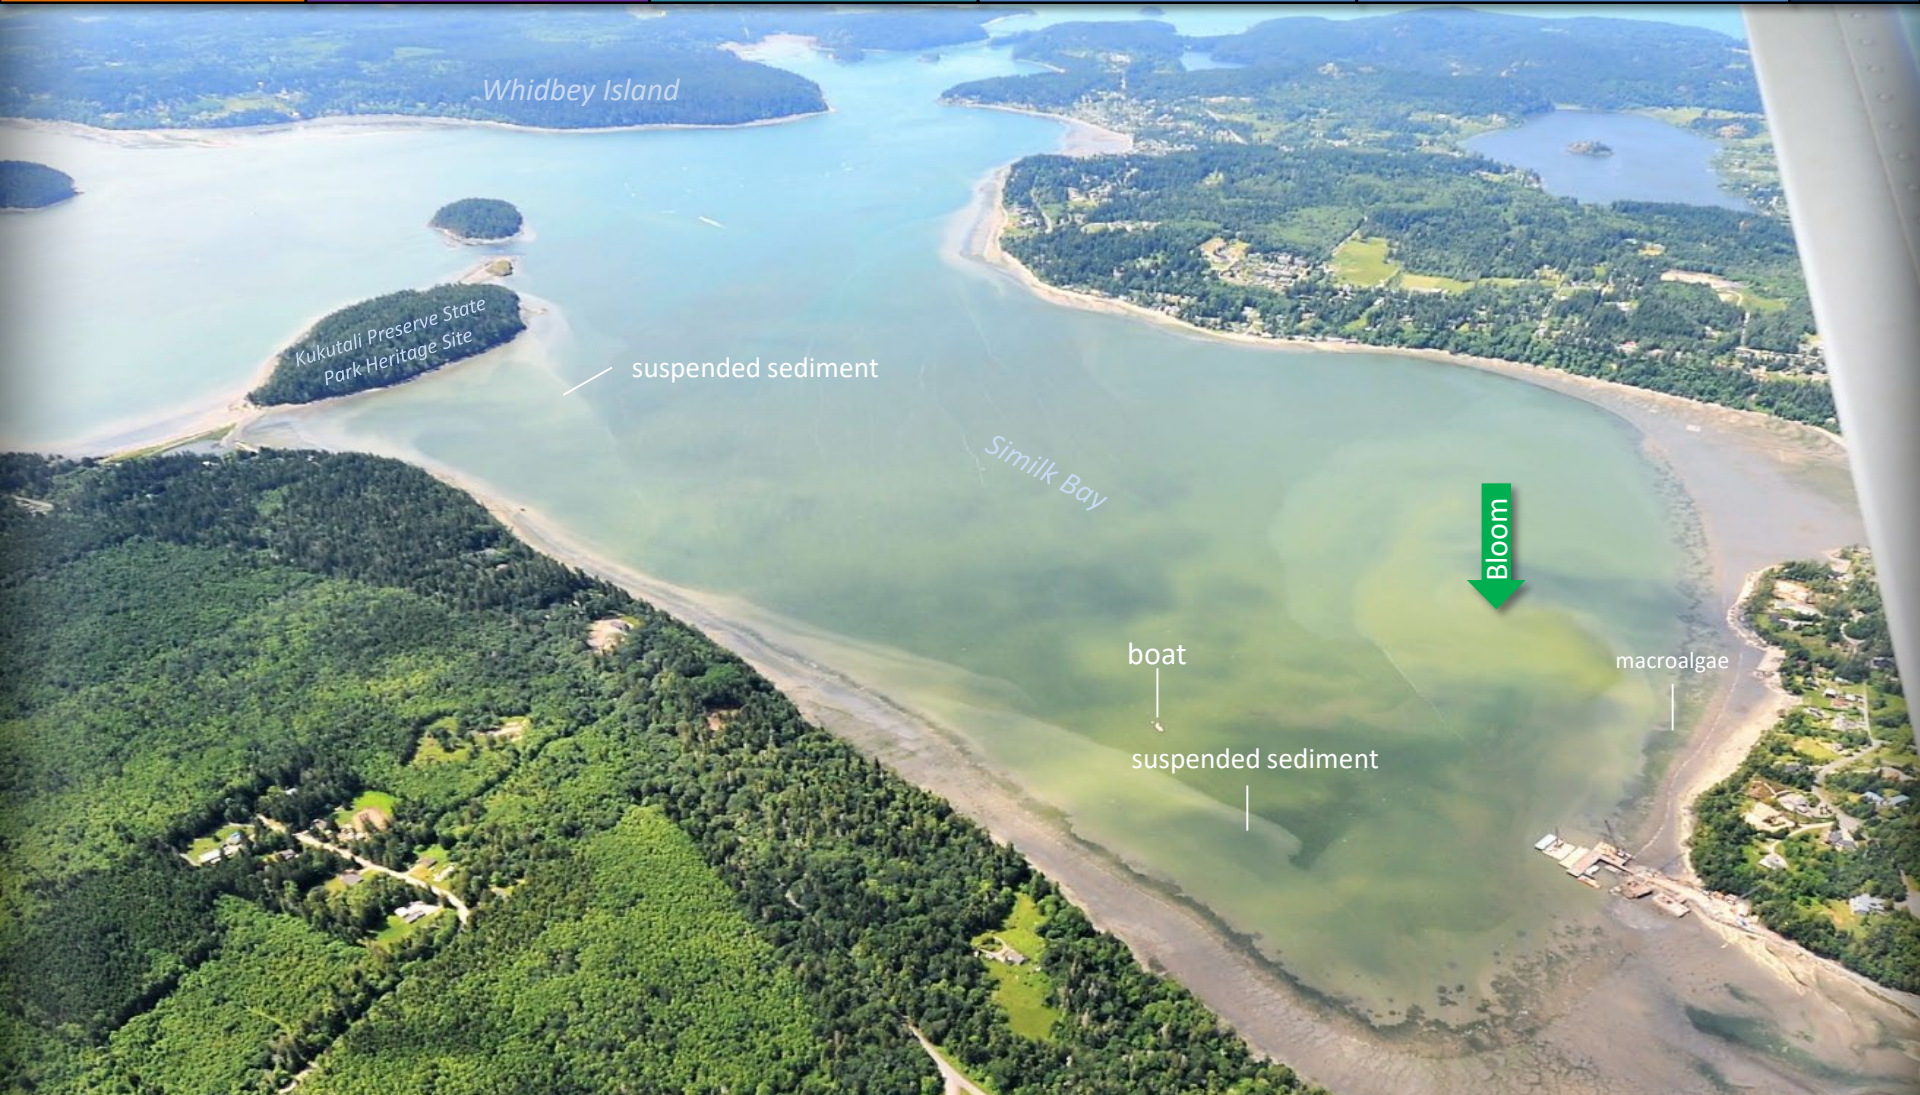
*Green bloom mixed with nearshore suspended sediment.
Location: Similk Bay (Whidbey Basin), 12:56 PM*

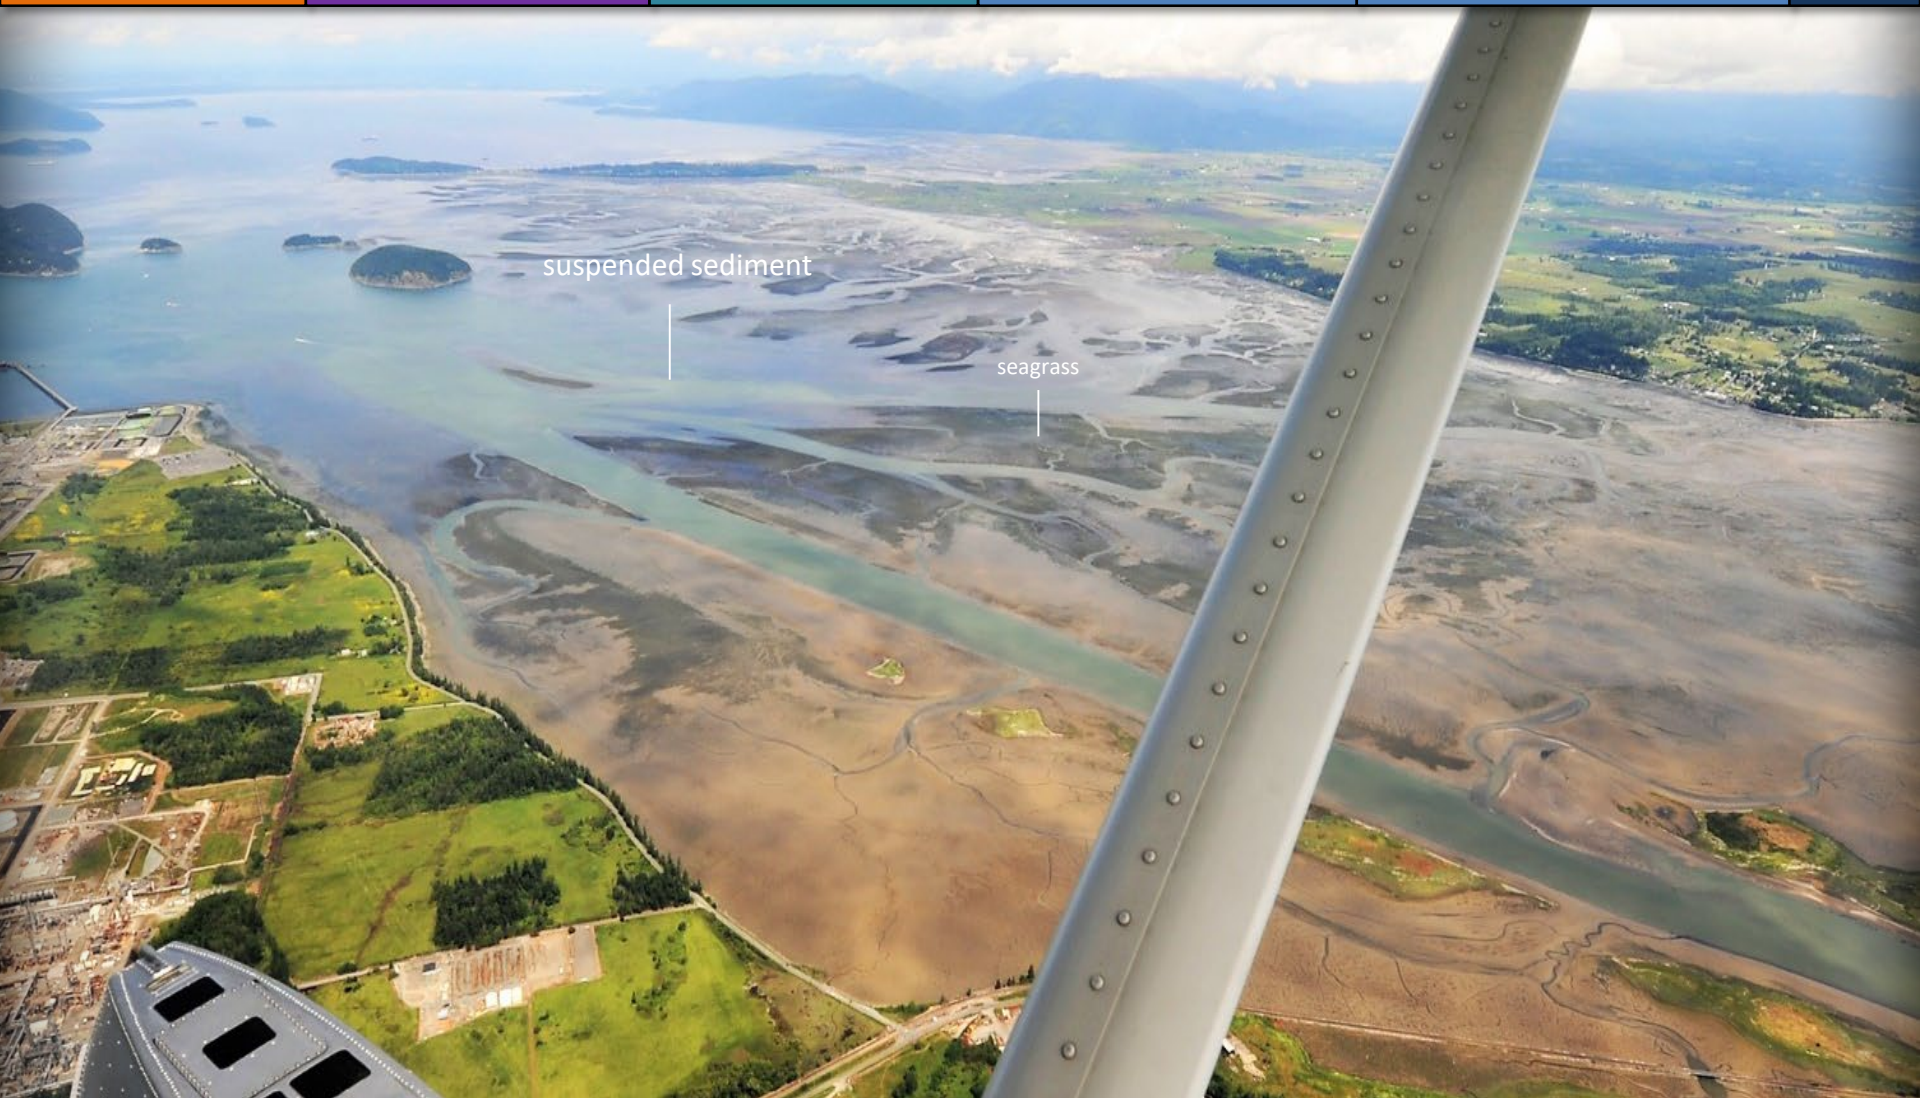
Very low tide exposing large areas of the Padilla Bay eelgrass beds to warm summer temperatures.

Location: Padilla Bay (North Sound), 1:00 PM

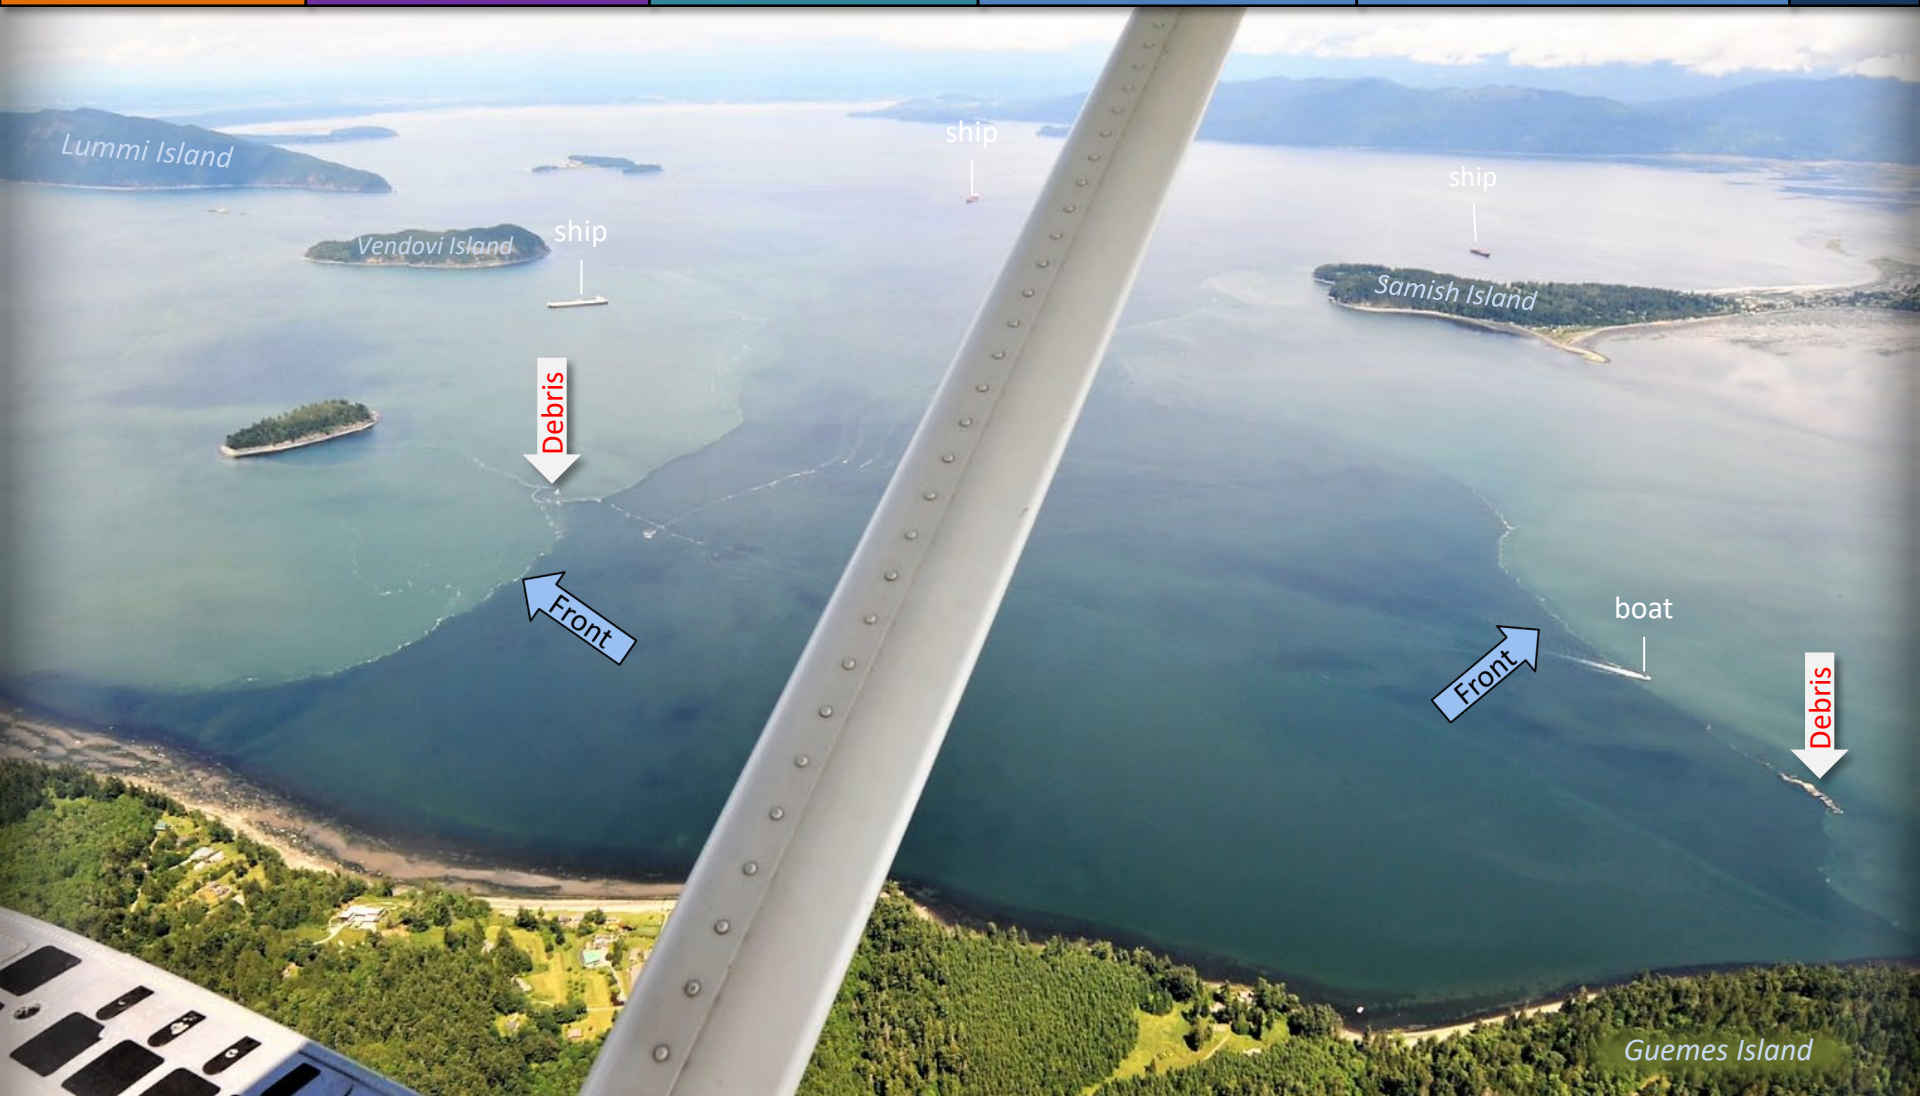
Sediment-laden water creates a mosaic of different surface conditions separated by fronts.

Location: Off Guemes Island (North Sound), 1:01 PM

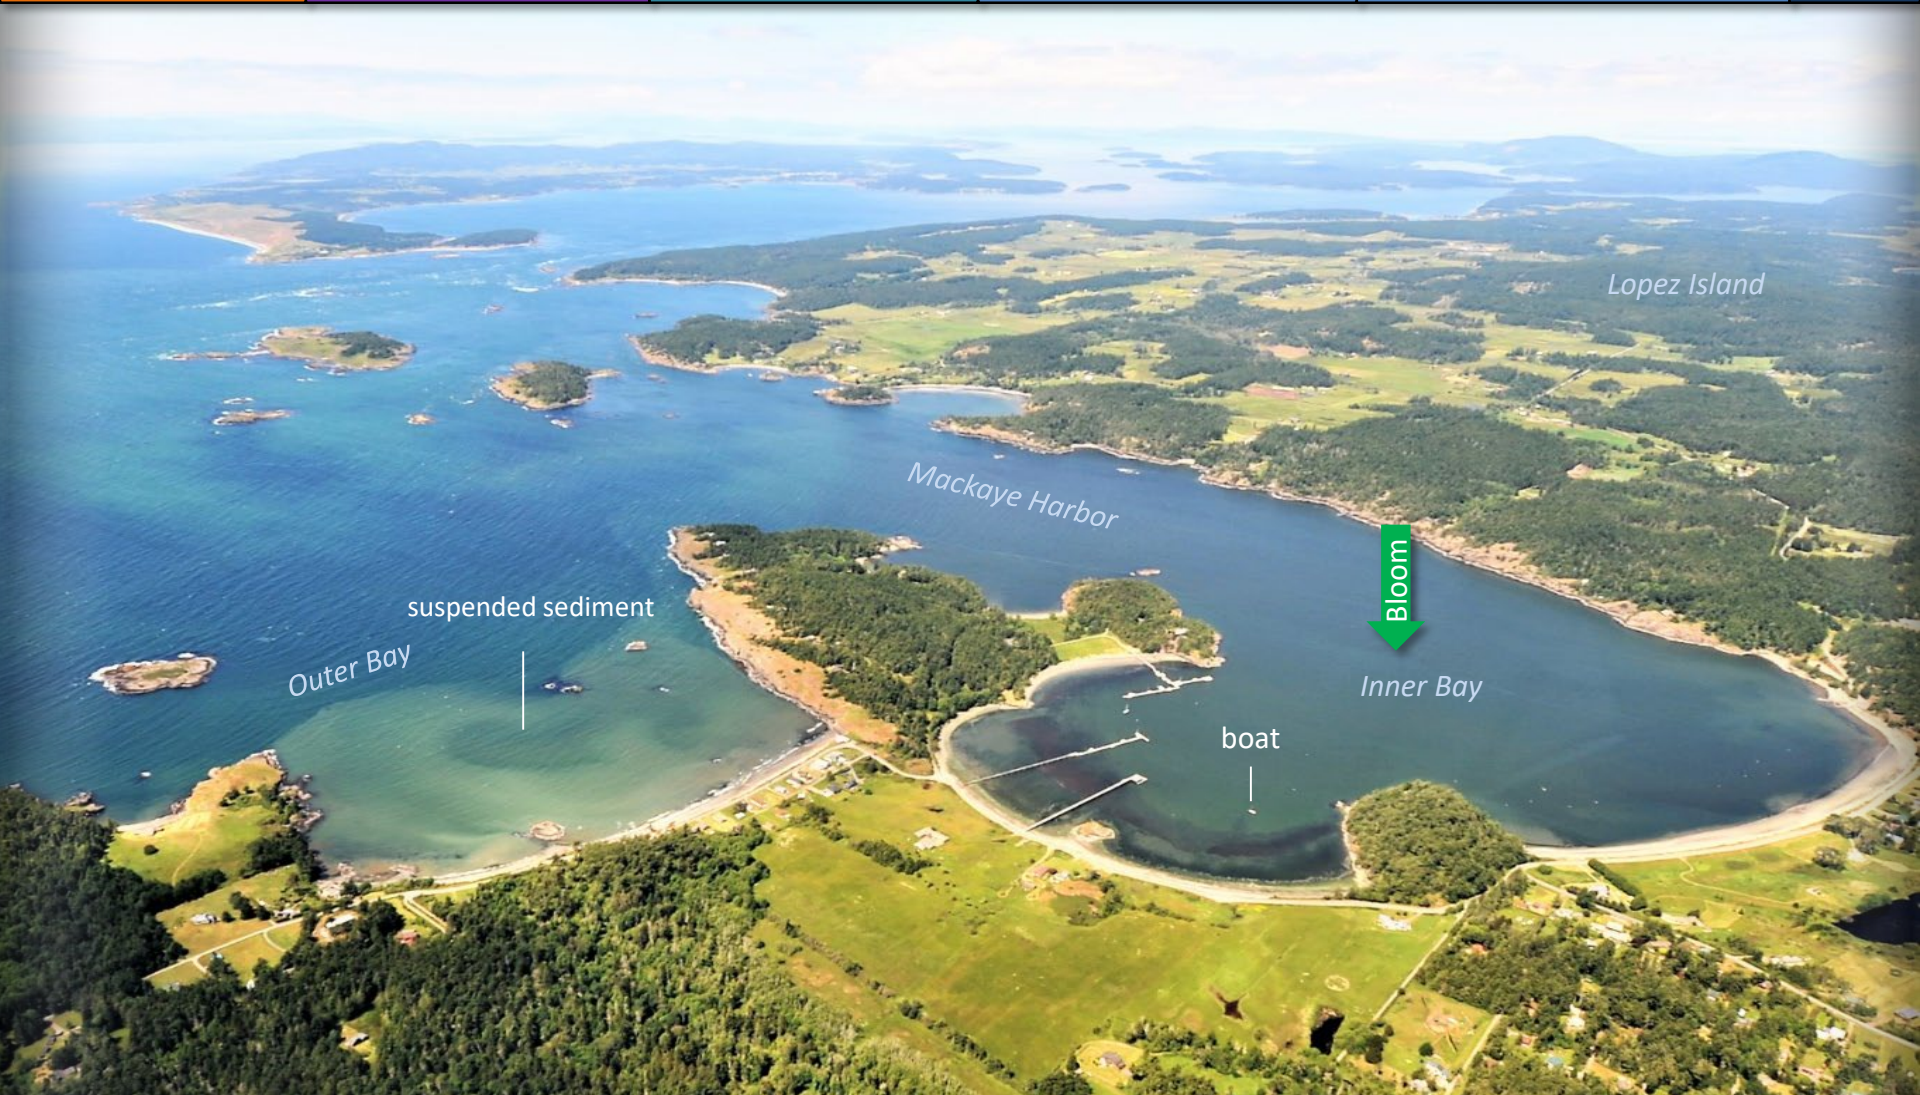
Eddy and suspended sediment in Outer Bay. Greener water in Inner Bay.

Location: Lopez Sound (San Juan Islands), 1:13 PM

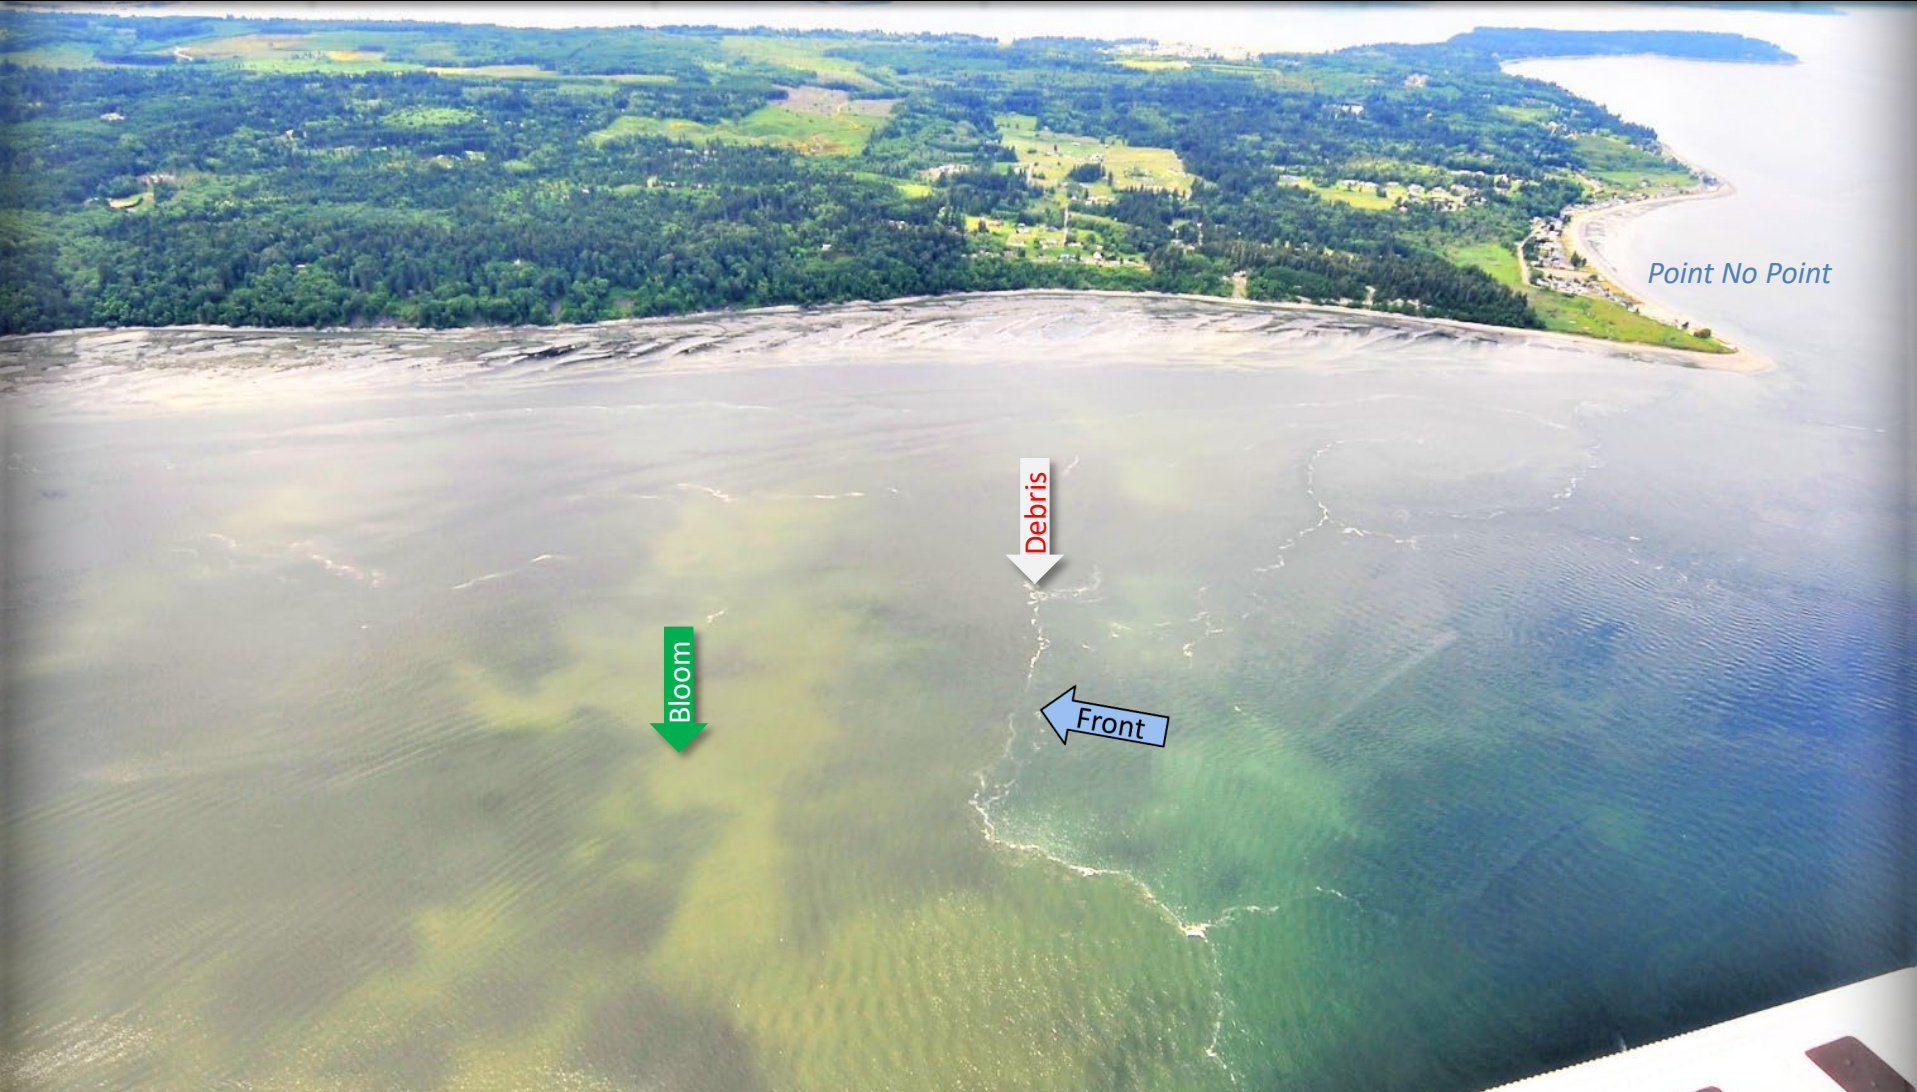
Front separating water discolored by a strong bloom in Central Basin from clearer water to the north.

Location: Point No Point (Central Sound), 1:35 PM
