Eyes Over Puget Sound

Surface Conditions Report: March-June 2022

Up-to-date observations of water quality conditions in Puget Sound and coastal bays

LONG-TERM MARINE MONITORING UNIT

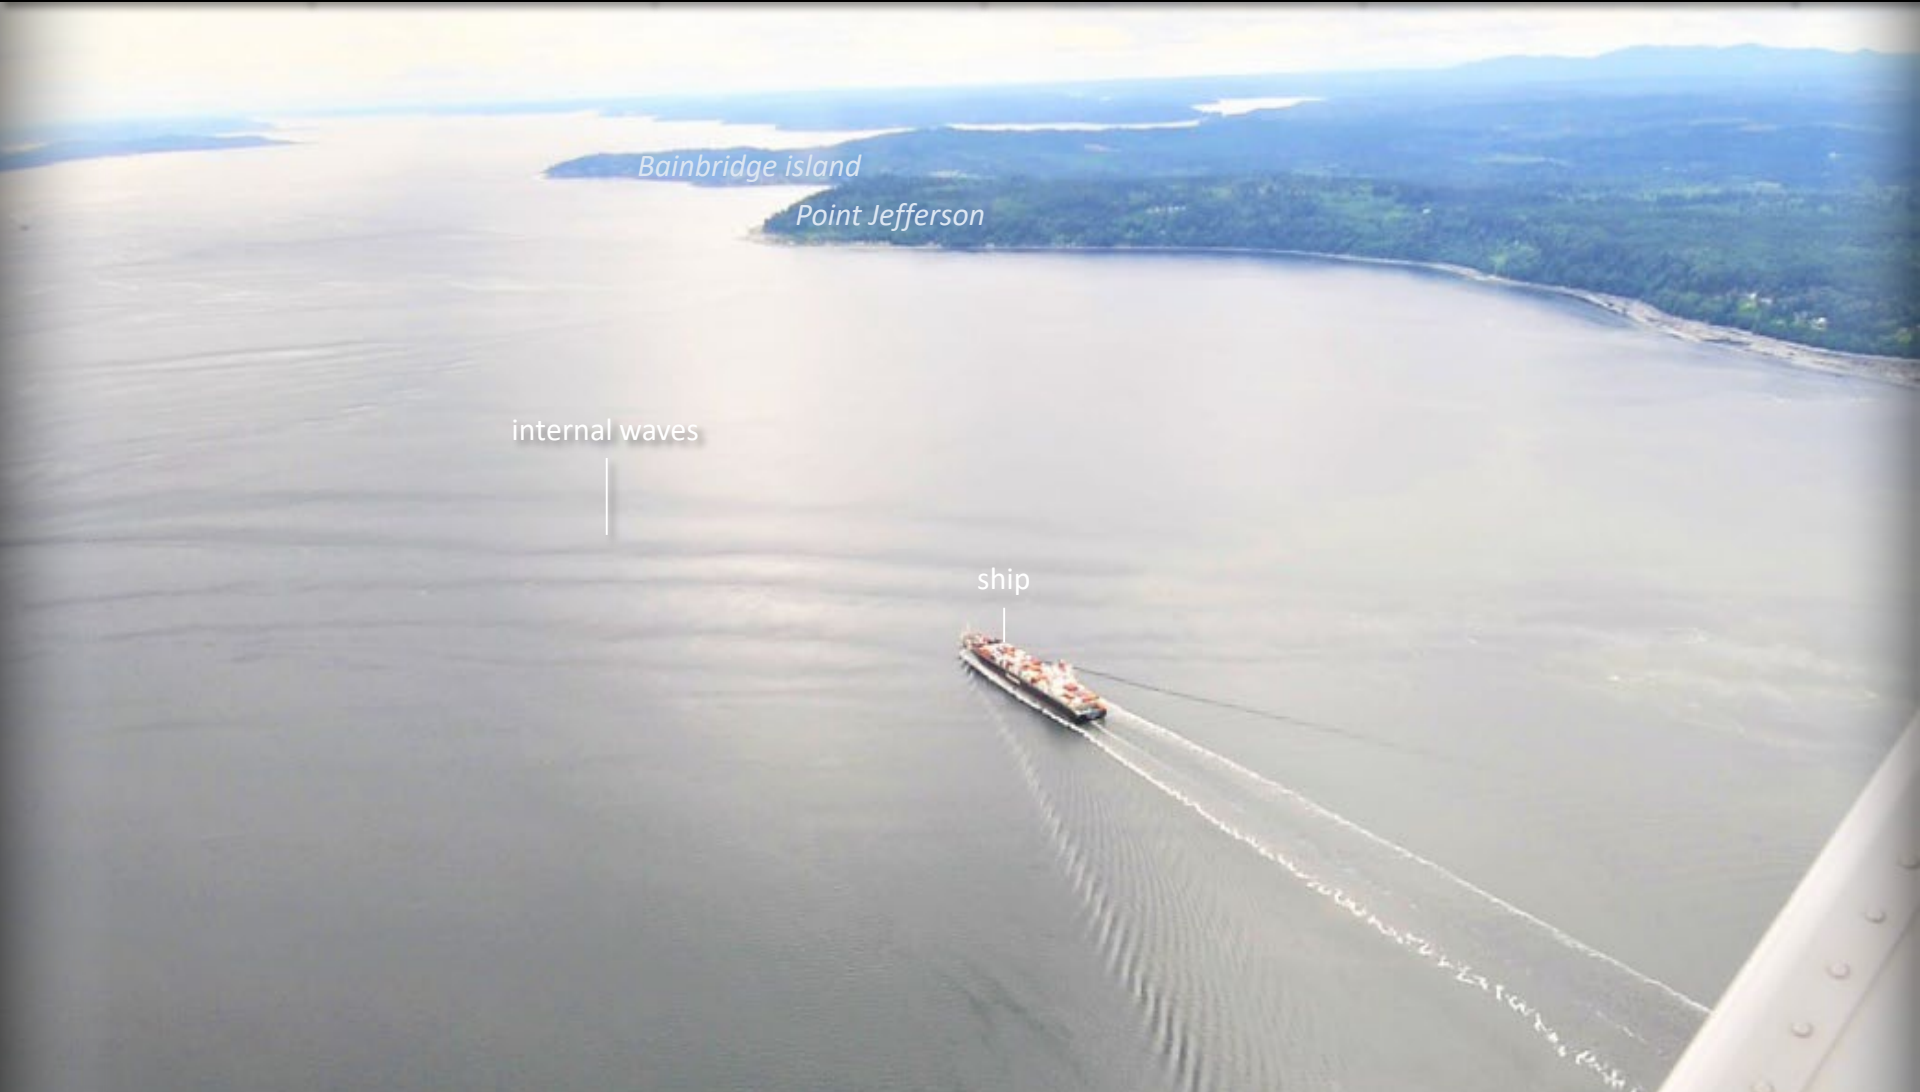
Large internal waves interacting with the water surface. The container ship surface waves appear small in comparison. Location: Kingston (Central Sound), 1:37 PM

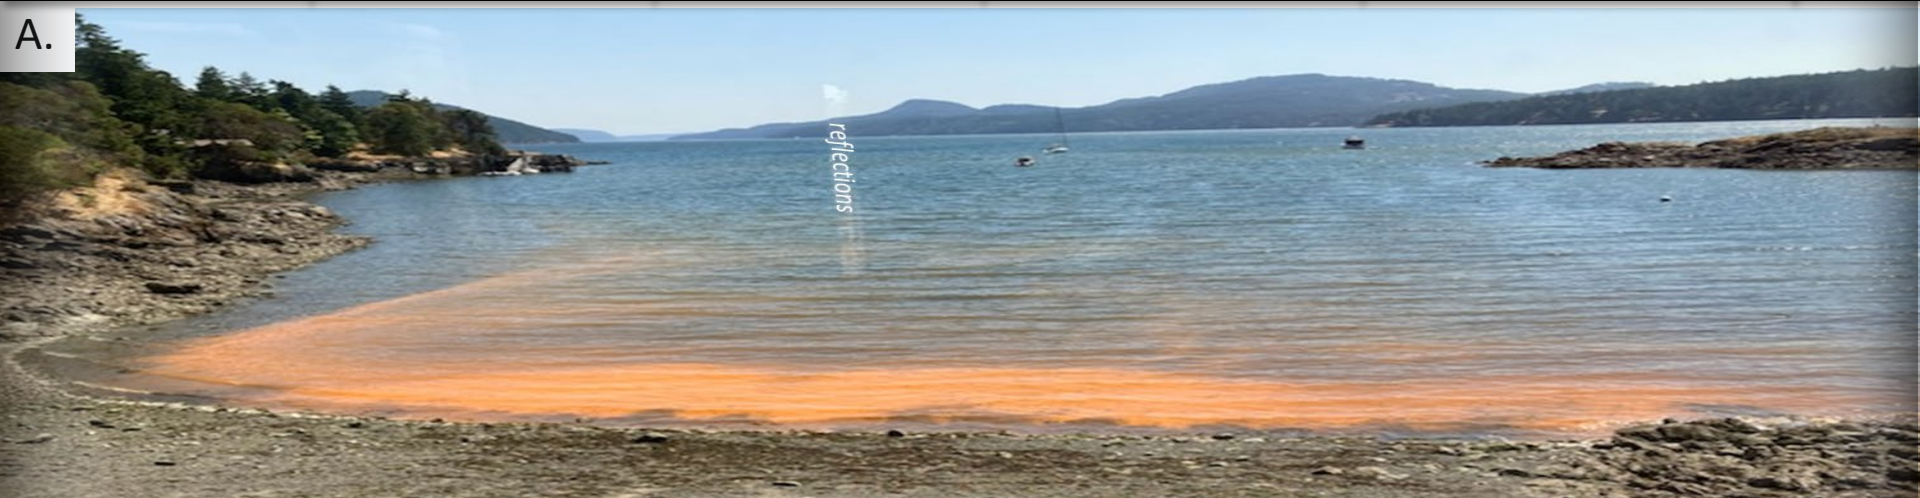
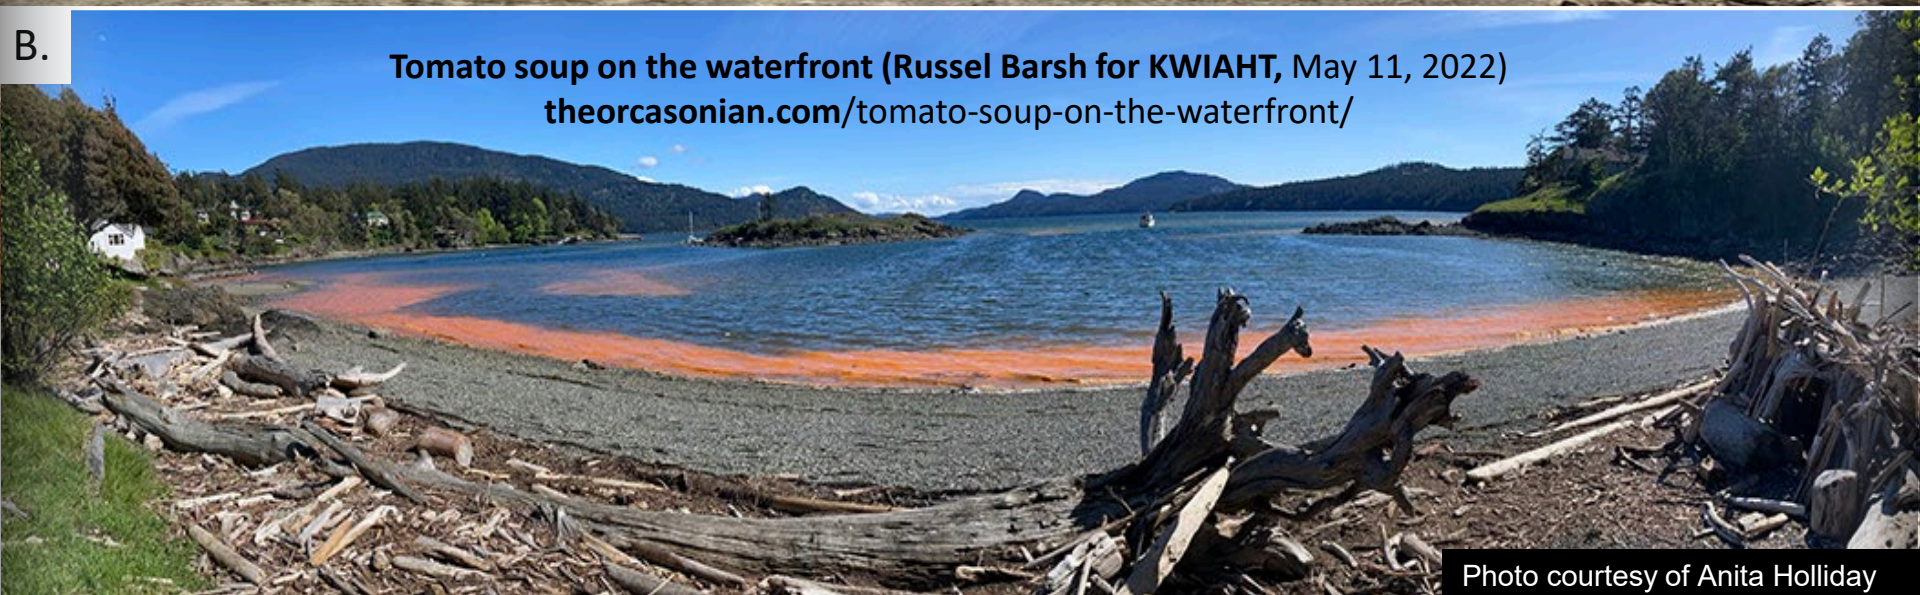
Tomato soup on the waterfront (Russel Barsh for KWIAHT, May 11, 2022)
theorcasonian.com/tomato-soup-on-the-waterfront/
